Browns Summit Creek Restoration Project Year 6 Monitoring Report

Guilford County, North Carolina

DMS Project ID No. 96313, DEQ Contract No. 5792

Monitoring Year: 6 of 7

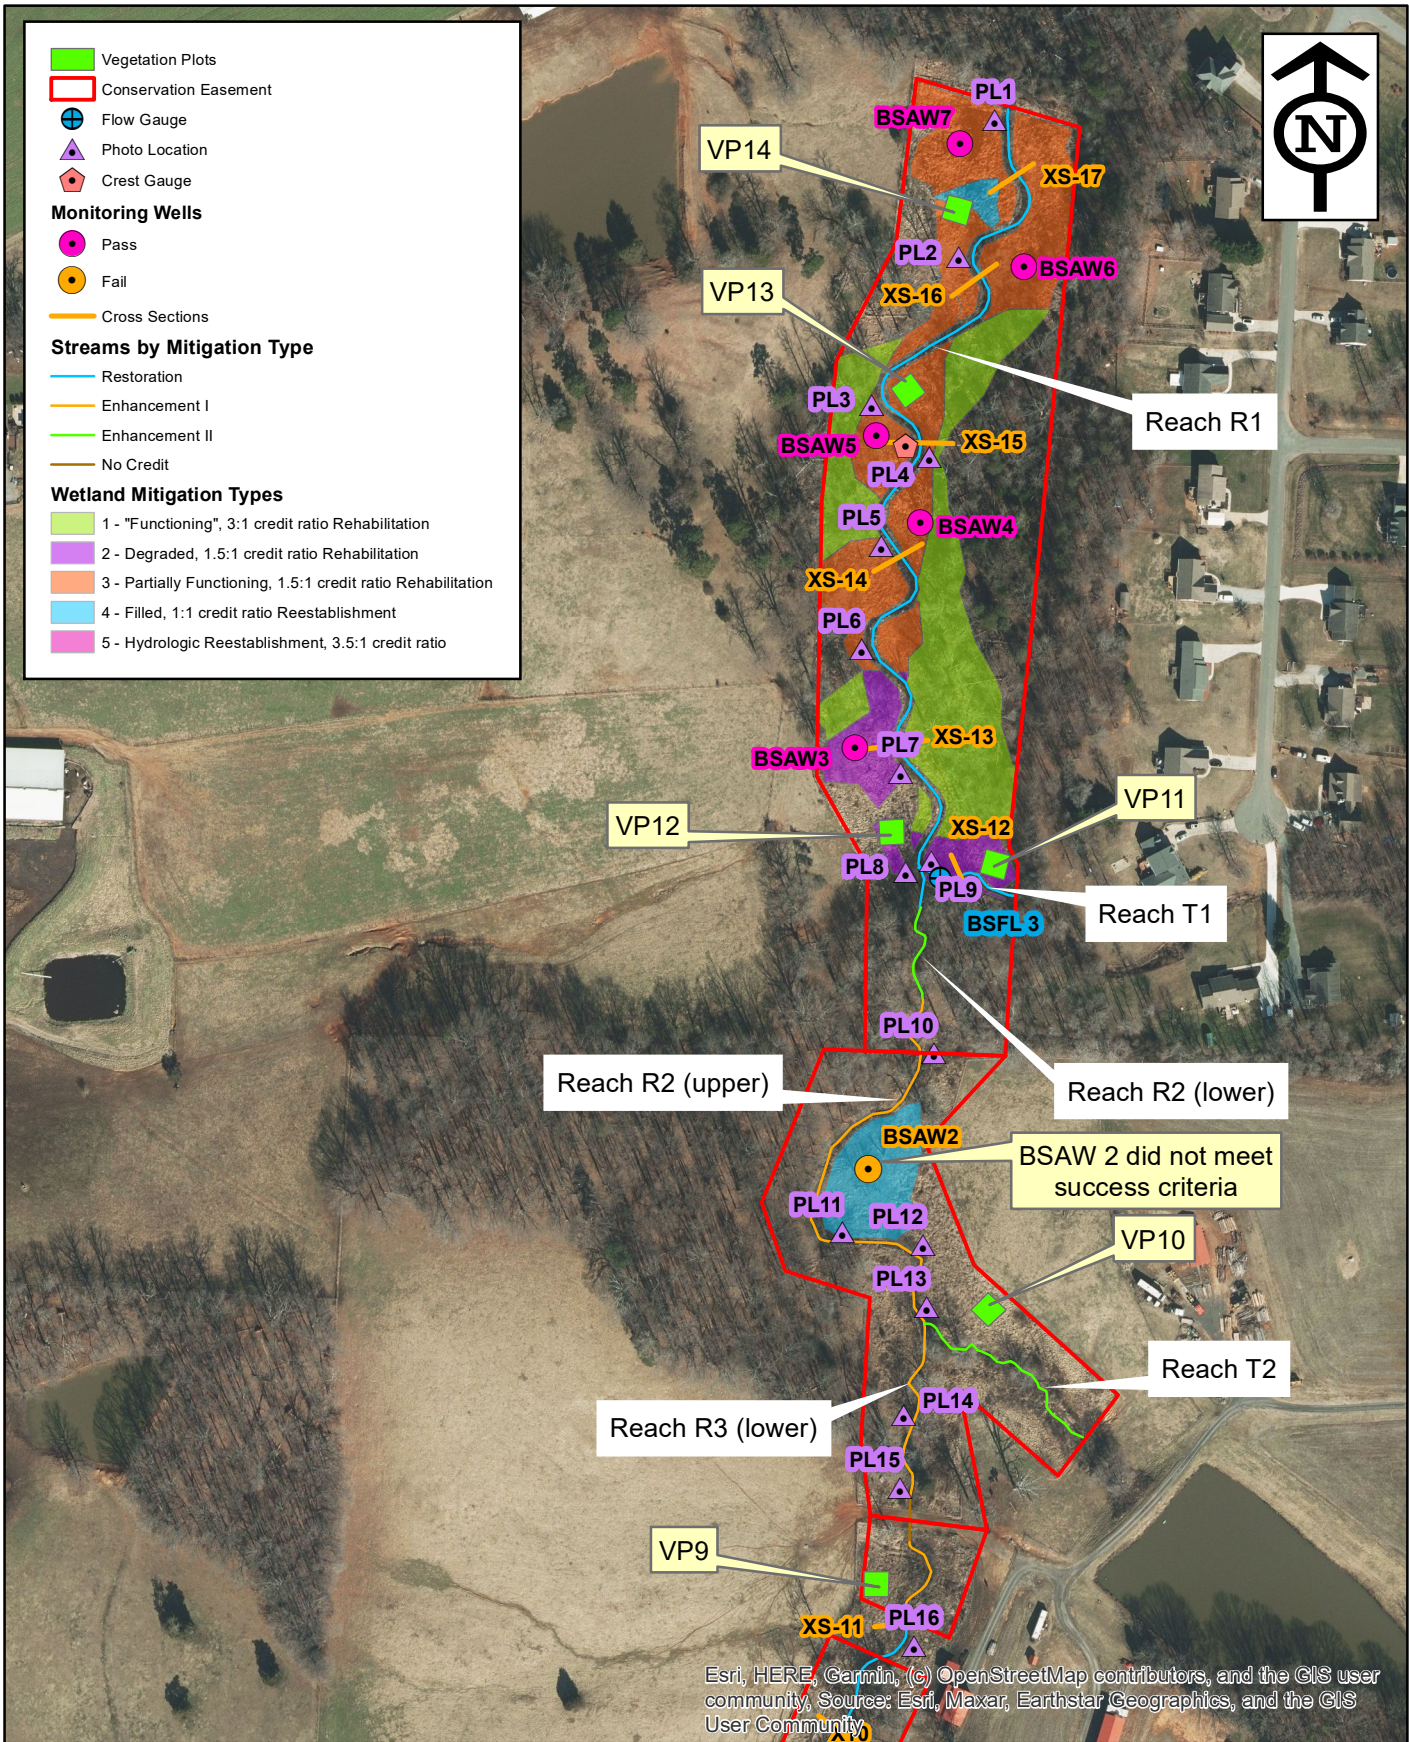
Figure 4.1
Current Conditions
Plan View
Browns Summit Site
(DMS #96313)

During Year 6 monitoring, visual site inspections were conducted throughout the year. Small areas of invasive species (Privet and Multiflora Rose) were treated on R1 and R2 during May 2022. Small pockets of privets are scattered throughout R1 and R2 and Michael Baker plans on a follow up treatment in the following monitoring year. One vegetation problem area (VPA) was discovered at the top of R6 left and right floodplain. It is observed that this area is approximately 0.03 acres and has low herbaceous survival and low tree vigor. In May 2022, Michael Baker added soil amendments to improve the soil quality in efforts that the native grasses surrounding the area will grow. Michael Baker plans to continue treating this area along with adding seed. These areas can be found on the CCPV in Appendix B.

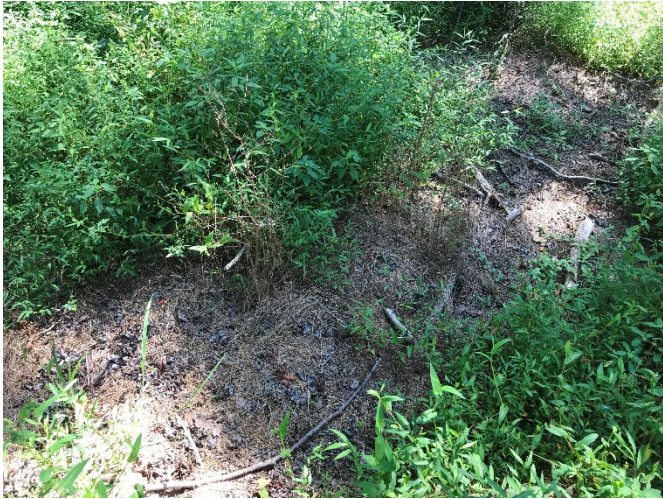
Invasive treatments on R1 Right floodplain (8/10/2022)

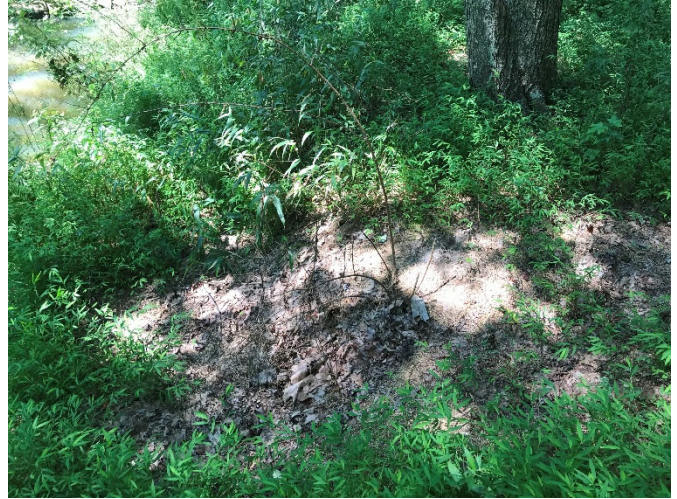
Invasive treatments on R1 left floodplain (8/10/2022)

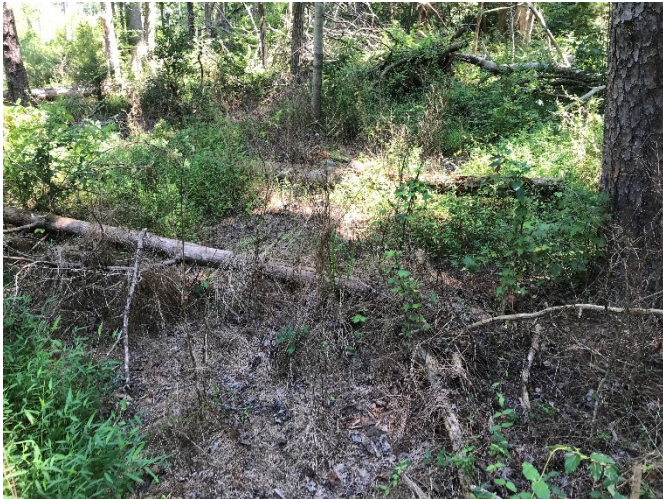
Invasive treatments on R1 right floodplain (8/10/2022)

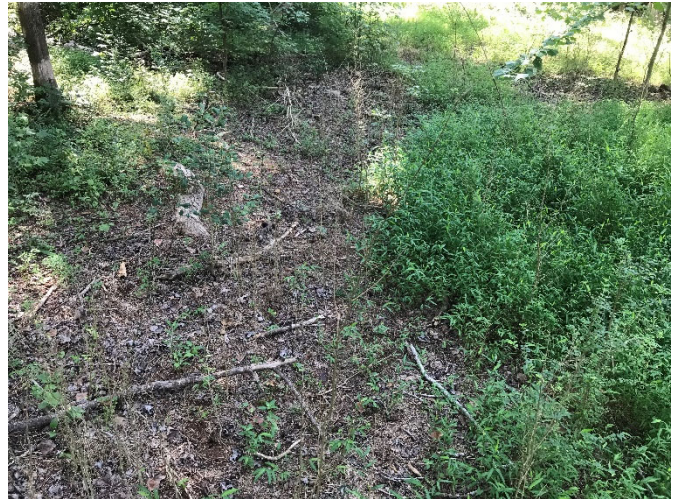
Invasive treatments on R1 left floodplain (8/10/2022)

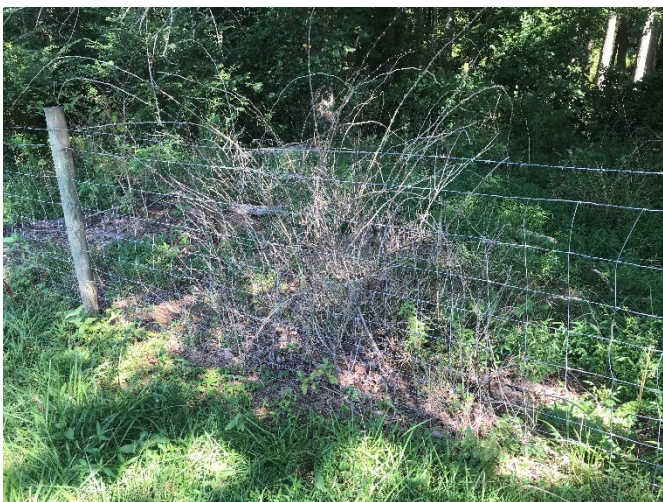
Invasive treatments on R2 (8/10/2022)

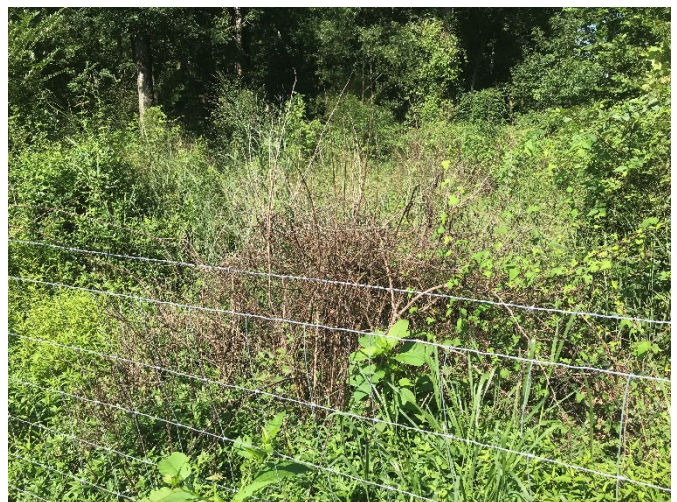
Invasive treatments on R3 (8/10/2022)

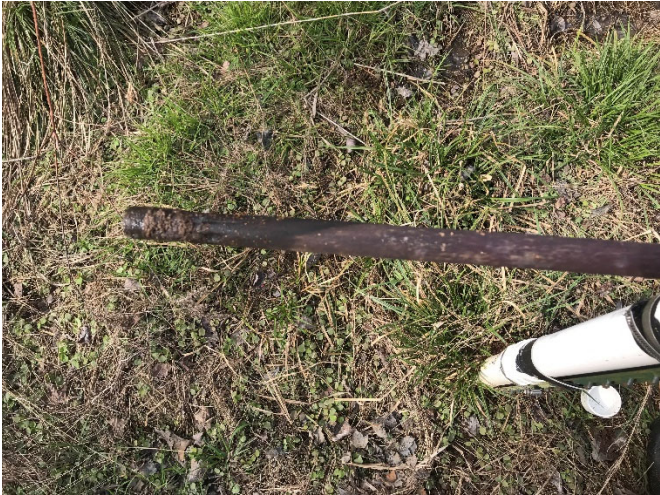
During Year 6 monitoring, the R1 crest gauge did not document any bankfull events. This was partially due to ant infestation within the cork at the bottom of the gauge. The gauge was cleaned out and replaced to record bankfull events in future monitoring years. The site has already met the bankfull flow requirement of two bankfull events within two separate monitoring years in previous monitoring years (MY1 and MY2).

Manual Crest Gauge – Reading 3/22/22 (No Reading)

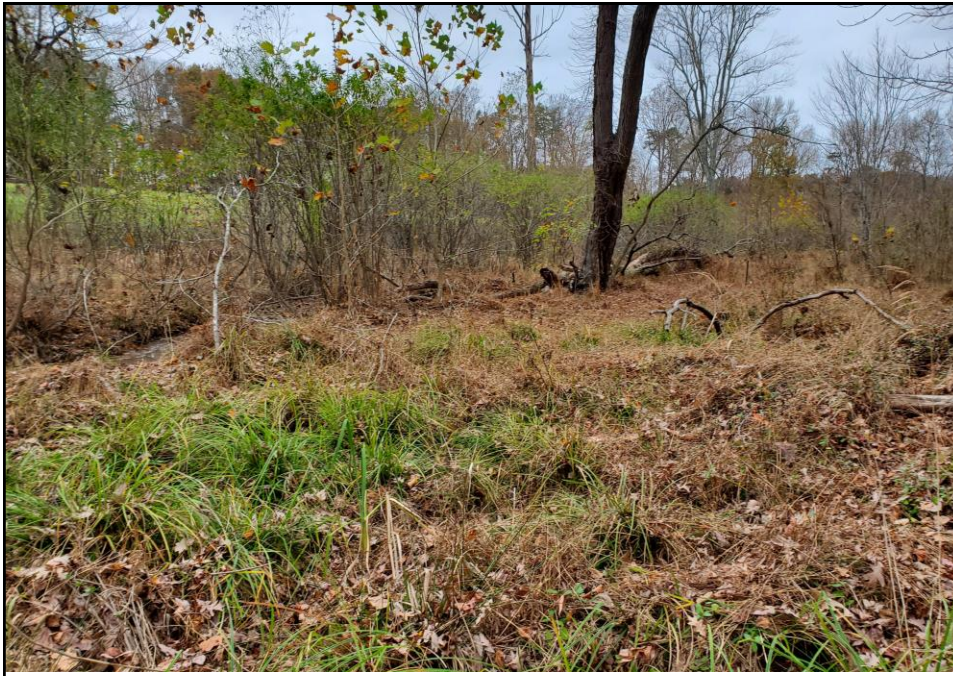
Photo 1. A view North along added wetland restoration area.

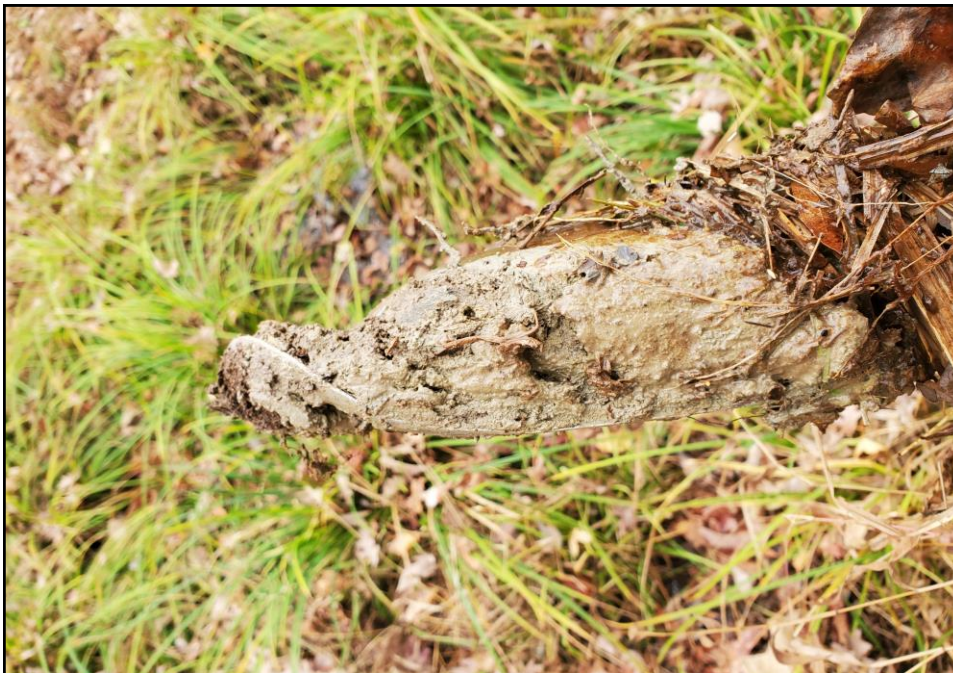
Photo 2. Hydric Soil present throughout added wetland restoration area.

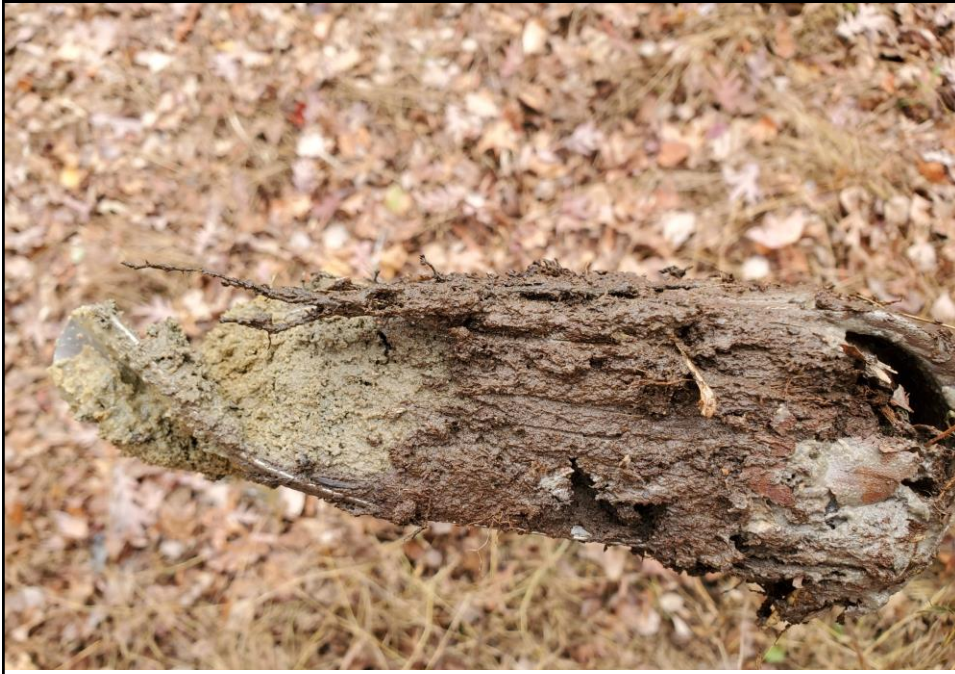
Photo 3. Hydric Soil present throughout added wetland restoration area.

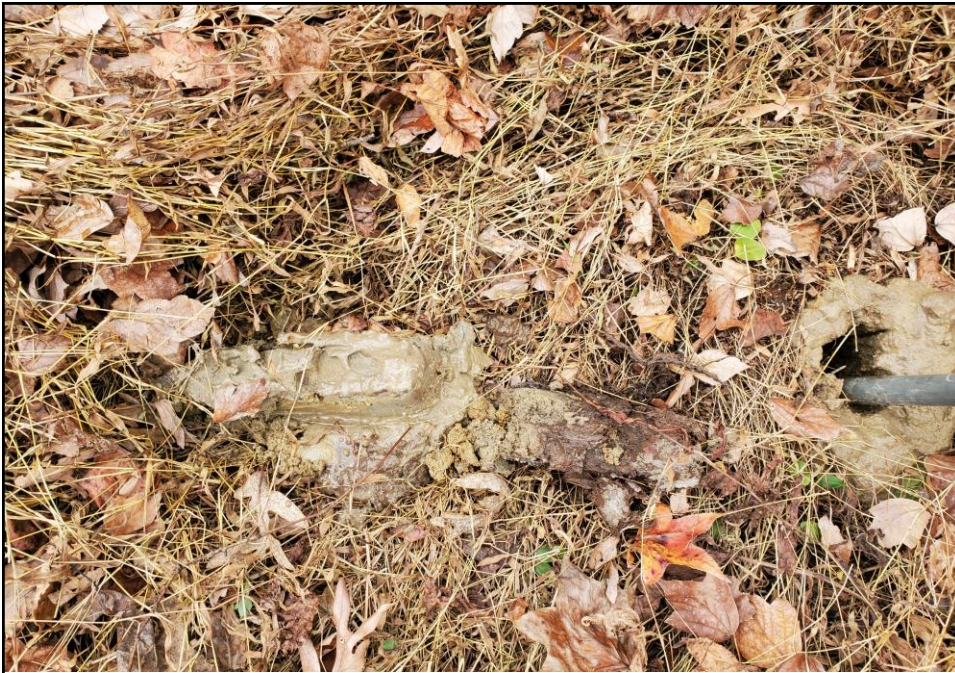
Photo 4. Hydric Soil present throughout added wetland restoration area.

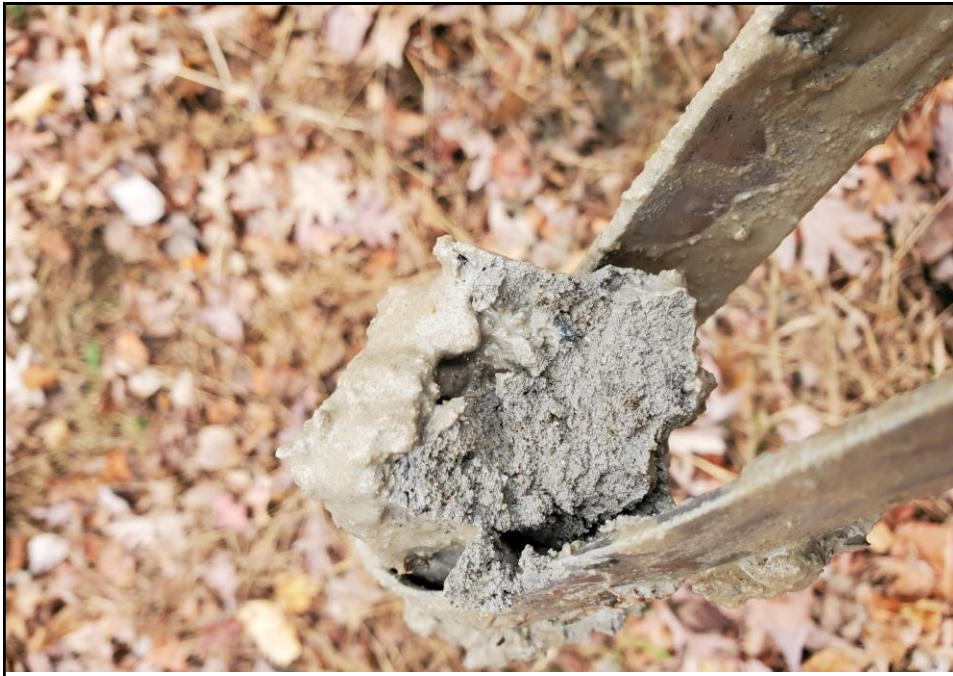
Photo 5. Hydric Soil present throughout added wetland restoration area.

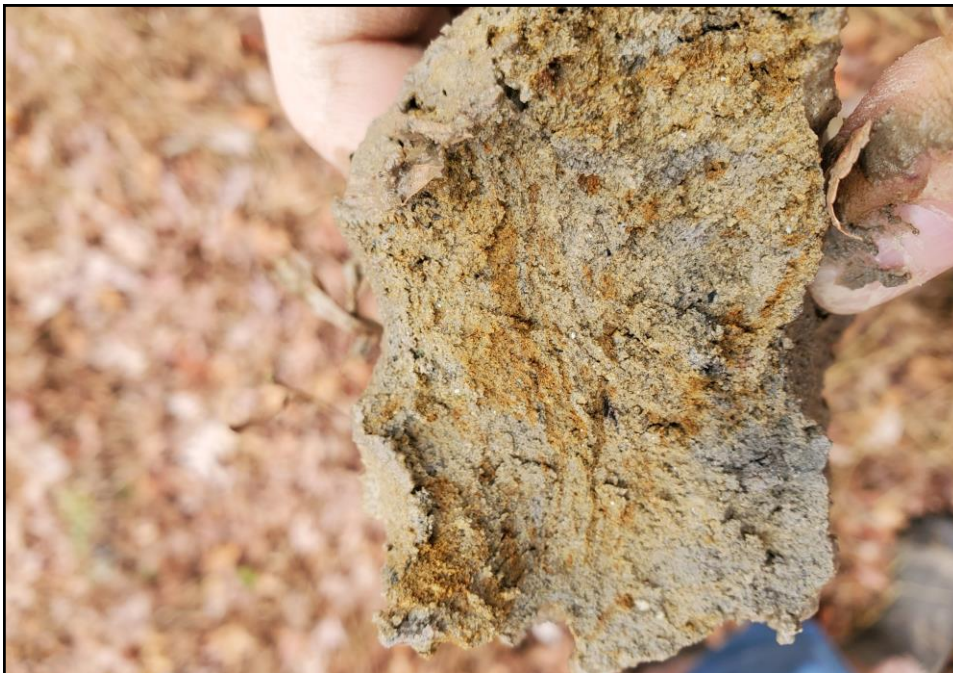
Photo 6. Hydric Soil present throughout added wetland restoration area.

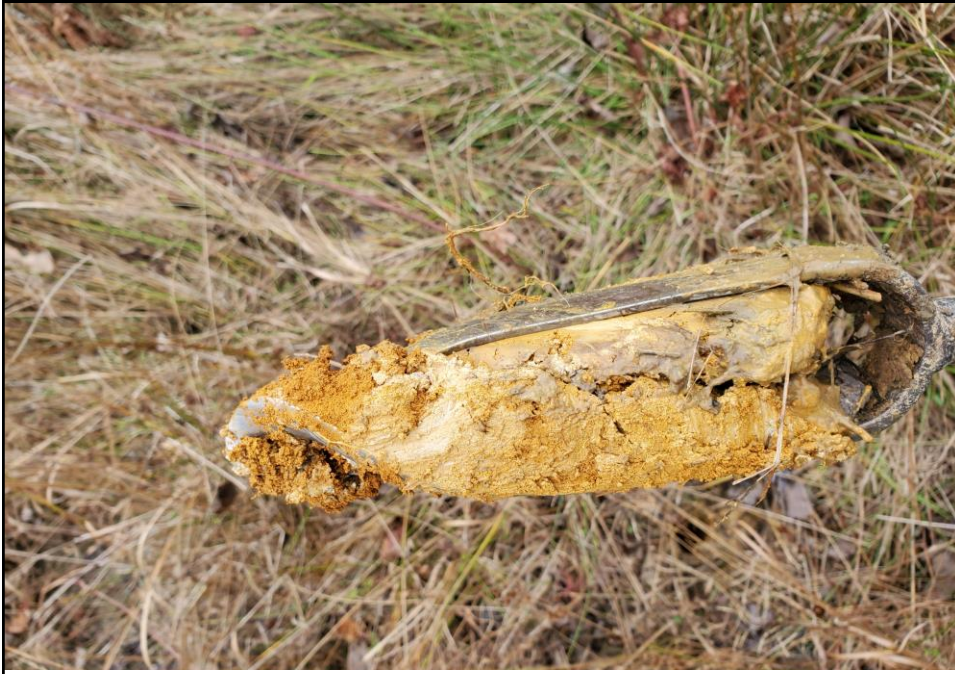
Photo 7. Hydric Soil present throughout added wetland restoration area.

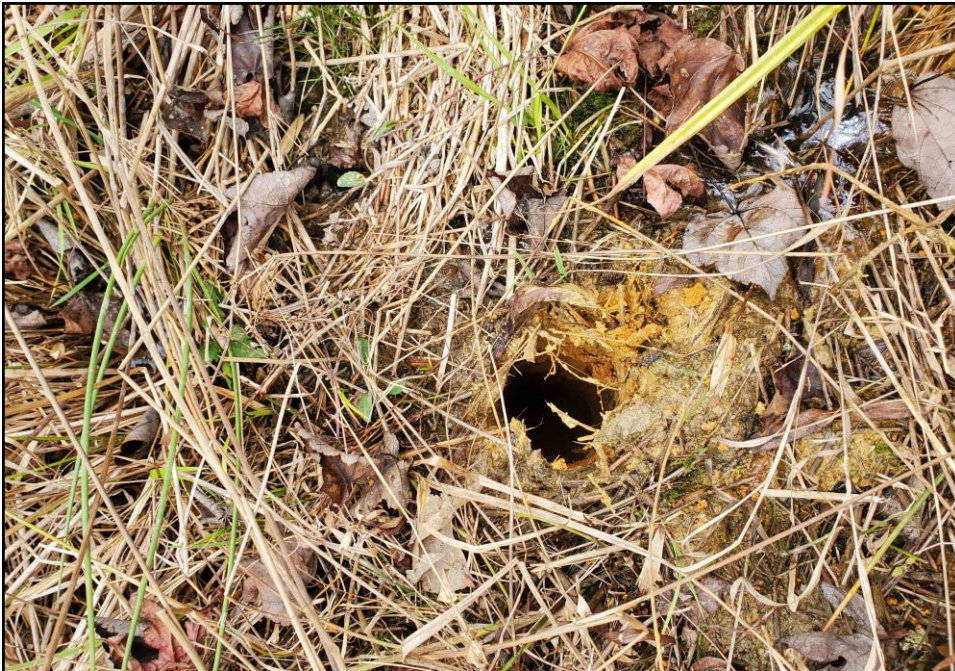
Photo 8. Hydric Soil present throughout added wetland restoration area.

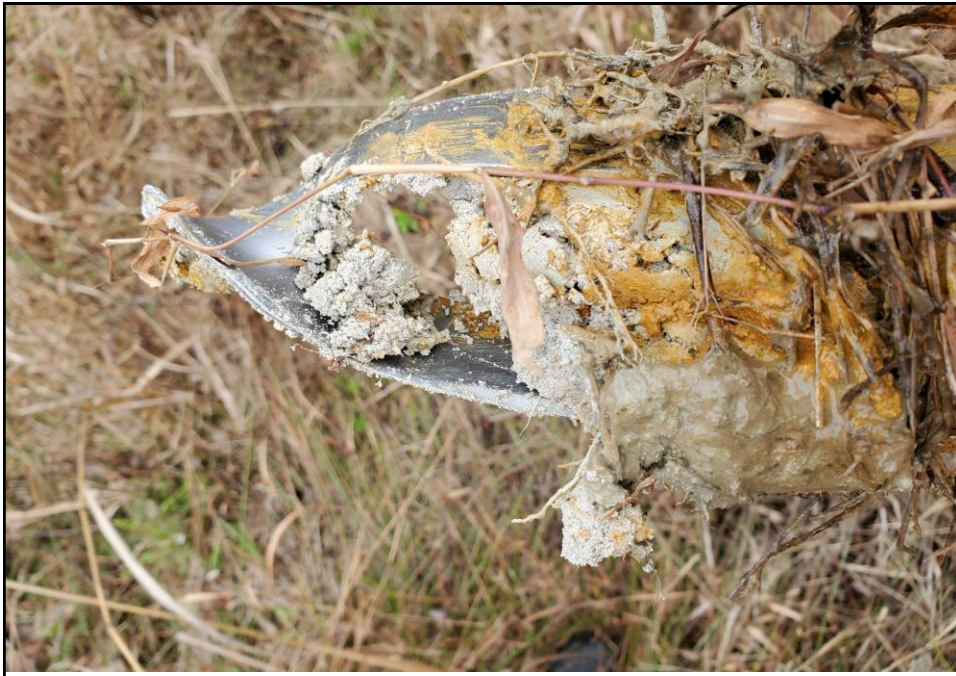
Photo 9. Hydric Soil present throughout added wetland restoration area.

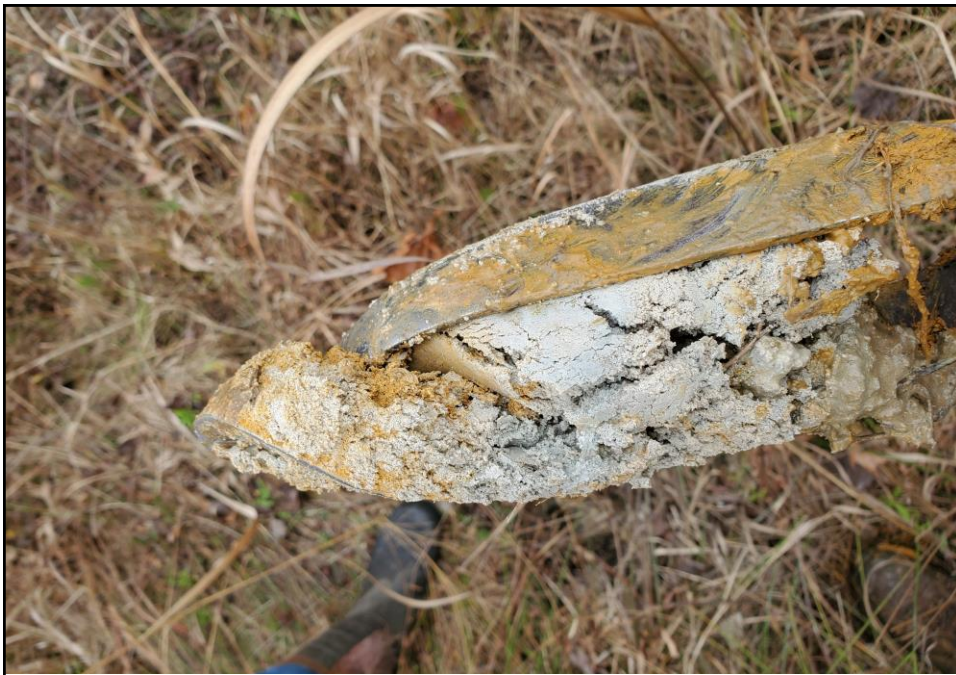
Photo 10. Hydric Soil present throughout added wetland restoration area.
