BRUSH CREEK – PROJECT NO. 54

MONITORING YEAR 10

2011 Monitoring Report

Fish and Wildlife Associates, Inc.

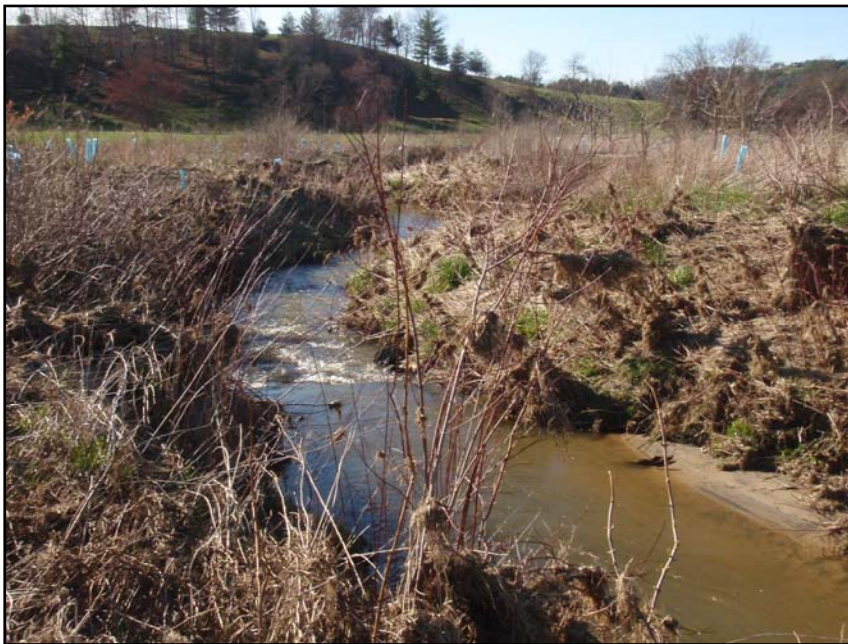
Site: Little Pine Creek
Project No: 54
Photo Station: 5
Date: April 3, 2011
Photographed by: C. Lawson
Description: Taken 300 degrees from north, facing downstream towards breached rock sill.

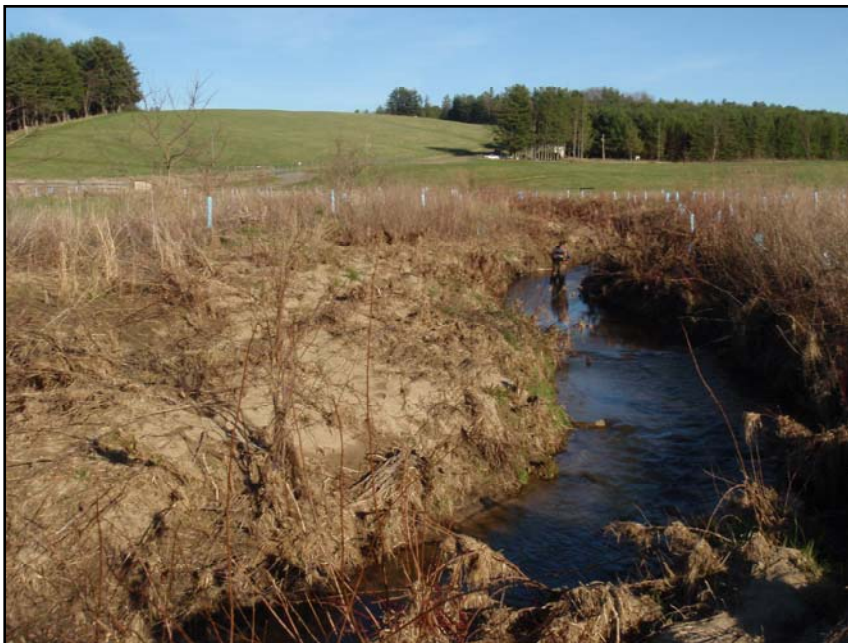
Site: Little Pine Creek
Project No: 54
Photo Station: 7
Date: April 3, 2011
Photographed by: C. Lawson
Description: Taken 115 degrees from north, showing sediment deposits.

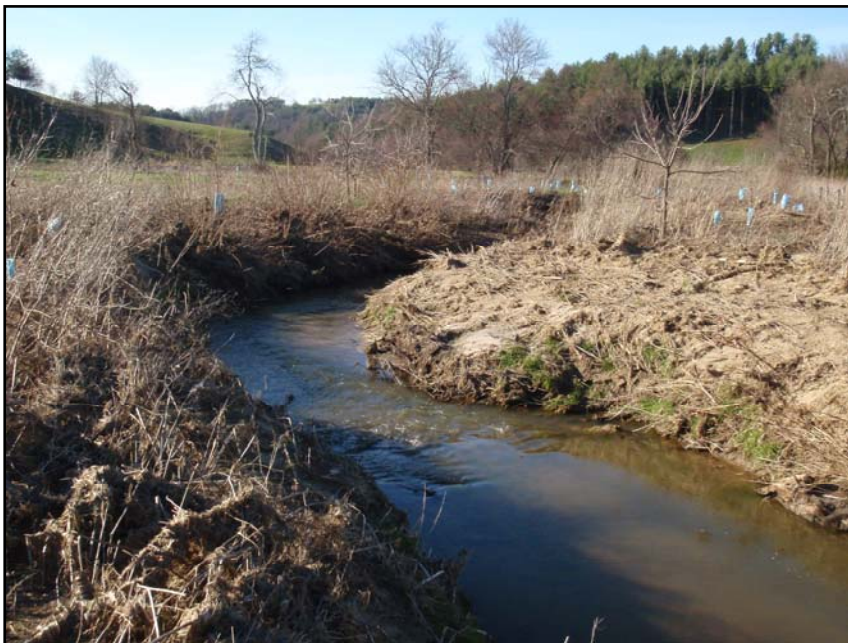
Site: Little Pine Creek
Project No: 54
Photo Station: 7
Date: April 3, 2011
Photographed by: C. Lawson
Description: Taken 352 degrees from north, showing overbank deposits.

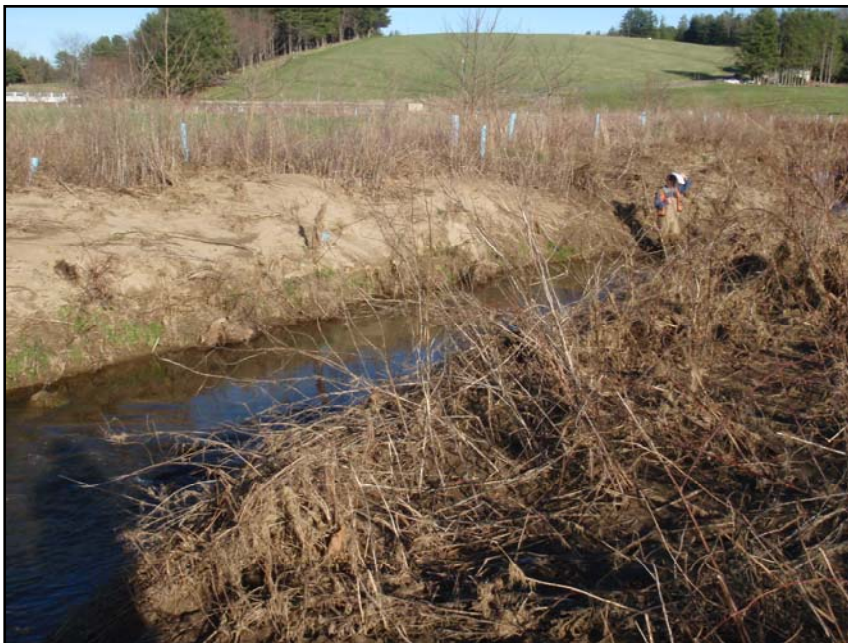
Site: Little Pine Creek
Project No: 54
Photo Station: 8
Date: April 3, 2011
Photographed by: C. Lawson
Description: Taken 100 degrees from north, showing sediment deposition from winter 2010-11 overbank event

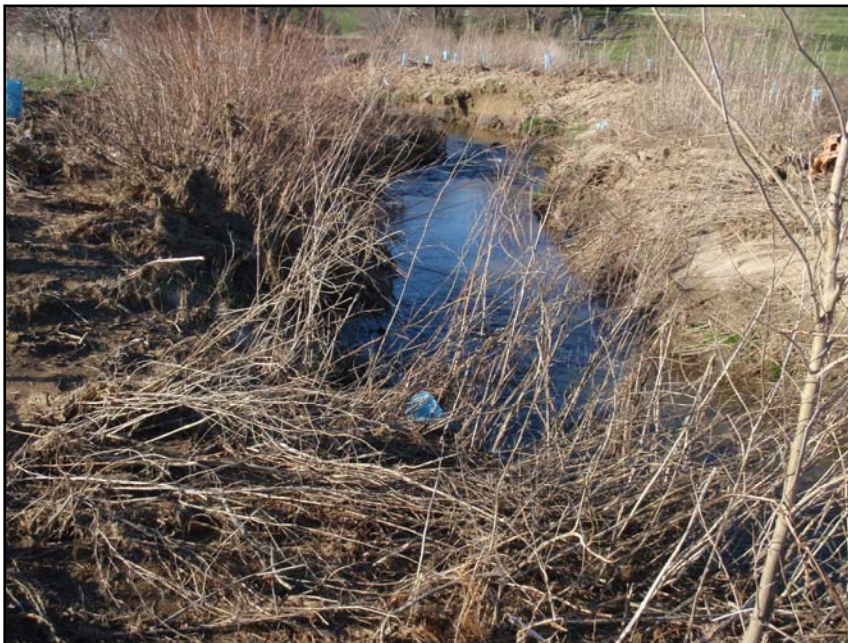
Site: Little Pine Creek
Project No: 54
Photo Station: 8
Date: April 3, 2011
Photographed by: C. Lawson
Description: Taken 350 degrees from north, showing sediment deposition from winter 2010-11 overbank event

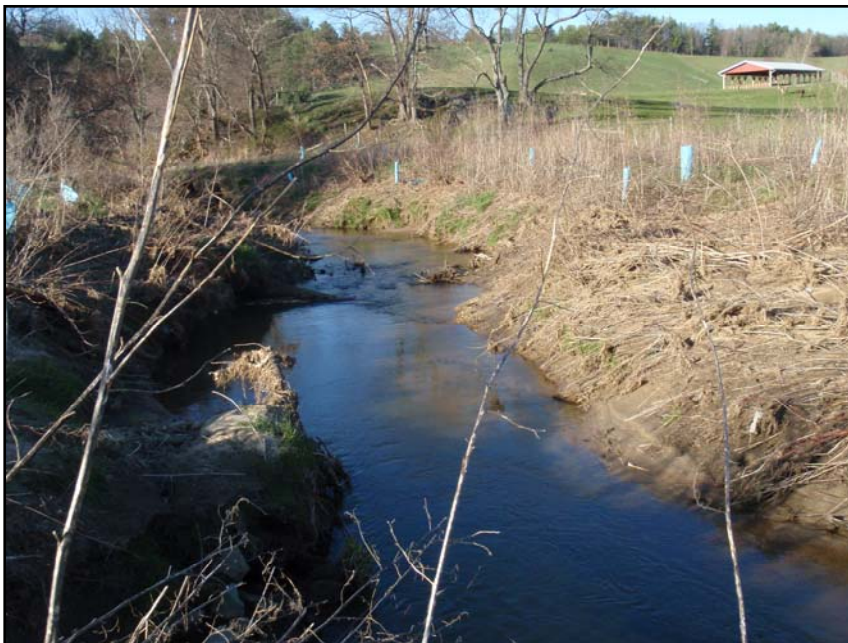
Site: Little Pine Creek
Project No: 54
Photo Station: 10
Date: April 3, 2011
Photographed by: C. Lawson
Description: Taken 20 degrees from north, water flowing under root wads along left descending bank.

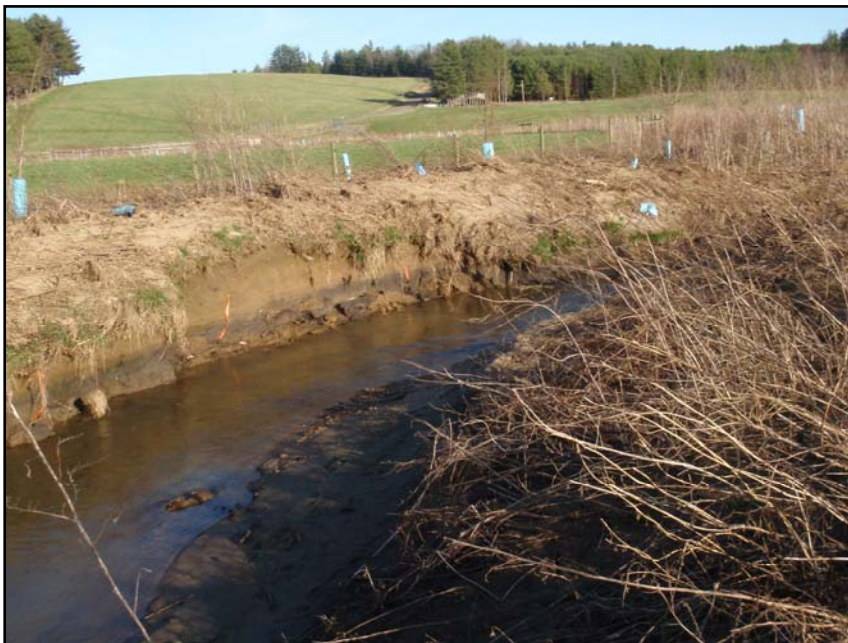
Site: Little Pine Creek
Project No: 54
Photo Station: 10
Date: March 31, 2010
Photographed by: C. Lawson
Description: Taken 160 degrees from north, showing cut bank at left.

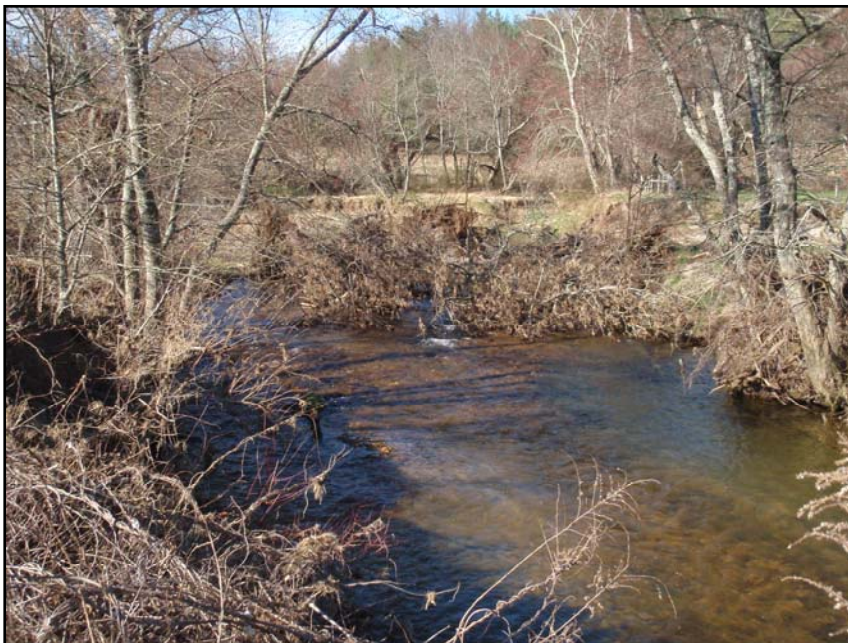
Site: Brush Creek
Project No: 54
Photo Station: 11
Date: April 4, 2011
Photographed by: C. Lawson
Description: Taken 226 degrees from north, showing a group of uprooted trees at project upper limit.

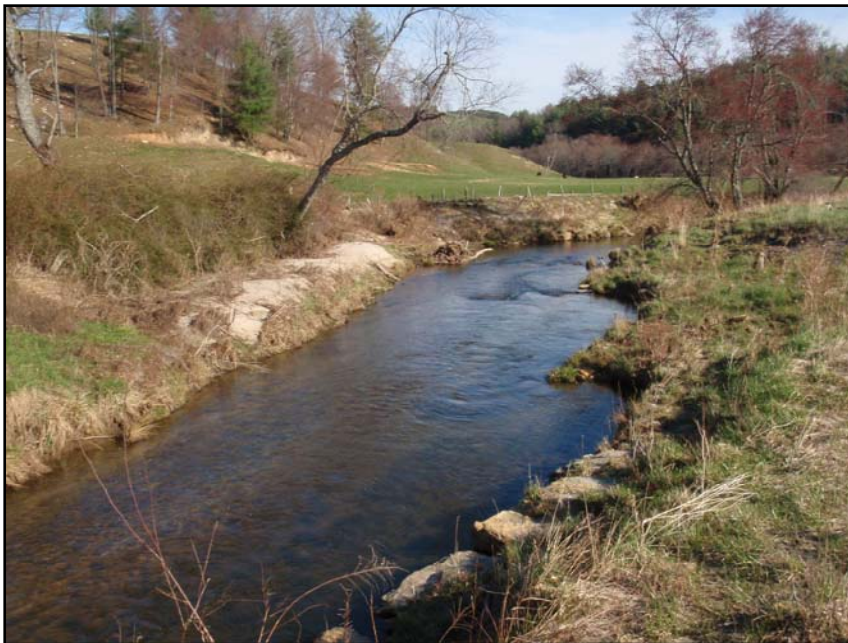
Site: Brush Creek
Project No: 54
Photo Station: 11
Date: April 4, 2011
Photographed by: C. Lawson
Description: Taken 350 degrees from north, showing overbank deposits on the left bank.

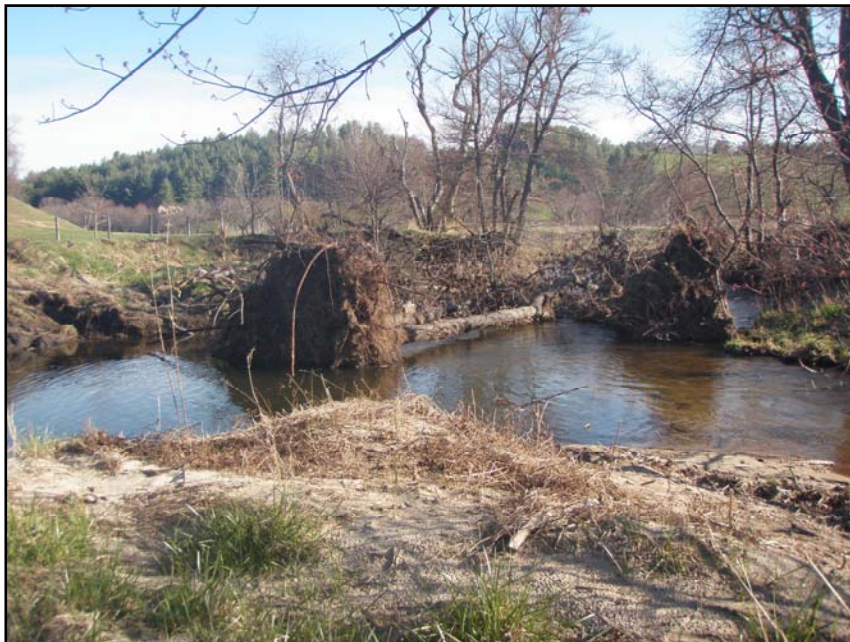
Site: Brush Creek
Project No: 54
Photo Station: 16
Date: April 4, 2011
Photographed by: B. Laseter
Description: Taken 28 degrees from north, showing small debris jam formed during the winter 2010-11.
