LITTLE PINE CREEK/BRUSH CREEK 2002 MONITORING REPORT

ALLEGHANY COUNTY, NORTH CAROLINA
HDR Project No. 09177-027-018

January 2003

2002 MONITORING REPORT

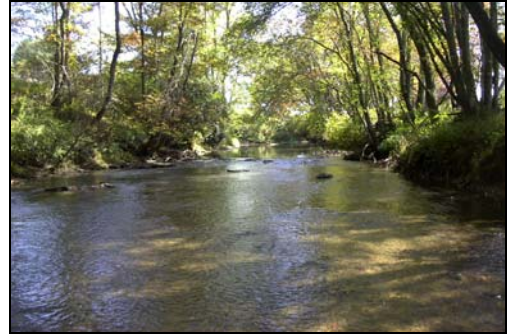
The lower 700 feet of Brush Creek, which is included in the conservation easement, does not include cross-section or permanent photograph station establishment. No grading work or planting was performed in this stable reach. Two boulder clusters were placed in the stream in this section to augment existing riffle sections.

Lower 700 feet of Brush Creek

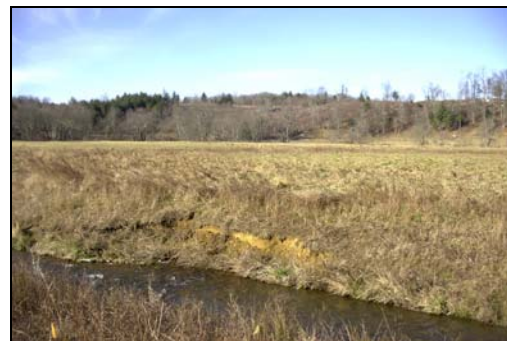
Bank erosion, right bank, near Cross-section 1

There is a bank failure near Cross-section 1. This area failed during the first storm event after construction. Although the bank has become partially revegetated, it needs to be repaired.

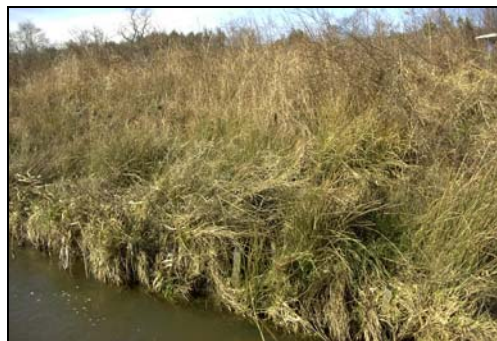
Near cross-section 3 on Little Pine Creek, there is evidence of animals burrowing into the banks. This could account for some of the bank sloughing into the stream. In addition, there are tunnels and dens in the stream banks. The photograph shows tunneling in the stream bank. Additional evidence is provided in the photograph taken from Station 4, 40° from north and in the stream dimensions at Cross-section 3. The dimension of Cross-section 3 different than that of the baseline, and it is possible that the animal impacts in the stream banks caused this change. Measures need to be taken to repair this area as well as to exclude wildlife from using the stream banks as shelter.

Tunneling in left bank near cross-section 3

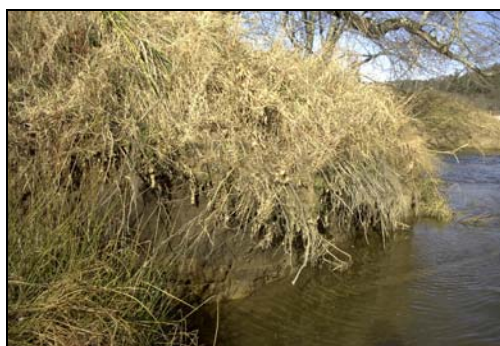
Finally, there has been some erosion on the left bank of Little Pine Creek at the confluence with Brush Creek. Although the area has been somewhat revegetated, the stream bank has been undercut. In this area, the bank needs to be rebuilt and may need to have a less severe side slope in order to prevent such severe erosion in the future. Providing toe protection in this area is advised to slow erosion.

Undercut left stream bank at the confluence with Brush Creek

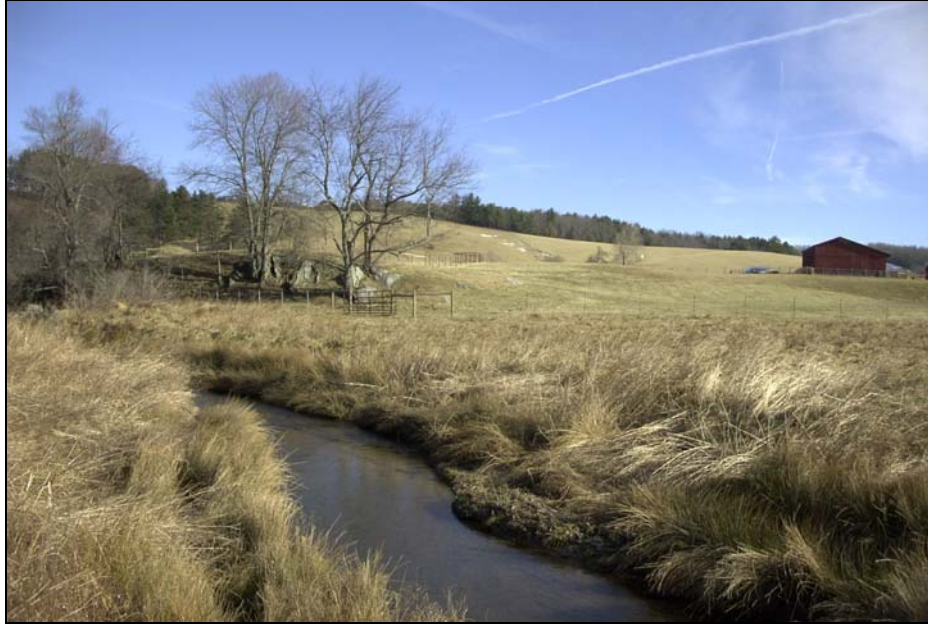
Little Pine Creek Photograph Station 4
40° from North

baseline. The only major difference is shown at Photograph Station 4, 40° from north. Comparison of the photographs shows the bank sloughing off into the channel. The baseline photograph shows a small sandbar in the channel, while the 2002 photograph shows that the bank and the sandbar have become connected.

Overall, photographs of the channel of Little Pine Creek look the same, compared to baseline. The only major difference is shown at Photograph Station 4, 40° from north. Comparison of the 2002 and baseline photographs shows the bank sloughing into the channel. Photographs from Brush Creek show vegetation growth along the stream banks, channel stability, and stability of structures placed in the stream.
