# Little Pine & Brush Creek

## 2003 Annual Monitoring Report

March, 2004

## 2003 Little Pine & Brush Creek Monitoring Abstract

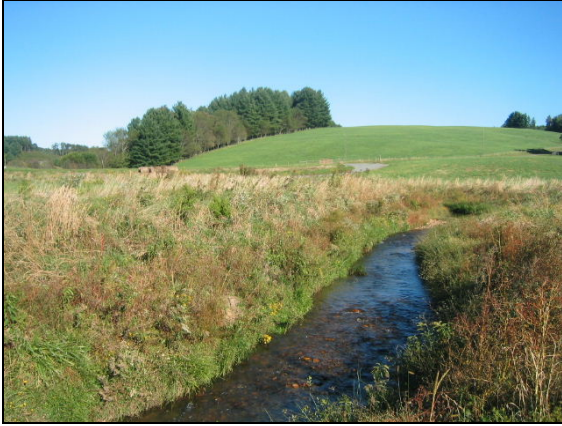
**Typical Photo 1.**  
**Typical Riffle along Little Pine Creek.**

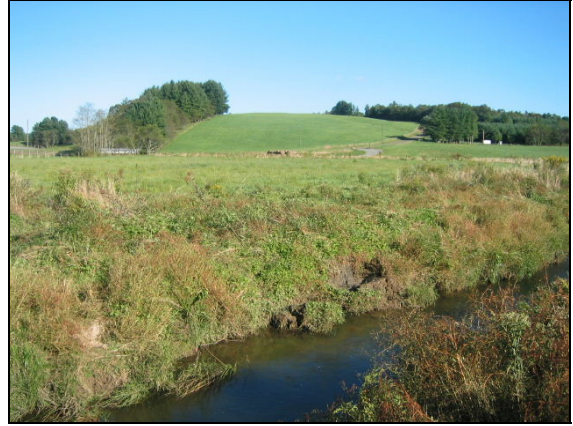
**Typical Photo 2.**  
**Typical Pool along Little Pine Creek.**

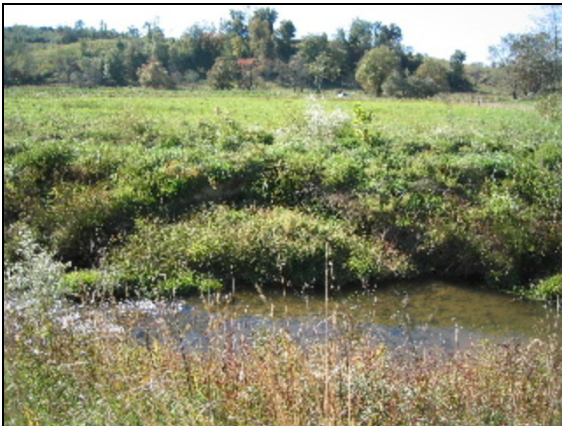
**Issue Photo 1.**  
**Little Pine near Station 1+00.**  
**Bank slump on right bank**

- Areas with bank slumping
  - These areas should be planted heavily with live stakes to help establish root mass along the channel bank.
  - Stations: 0+50, 1+00, 2+50, and 6+50.

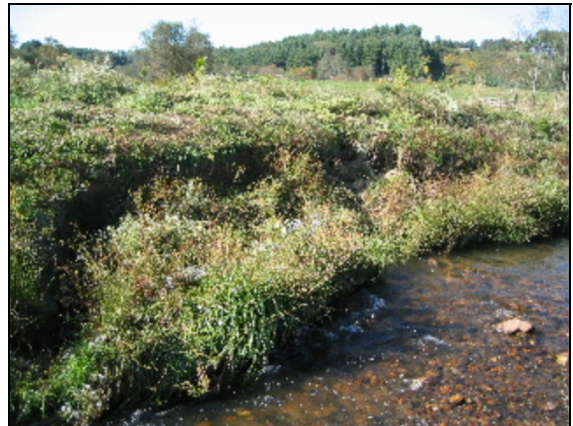
**Issue Photo 2.**  
**Little Pine near Station 2+50.**  
**Bank slump on left bank.**

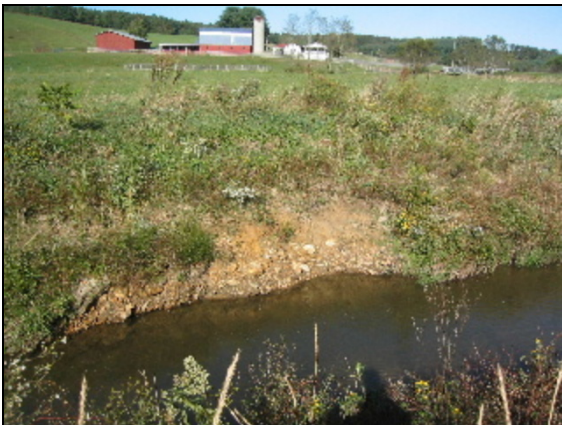
**Issue Photo 3.** Little Pine near station 6+50.  
**Bank Scour on Right Bank**

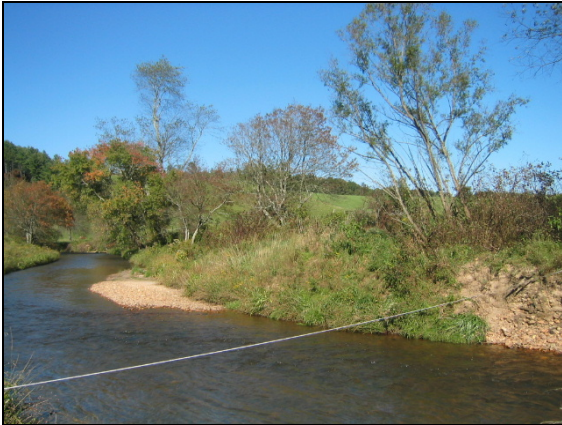
**Typical Photo 1.**  
**Typical Riffle along Brush Creek.**

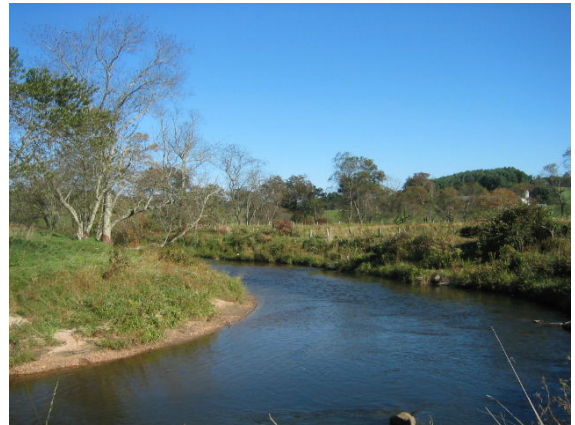
**Typical Photo 2.**  
**Typical Pool along Brush Creek.**

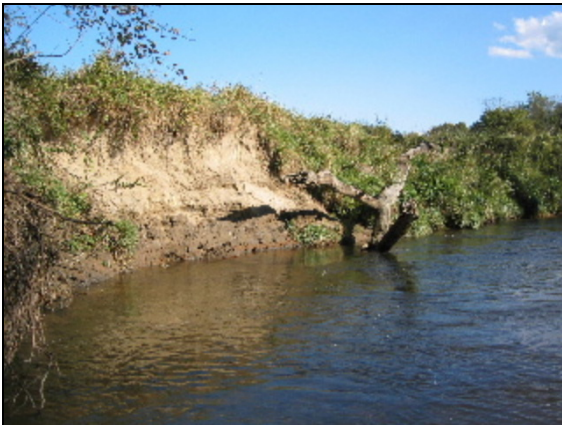
**Issue Photo 1.**  
**Brush Creek near Station 1+50.**  
**Left Bank slump and scour.**

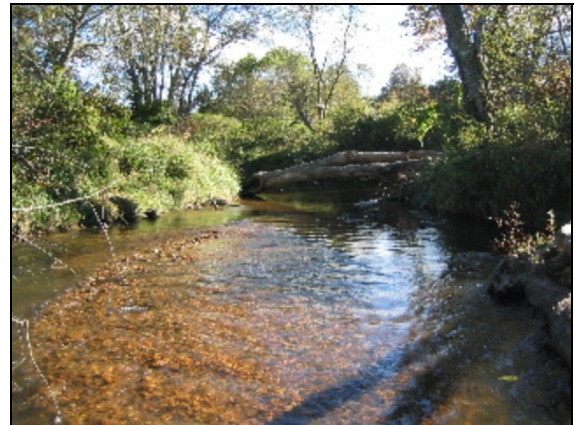
**Issue Photo 2.**  
**Brush Creek near Station 0+50.**  
**Transverse bar at start of project.**

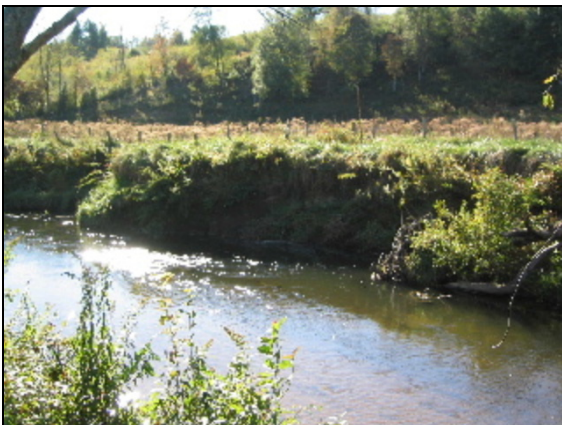
**Issue Photo 1.**  
**Brush Creek near Station 2+00.**  
**Right bank slump and scour.**

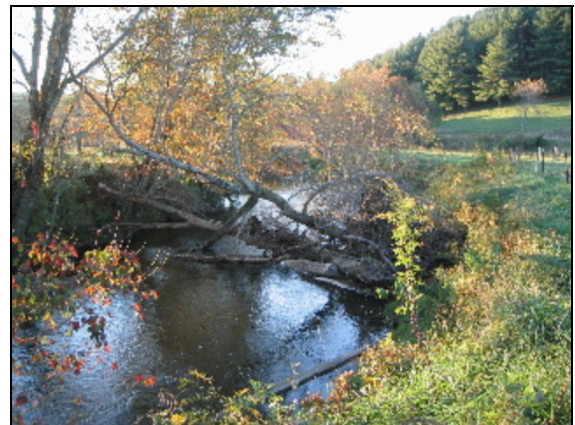
**Issue Photo 2.**  
**Brush Creek near Station 5+00.**  
**Large Woody Debris in channel.**
