BRUSH CREEK – PROJECT NO. 54
MONITORING YEAR 7
2008

NCDENR Ecosystem Enhancement Program
1652 Mail Service Center
Raleigh, NC 27699

January 2009

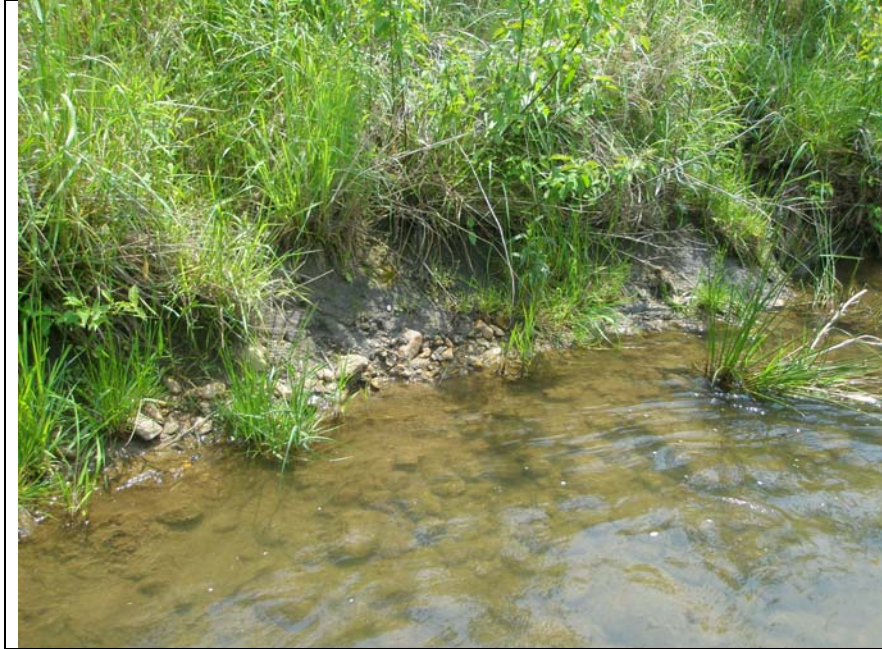
Alleghany County, NC
Site: Little Pine Creek Station 01+78-01+92
Date: May 2008
Photo No: 11
Photographed by: L. Bilbrey
Description: Bare bank observed along the left descending bank on Little Pine Creek. A rock vane was washed out from this location, exposing the bank. Vegetation is likely to reestablish.

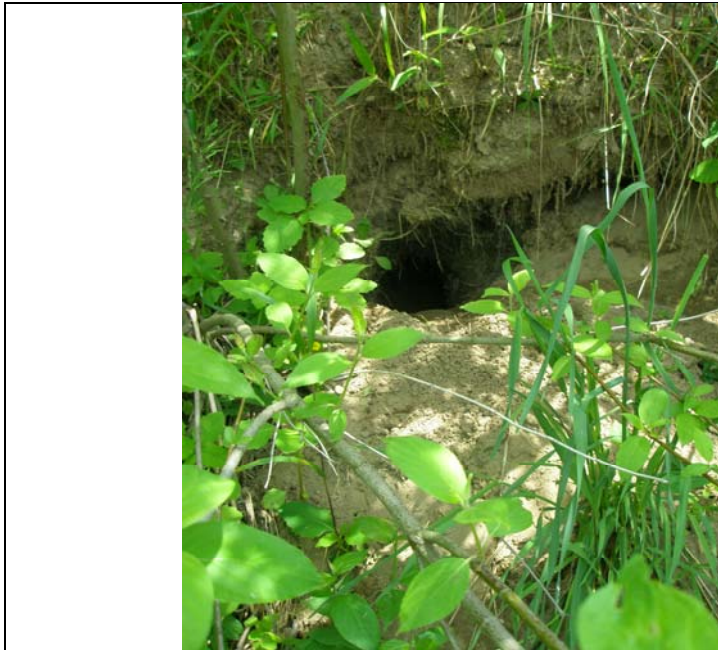
Alleghany County, NC
Site: Little Pine Creek, Station 02+80
Date: May 2008
Photo No: 19
Photographed by: L. Bilbrey
Description: Representative photograph of bare bank as a result of mammal burrows.

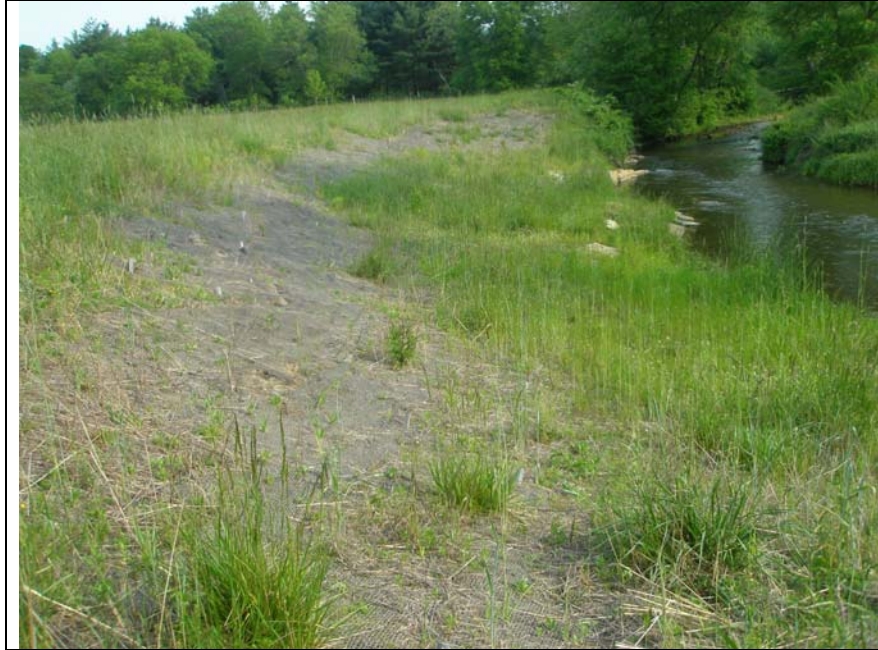
Bare floodplain was observed along the right bank of Brush Creek in and near the vegetation plot. The number of woody stems in the vegetation plot did not differ significantly from the other plots, but the herbaceous cover was relatively sparse. The fiber matting was exposed and falling apart which resulted in soils with little erosion control.

Alleghany County, NC
Site: Brush Creek
Date: May 2008
Photo No: 66
Photographed by: L. Bilbrey
Description: Bare flood plain near BCVP 1, facing upstream.

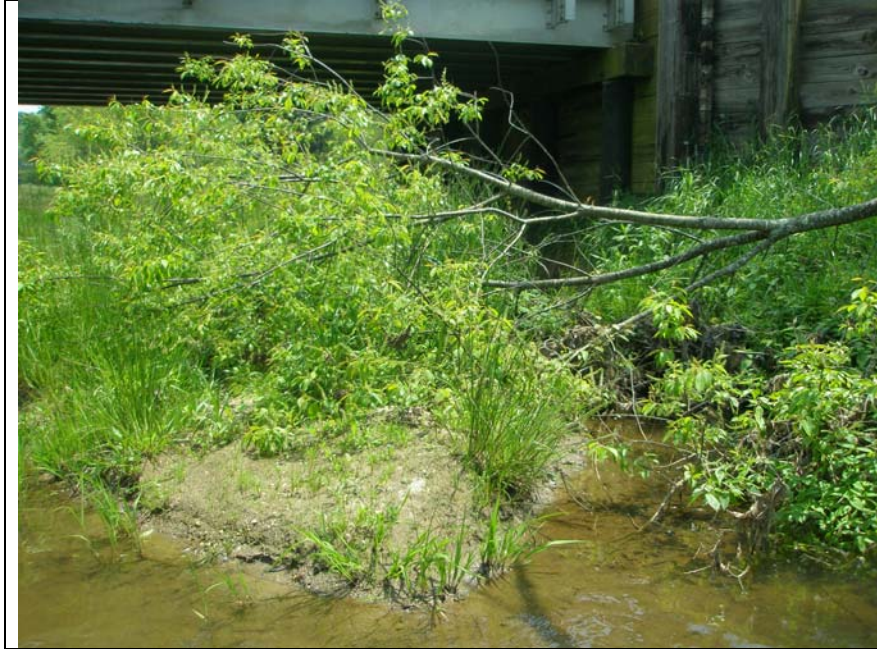
Alleghany County, NC
Site: Little Pine Creek Station 00+10-00+22
Date: May 2008
Photo No: 1
Photographed by: L. Bilbrey
Description: Representative photograph of mid-bar formation observed along Little Pine Creek, facing upstream.

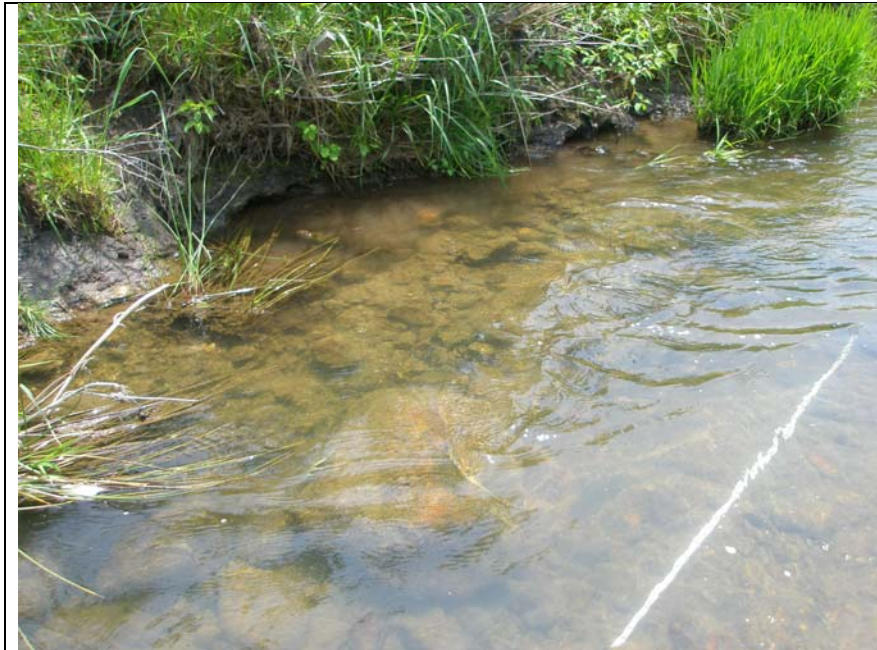
Most of the engineered structures were intact and working properly. Of the engineered structures, the following were missing or no longer intact: three rock sills, two rock vanes, and one root wad. In addition to missing structures the following were shifted or need to be watched: two root wads and one digger log. Rock vanes that failed were likely due to the small size of the

Alleghany County, NC
Site: Little Pine Creek Station 01+85
Date: May 2008
Photo No: 12
Photographed by: L. Bilbrey
Description: Photograph of missing rock vane, likely the result of a high water event. Facing downstream at left descending bank.

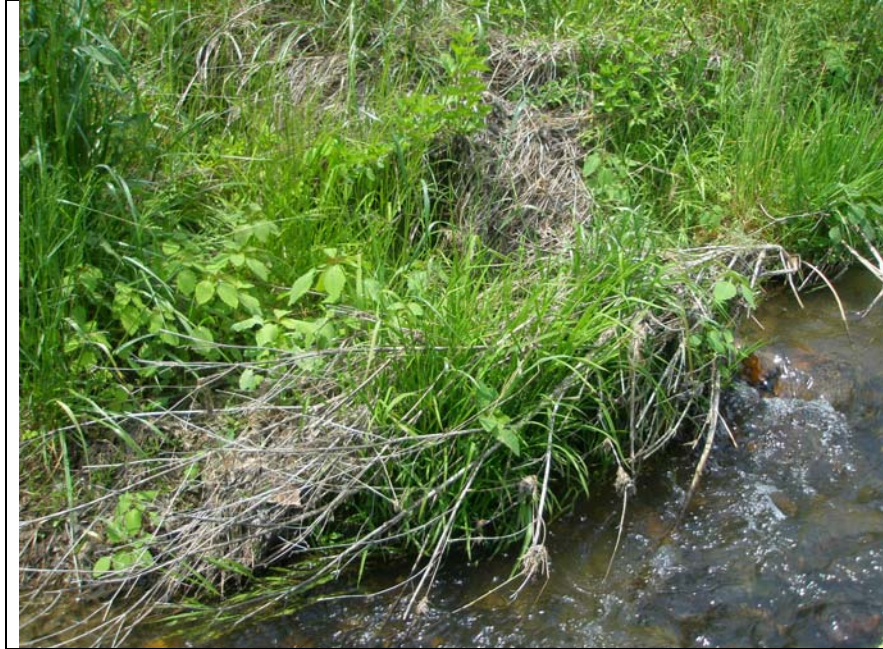
Alleghany County, NC
Site: Little Pine Creek Station 02+45-02+50
Date: May 2008
Photo No: 16
Photographed by: L. Bilbrey
Description: Representative photograph of bank slump observed along Little Pine Creek.

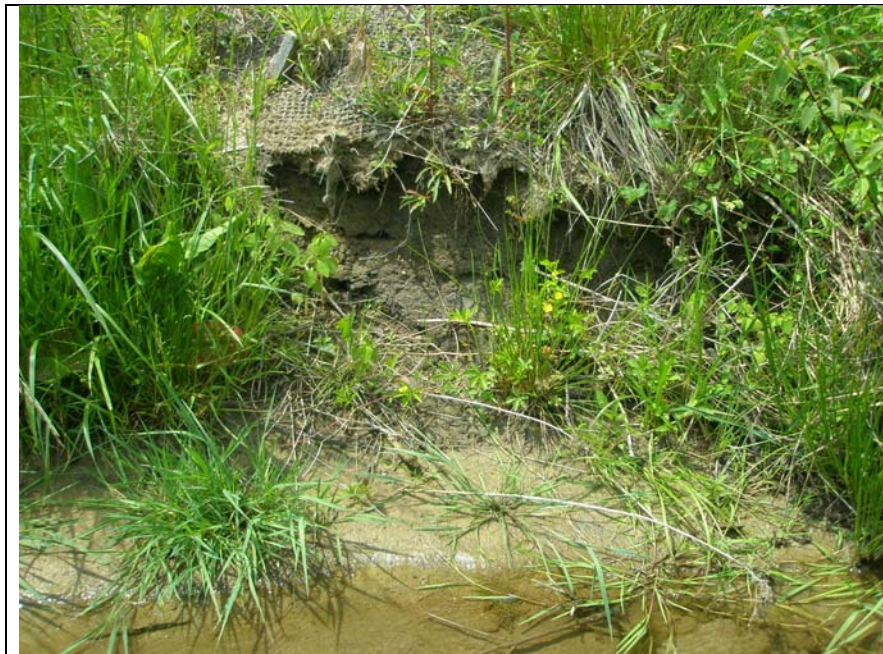
Alleghany County, NC
Site: Little Pine Creek Station 02+61
Date: May 2008
Photo No: 18
Photographed by: L. Bilbrey
Description: Representative photograph of bank scour observed along Little Pine Creek.

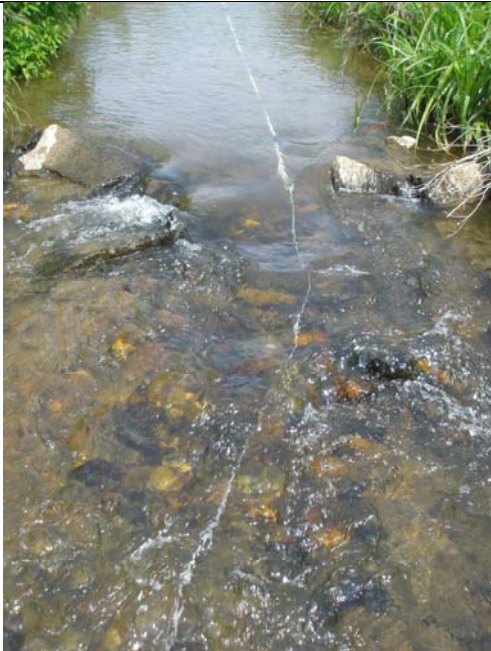
rocks used. The most common failed structure was rock sills. The Stream Current Condition Plan View is provided in the Project Problem Areas Plan View in Appendix C.

Alleghany County, NC
		Site: Little Pine Creek Station 04+87
		Date: May 2008
		Photo No: 28
		Photographed by: L. Bilbrey
		Description: Representative photograph of failed rock sills in some riffles (04+87, 06+00, 07+74) in Little Pine Creek, facing upstream.

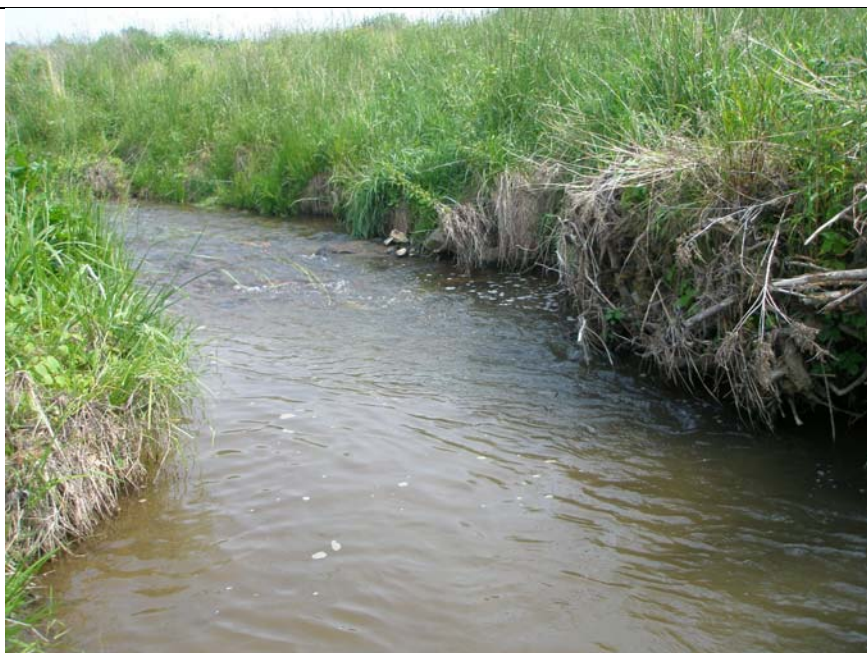
The stability of structures has also decreased as some were no longer present. Two additional root wads have been noted in the problem areas as “to be watched”. These structures are being threatened by undercutting; therefore the percentage of stable structures may decrease in the future.

Alleghany County, NC
		Site: Little Pine Creek Station 06+29-06+31
		Date: May 2008
		Photo No: 39
		Photographed by: L. Bilbrey
		Description: Flow directed at bank, causing undercut banks under root wads. These structures should be watched (06-29-06+61, 08+63-08+68).

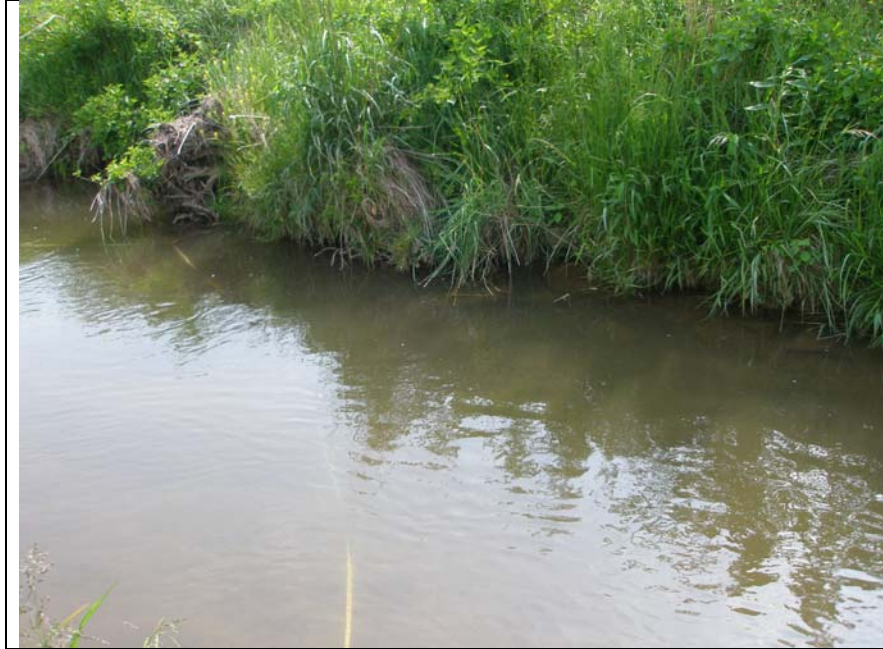
Alleghany County, NC
Site: Little Pine Creek Station 07+52
Date: May 2008
Photo No: 47
Photographed by: L. Bilbrey
Description: Missing root wad, facing upstream at left bank.

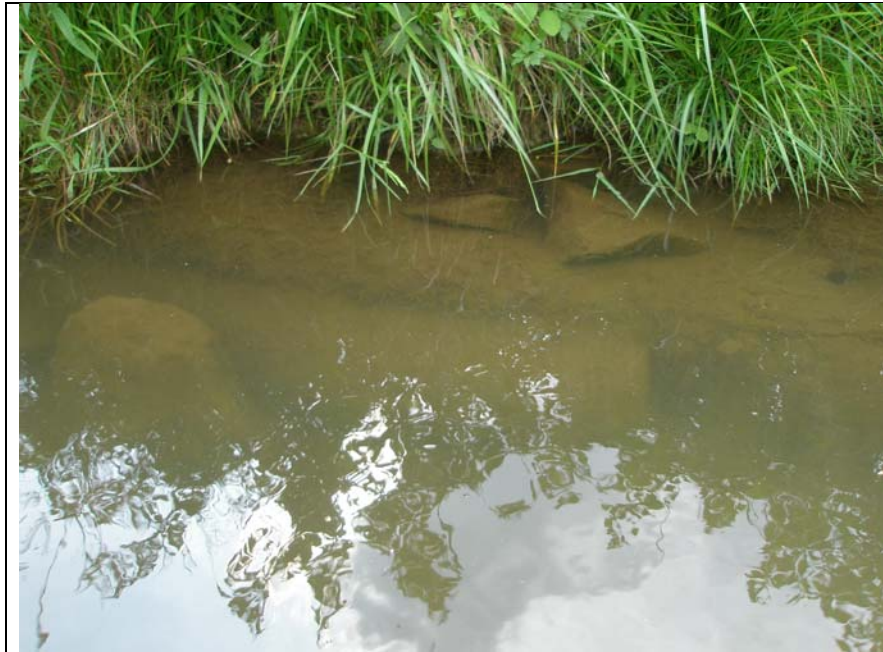
Alleghany County, NC
Site: Little Pine Creek Station 07+50
Date: May 2008
Photo No: 50
Photographed by: L. Bilbrey
Description: Digger log shifted and turned downstream, likely due to a high water event.

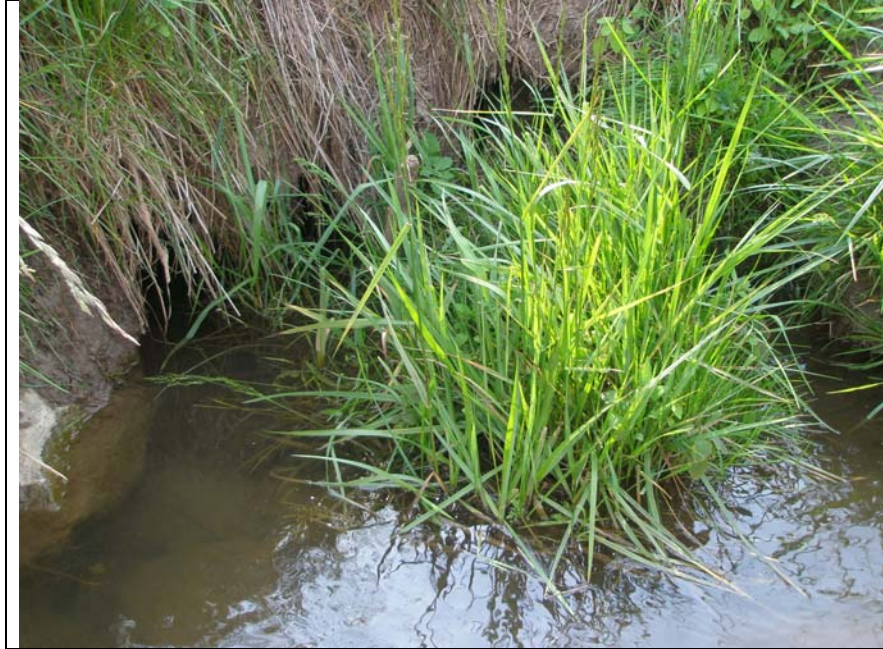
Alleghany County, NC
Site: Little Pine Creek Station 08+73
Date: May 2008
Photo No: 55
Photographed by: L. Bilbrey
Description: Representative photograph of muskrat burrows observed along the downstream portion of Little Pine Creek.

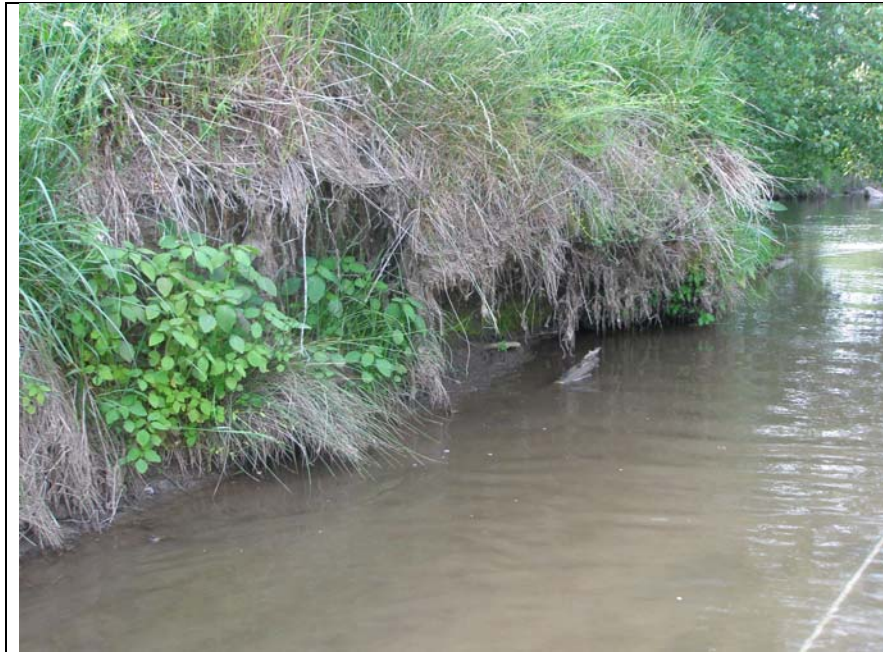
Stream problems areas were noted for both Brush Creek and Little Pine Creek. The left descending bank of Little Pine Creek (Station 09+67 – 09+86) just above the confluence with Brush Creek had a significant undercut bank and lacked vegetation. The right descending bank of Brush Creek, near Photo Station 14, also had significant bank scour. Upon the October 2008 visit, it was noted that the amount of bank scour at this location had increased after the August storm event. Both locations should be watched and potentially repaired to prevent further erosion and scour. Representative photographs of stream problem areas are included in Appendix B.

Alleghany County, NC
Site: Little Pine Creek Station 09+67-09+86
Date: May 2008
Photo No: 57
Photographed by: L. Bilbrey
Description: Major bank scour and undercut bank just at the confluence of Little Pine Creek and Brush Creek, facing downstream at left bank.

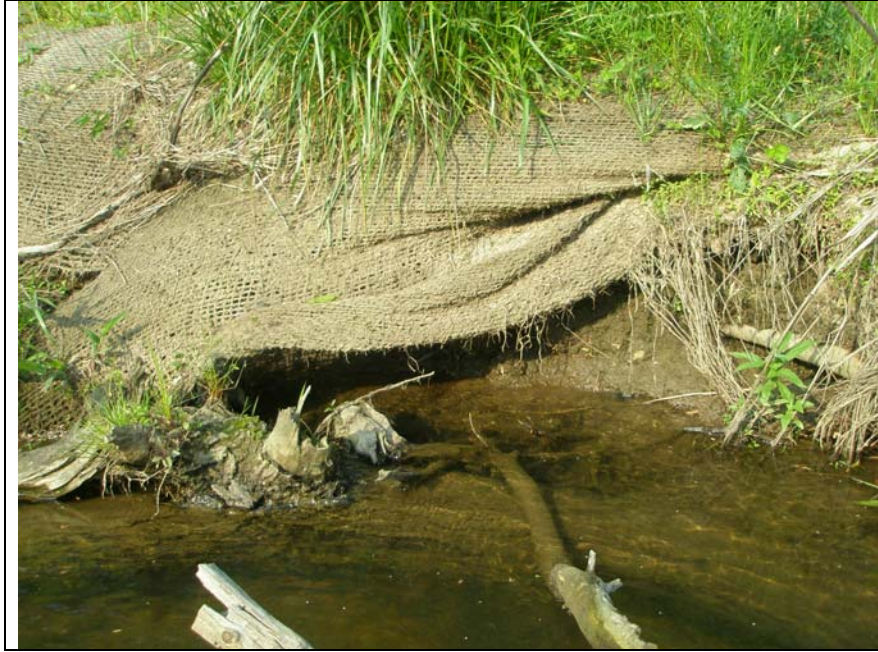
Data collection for MY7 was conducted prior to the storm event in late August; therefore any changes due to the storm event were not documented in cross-sectional or longitudinal samples. No obvious changes or damage to engineered structures or the stream channel were observed in October 2008, with the exception of one area of bank scour along Brush Creek (discussed below in Section III.B.2.).

Alleghany County, NC
Site: Brush Creek
Date: May 2008
Photo No: 62
Photographed by: L. Bilbrey
Description: Bank Scour, near Photo Station 14 along the right descending bank.

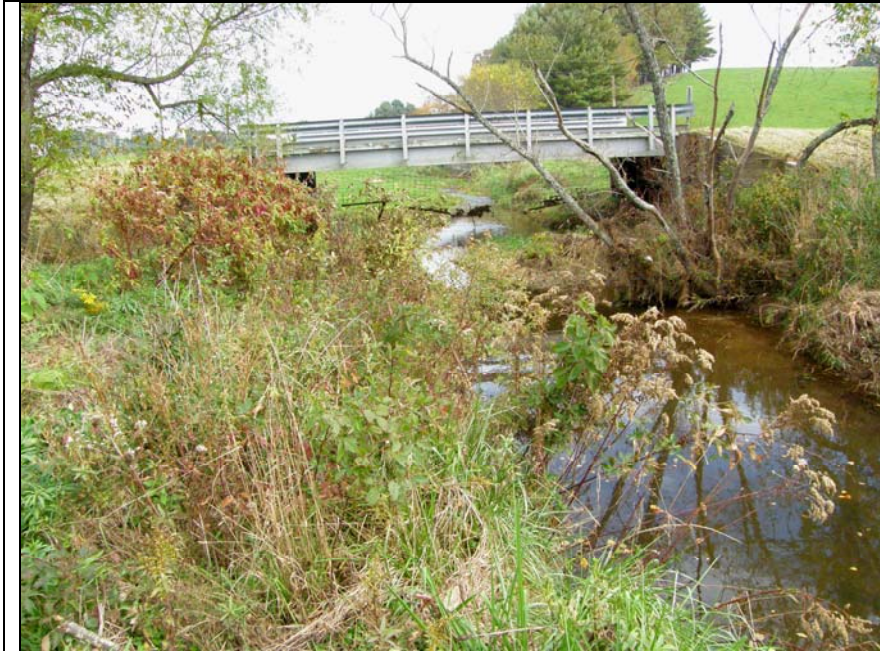
Site: Little Pine Creek
Project No: 54
Photo Station: 2
Date: October 16, 2008
Photographed by: L. Bilbrey
Description: Taken 70 degrees from north, facing upstream. Midbar forming under bridge (station 00+10-00+22).

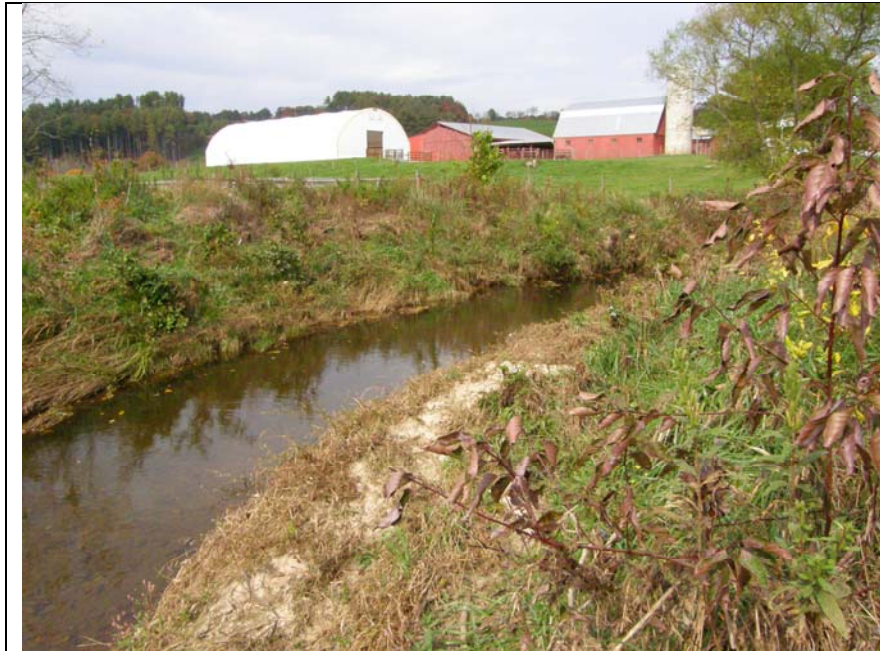
Site: Little Pine Creek
Project No: 54
Photo Station: 3
Date: October 16, 2008
Photographed by: L. Bilbrey
Description: Taken 25 degrees from north, showing sediment deposits.

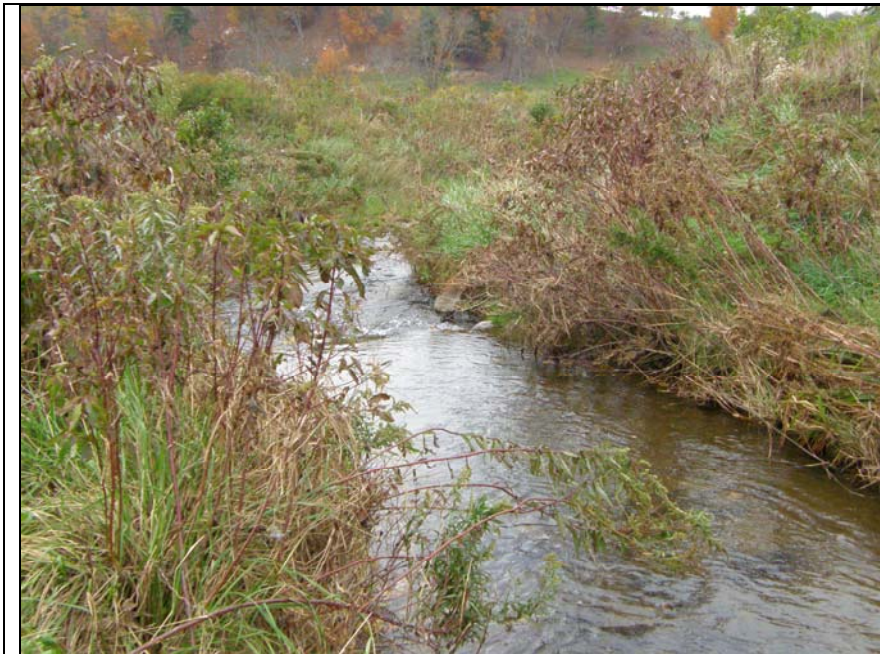
Site: Little Pine Creek
Project No: 54
Photo Station: 5
Date: October 16, 2008
Photographed by: L. Bilbrey
Description: Taken 300 degrees from north, facing downstream towards shifted riffle and breached rock sill.

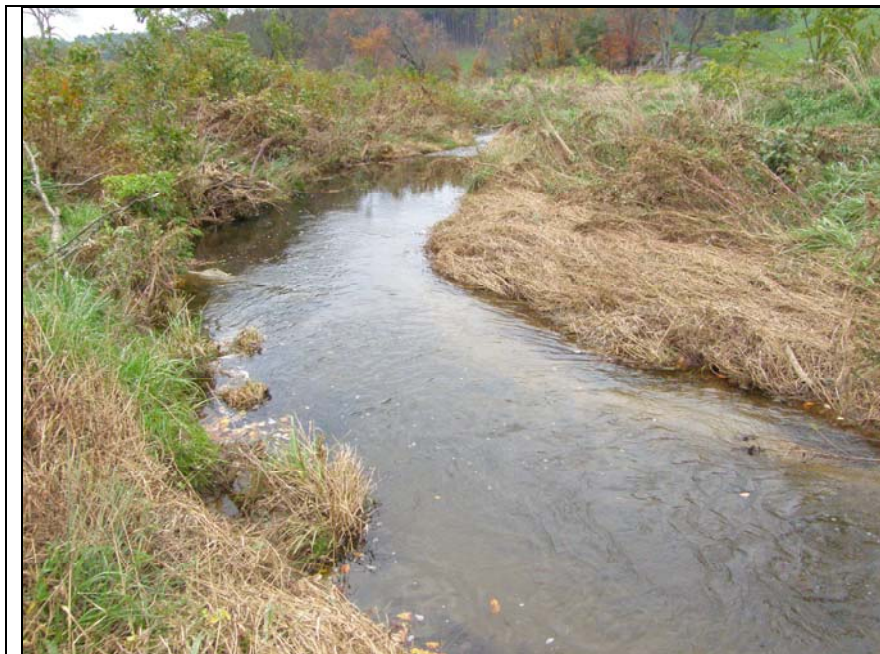
Site: Little Pine Creek
Project No: 54
Photo Station: 8
Date: October 16, 2008
Photographed by: L. Bilbrey
Description: Taken 350 degrees from north, muskrat holes along the left descending bank.

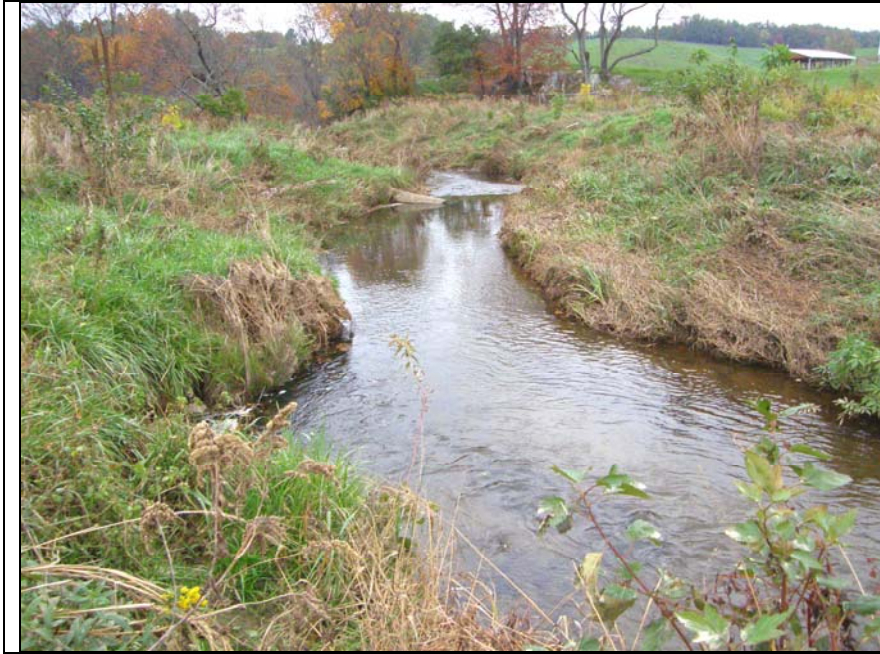
Site: Little Pine Creek
Project No: 54
Photo Station: 10
Date: October 16, 2008
Photographed by: L. Bilbrey
Description: Taken 20 degrees from north, water flowing under root wads along left descending bank.

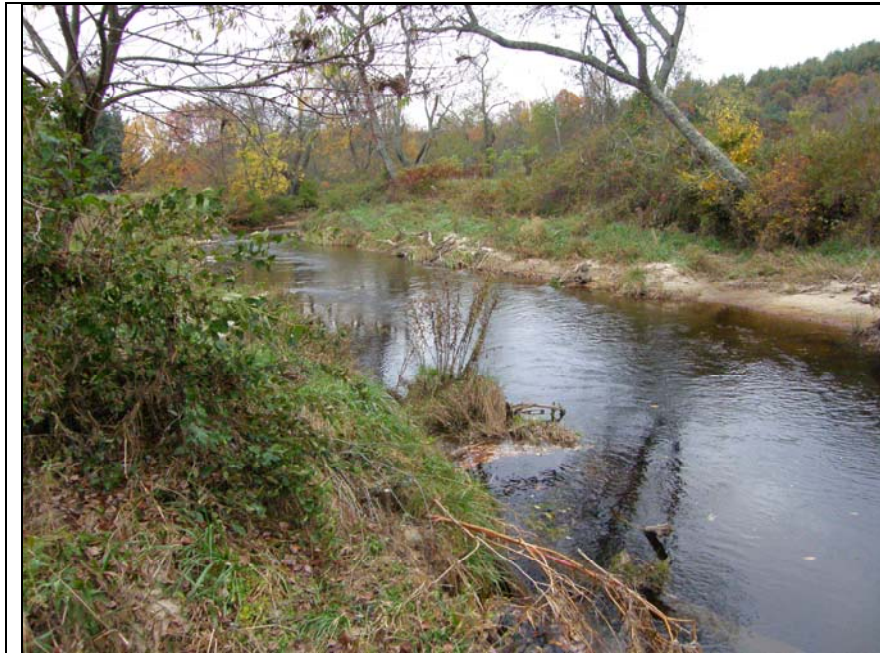
Site: Little Pine Creek
Project No: 54
Photo Station: 14
Date: October 16, 2008
Photographed by: L. Bilbrey
Description: Taken 190 degrees from north, facing upstream, bank scour is visible along the right descending bank.
