BRUSH CREEK – PROJECT NO. 54

MONITORING YEAR 9

2010 Monitoring Report

Fish and Wildlife Associates, Inc.

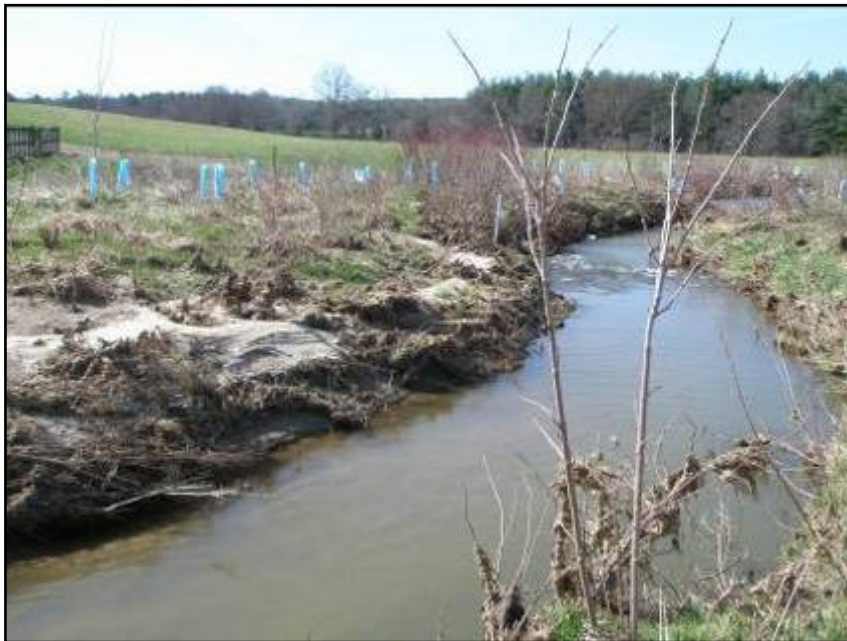
Site: Little Pine Creek
Project No: 54
Photo Station: 2
Date: March 31, 2010
Photographed by: C. Lawson
Description: Taken 200 degrees from north. Facing downstream towards riffle cross section 1.

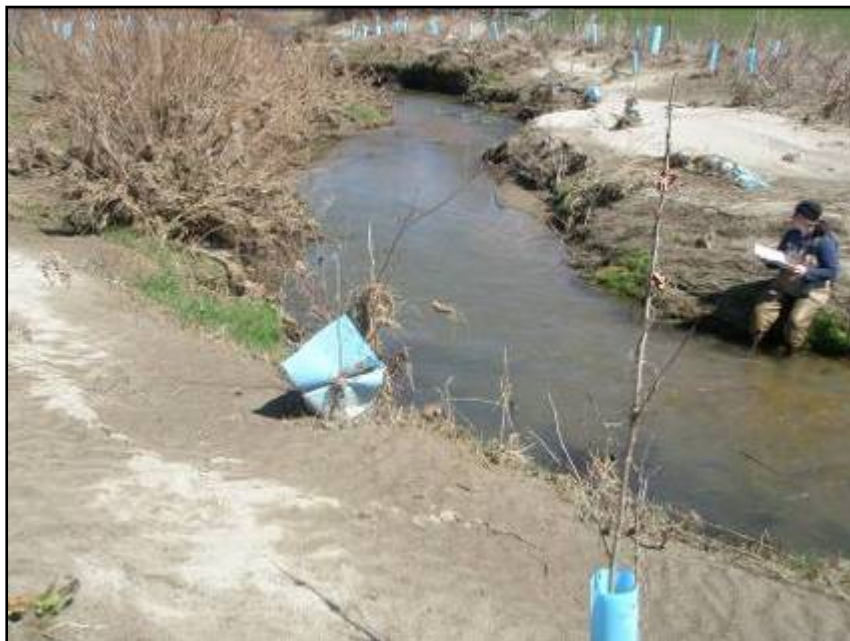
Site: Little Pine Creek
Project No: 54
Photo Station: 8
Date: March 31, 2010
Photographed by: C. Lawson
Description: Taken 350 degrees from north, muskrat holes along the left descending bank.
