MONITORING YEAR 1 ANNUAL REPORT FINAL

BUCKWATER MITIGATION SITE

Orange County, NC

DMS Project Number 97084

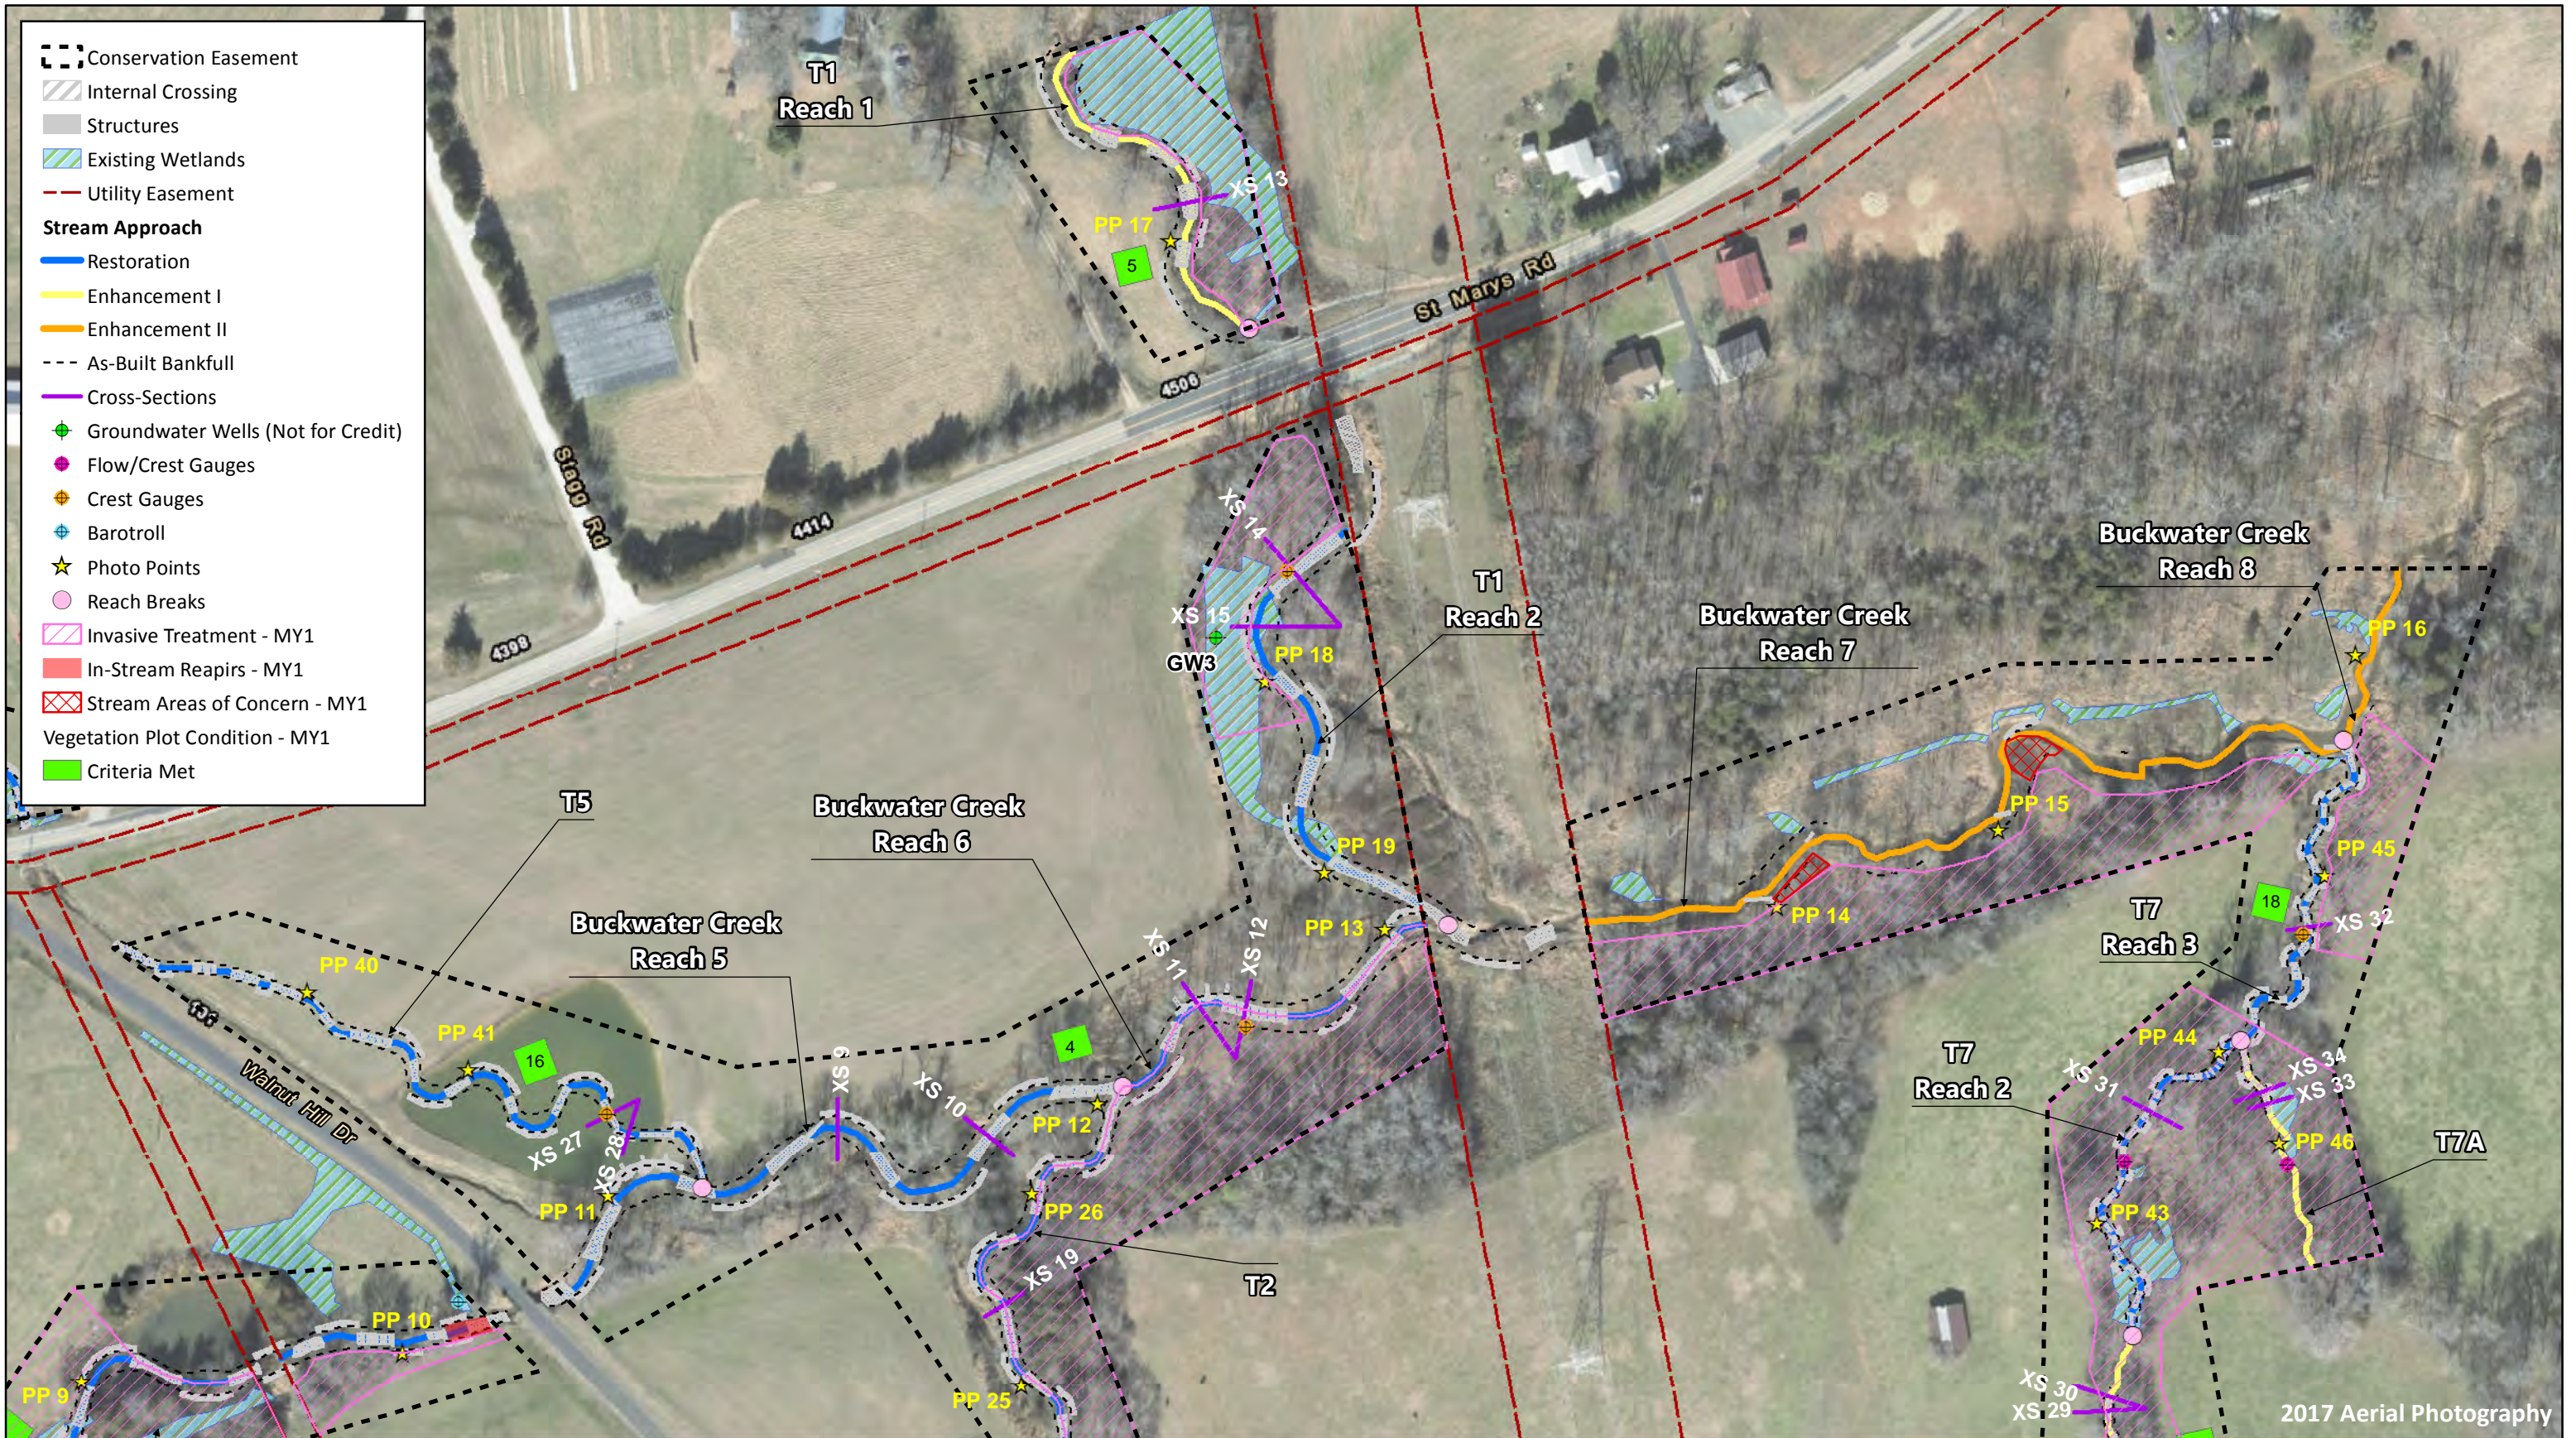
Figure 3b. Integrated Current Condition Plan View
 Buckwater Mitigation Site
 DMS Project No. 97084
 Monitoring Year 1 - 2019

During an IRT site walk on November 21, 2019, bank erosion was identified on Buckwater Creek Reach 7, which is an Enhancement II section. Bank repairs will be conducted during MY2 and are shown on Figure 3b (CCPV Map, Appendix 2).

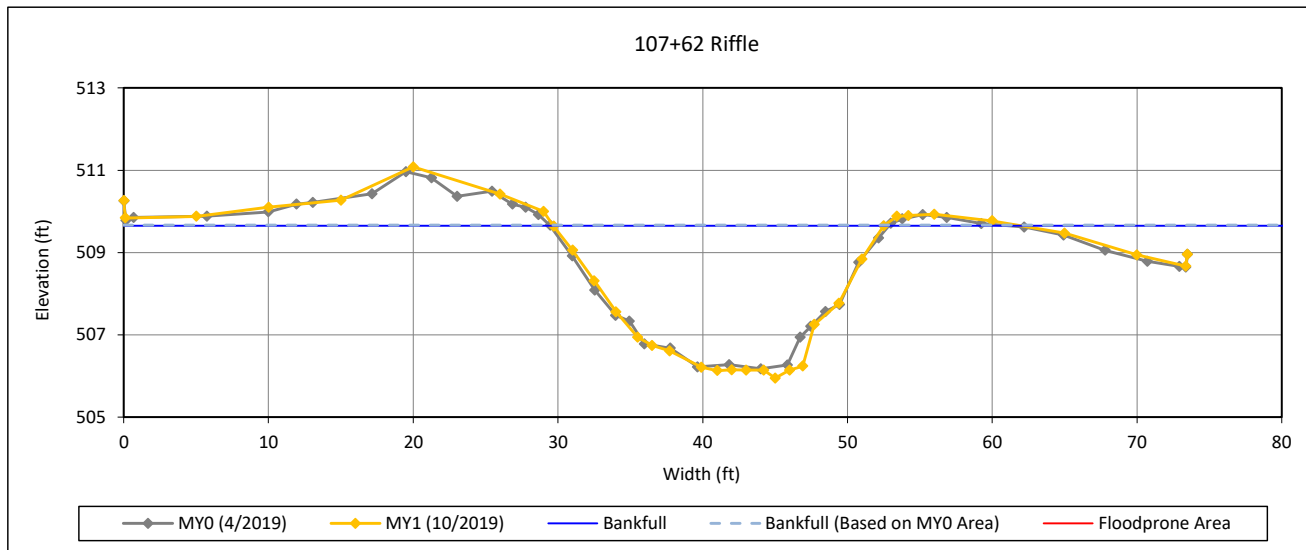
Cross-Section 3 - Buckwater Creek Reach 3

- a. Please consider rounding some of the cross section BHRs listed as <1 to 1.0. For example, cross section 3's BHR is listed as <1 with an actual BHR of 0.995. A 1.0 BHR more accurately describes conditions.

Bank height ratios were evaluated on all cross sections and cross sections 3, 4, and 6 were rounded from <1 to 1.0.

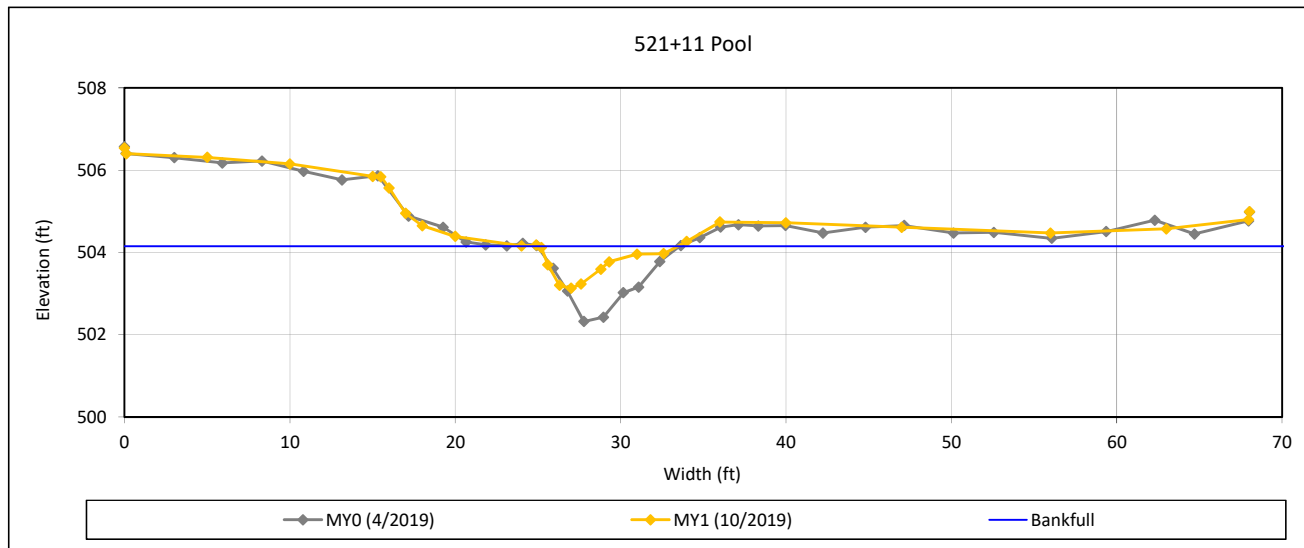
Cross-Section 26 - T5

Two of the 36 cross-sections (pool cross-sections, XS 26 and XS 28, on T5) show excessive sedimentation on the point bar. Most stream channels were dry due to drought conditions during time of survey. Due to lack of streamflow, sediment was not transported through the channels and collected in some pools. Sediment deposition on the point bar of a pool is ideal; this sediment is expected to be transported downstream during future storm events. No remedial action will be taken at this time.
