**MONITORING YEAR 2  
ANNUAL REPORT  
FINAL**

**BUCKWATER MITIGATION SITE**

Orange County, NC  
NCDEQ Contract No. 006829  
DMS Project Number 97084  
USACE Action ID Number 2016-00873  
NCDWR Project Number 2016-0406

Data Collection Period: January – October 2020  
Draft Submission Date: November 19, 2020  
Final Submission Date: December 18, 2020

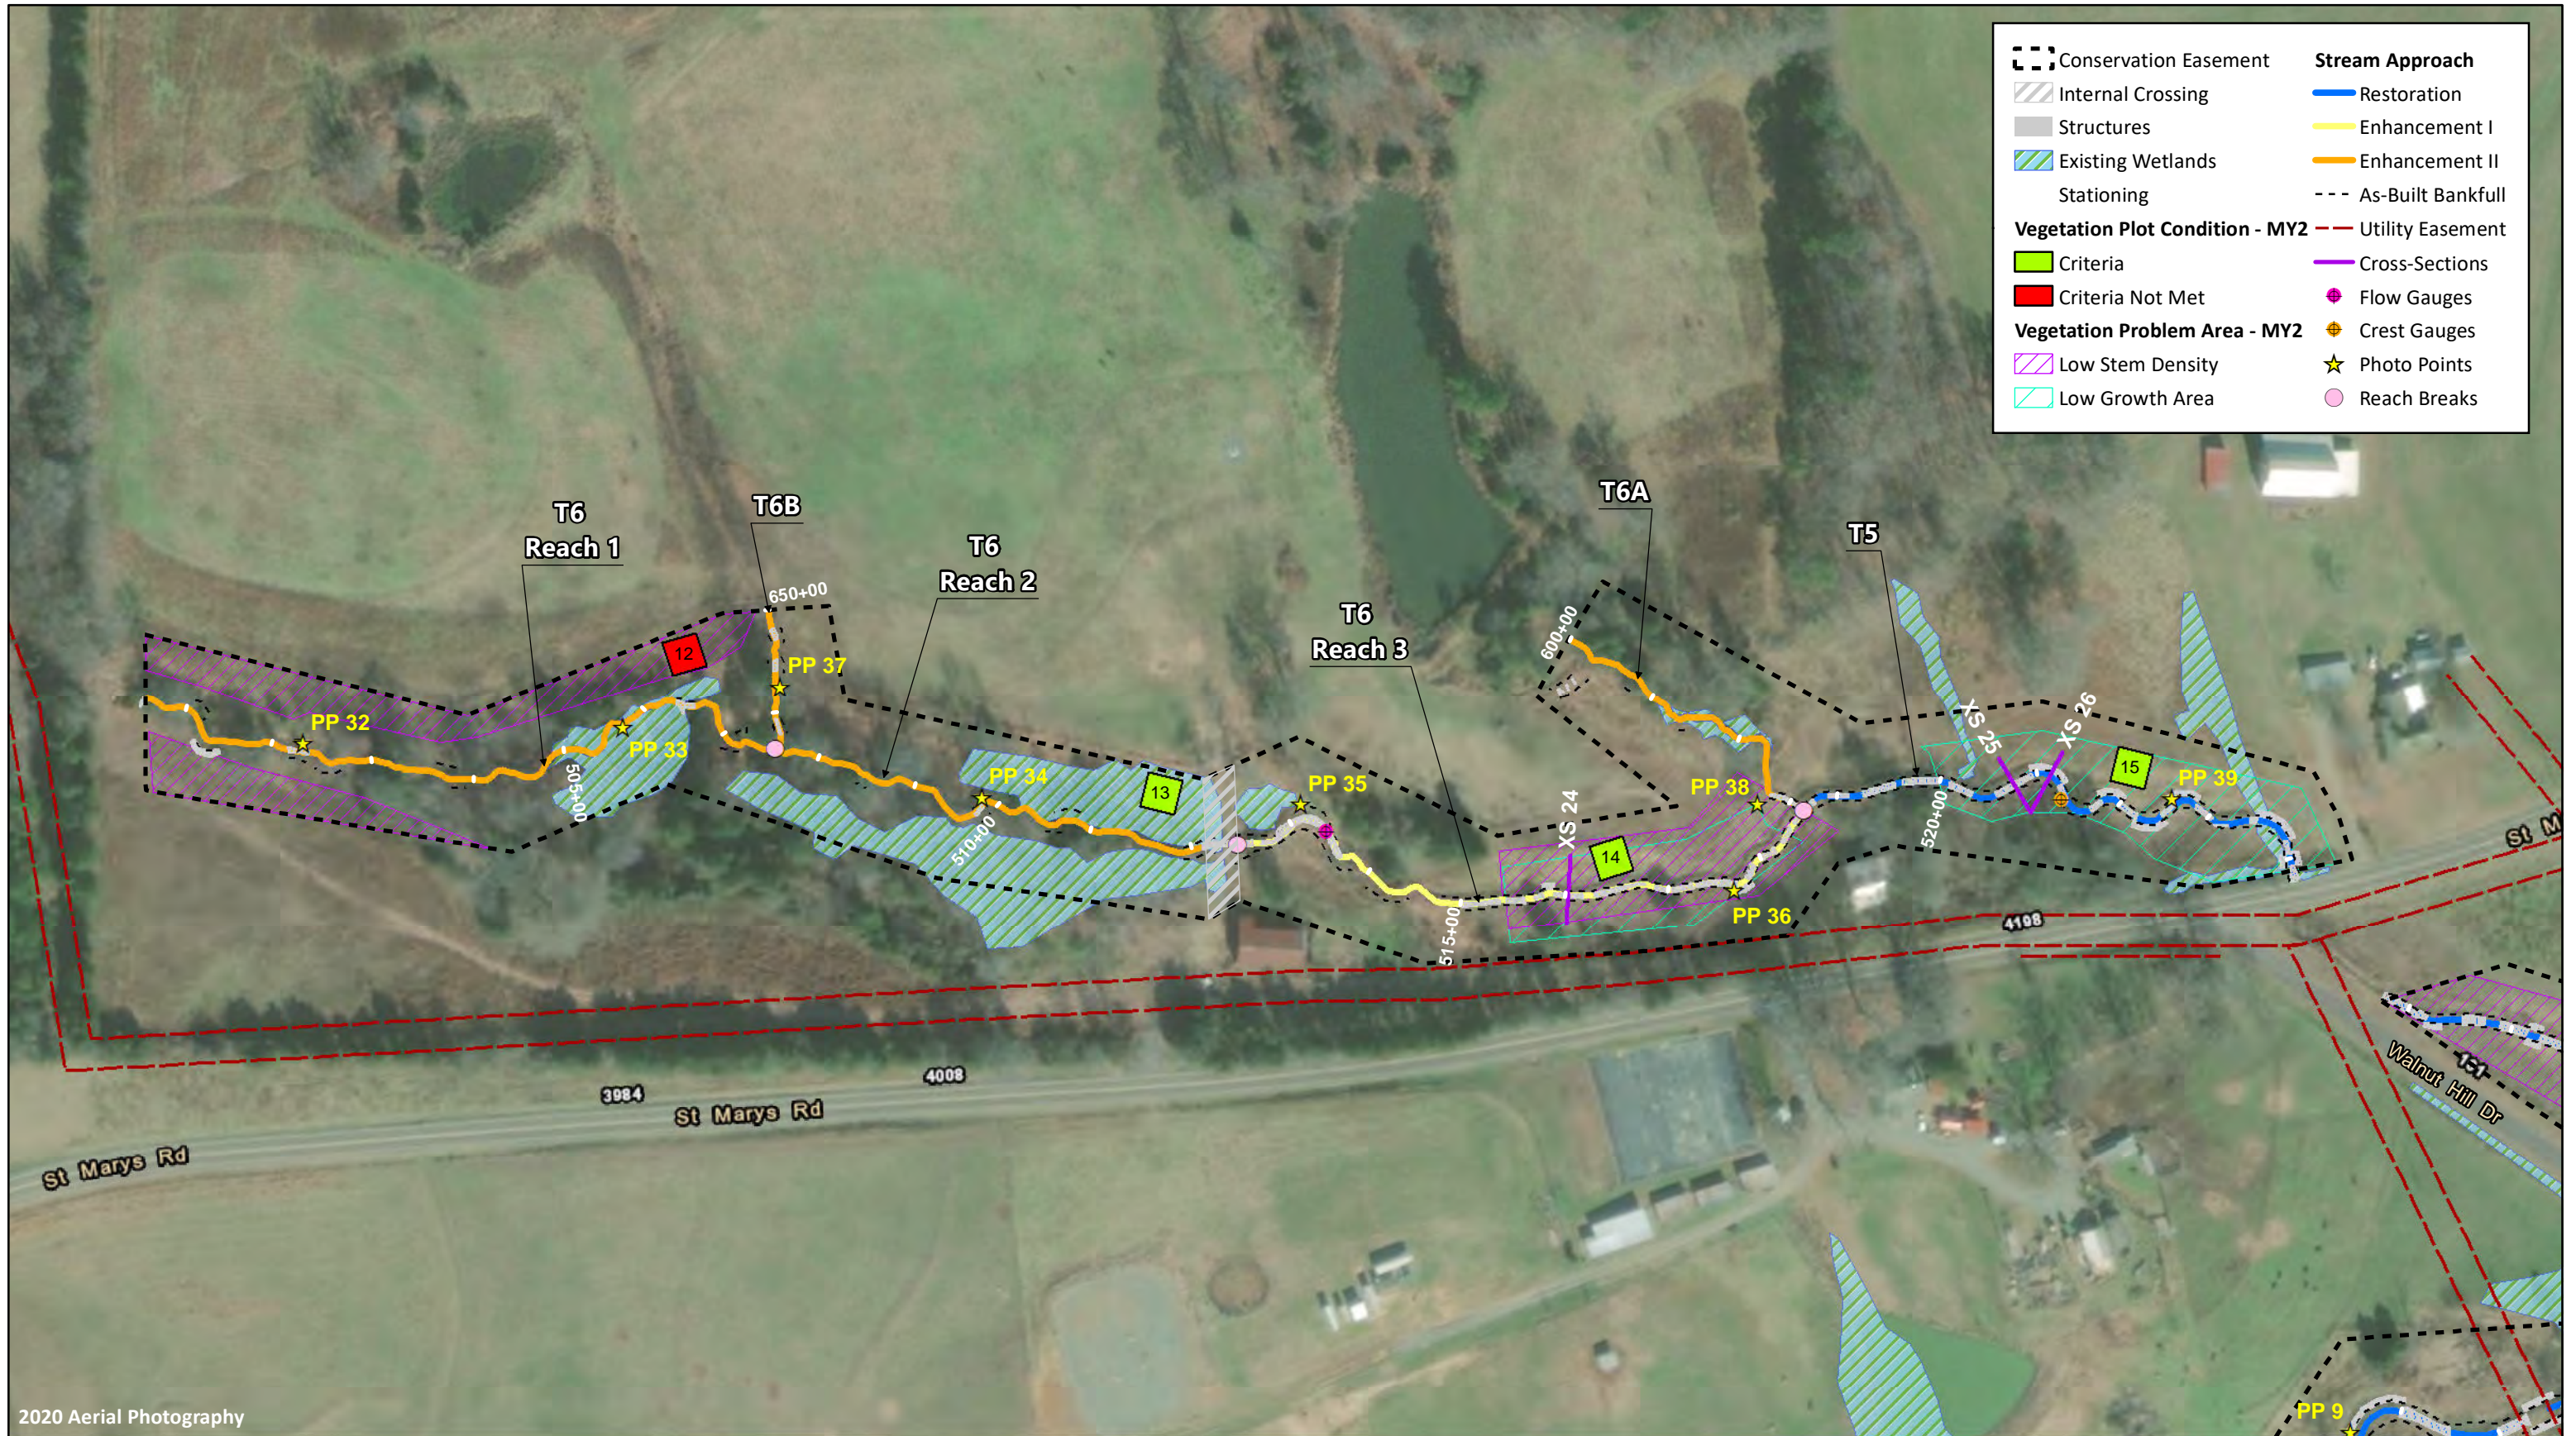
Figure 3e. Integrated Current Condition Plan View  
 Buckwater Mitigation Site  
 DMS Project No. 97084  
 Monitoring Year 2 - 2020

A high mortality rate of planted trees was observed between MY1 and MY2 (Figures 3a-3e Current Condition Plan View (CCPV)). The mortality rate can be attributed to competition from fescue and poor soils. A supplemental planting plan of 10.7 acres is presented in Section 1.2.7.

A 1.4-acre area of low vegetative growth was noted along T5 (upstream of St. Mary's Rd) and T6 (Figure 3e CCPV and Table 6, Appendix 2). Grading during construction exposed rocky poor-quality subsoil near the surface. Soil amendments including a mixture of dolomitic lime, fertilizer, and humic acid, and a seed mix of herbaceous vegetation were applied to this area in August 2020. Amendments will continue to be applied throughout subsequent monitoring years, as necessary.

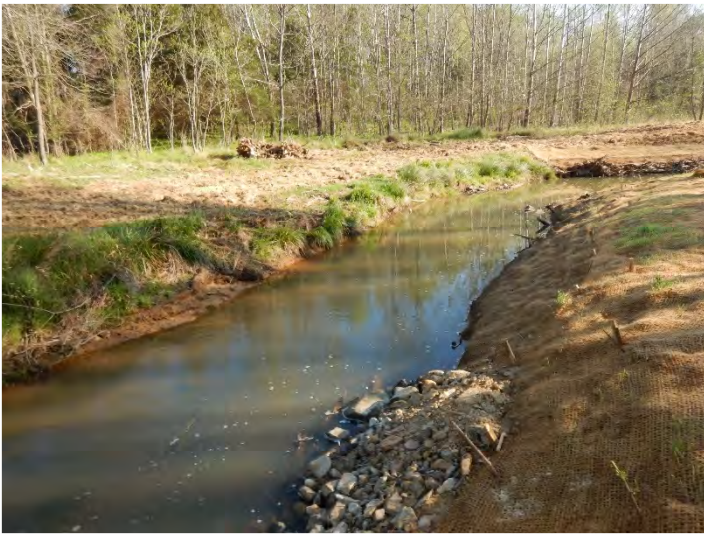
Bank erosion was identified on Buckwater Creek Reach 7 between stations 146+00 and 151+00 during MY1. Stream bank repairs were conducted in April 2020 and are shown on Figure 3b (CCPV Map, and Stream Areas of Concern Photographs, Appendix 2).

**Before - Localized Erosion (10/9/2019)**

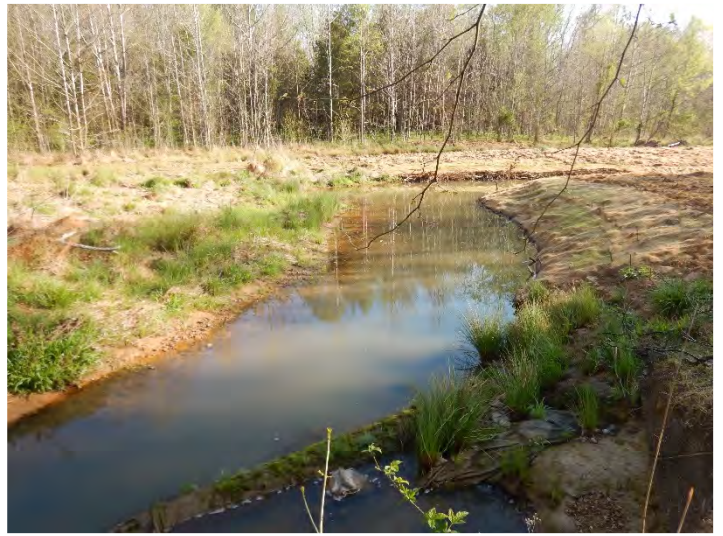
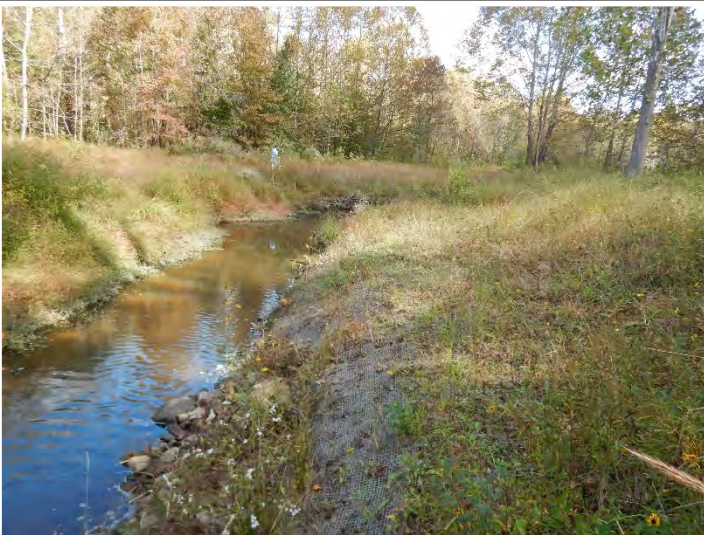
**After - Repaired Localized Erosion (4/7/2020)**

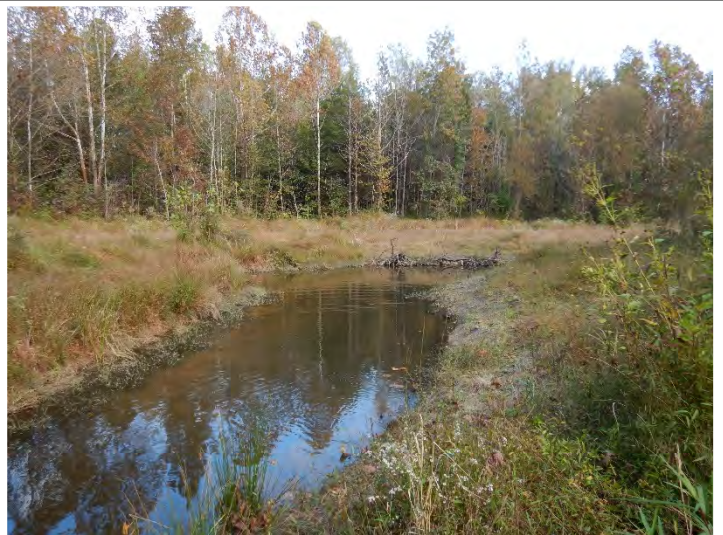
**After - Repaired Localized Erosion (10/21/2020)**
