**MONITORING YEAR 4
ANNUAL REPORT**
Final

BUCKWATER MITIGATION SITE

Orange County, NC
Neuse River Basin
HUC 03020201

DMS Project No. 97084
NCDEQ Contract No. 006829
USACE Action ID No. 2016-00873
DWR Project No. 2016-0406 v2

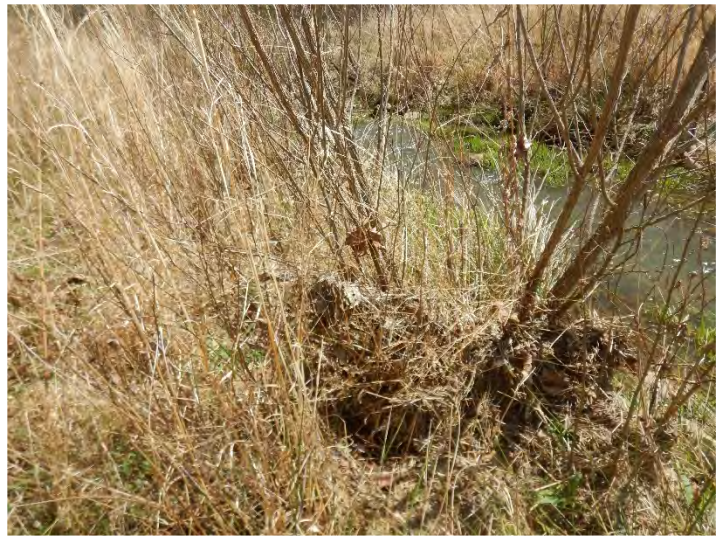
Buckwater Creek Reach 4 (4/6/2022)

Several beaver dams were removed along Buckwater Creek Reach 4 (Figure 1b) in August 2022 by APHIS. Beaver have not returned since the dams were removed. The two areas where beaver dams occurred experienced some vegetation loss and sediment deposition. The vegetation is expected to grow back in over the next year. The sediment deposition occurred on the point bars and is not a concern.

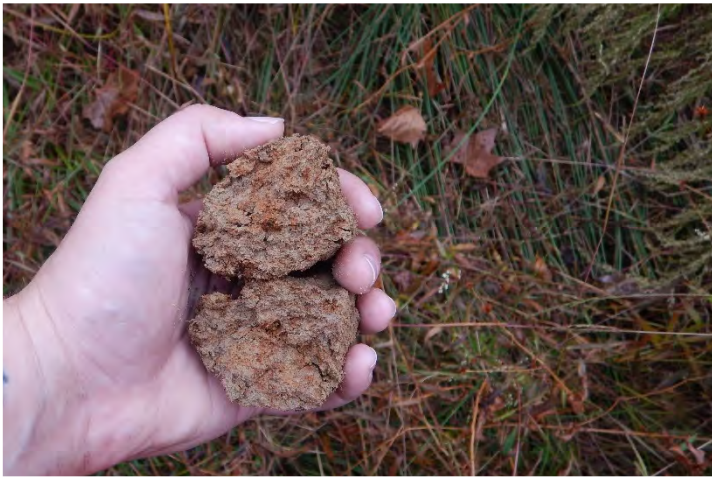
T2 – Soil ped observed within 0-12 inches of the soil surface in additional wetland areas (10/20/2022)

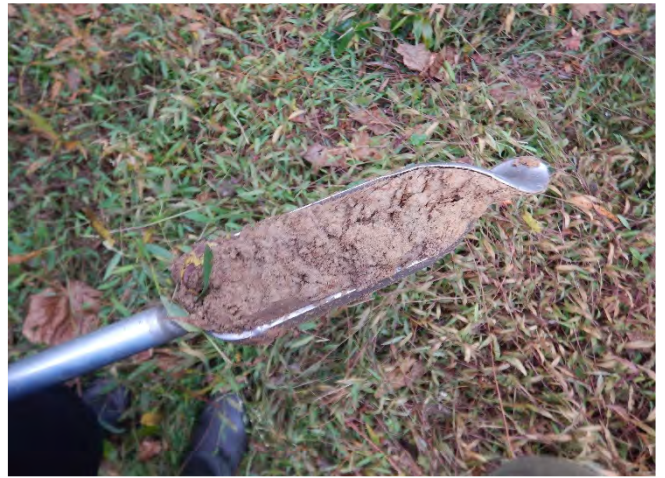
T1 Reach 2 – Soil profile observed within 0-12 inches of the soil surface in existing wetland areas onsite (10/26/2022)

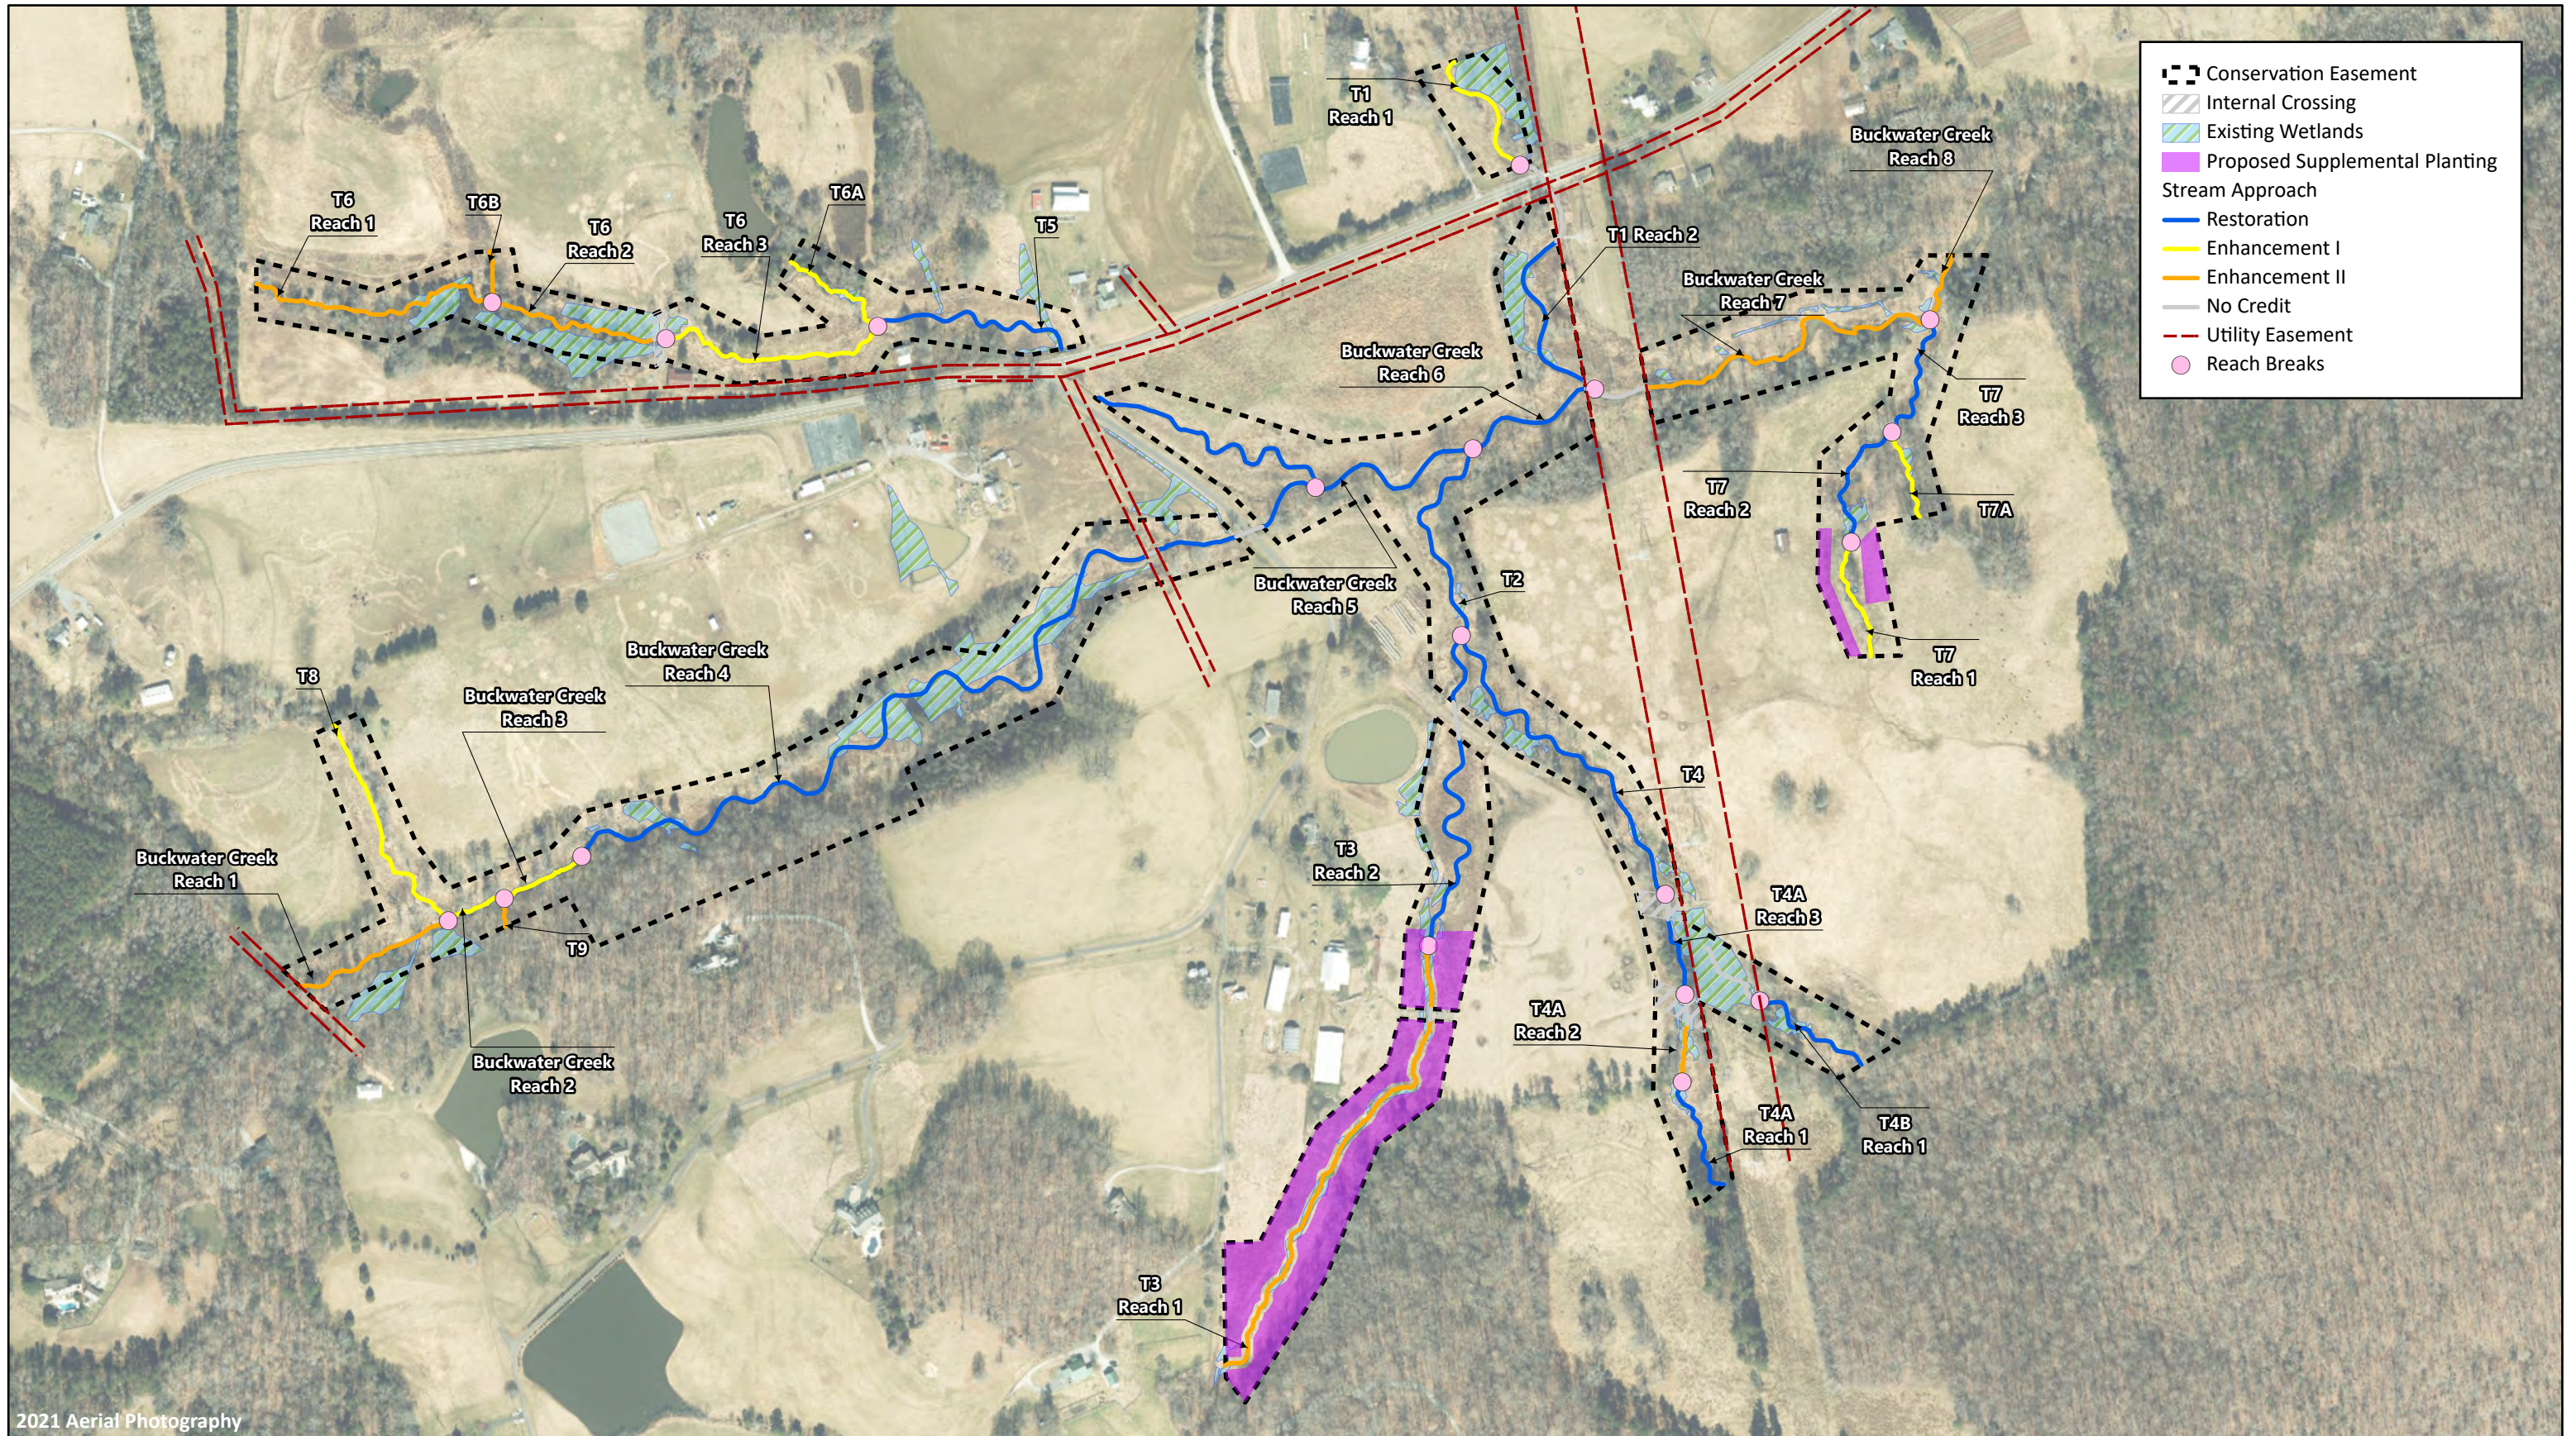
Figure 1. Supplemental Planting Along UT3 and UT7
 Buckwater Mitigation Site
 DMS Project No. 97084
 Monitoring Year 4 - 2022

Based on visual observations, Wildlands was concerned about lack of species diversity along portions of T3 and T7. With this in mind, Wildlands received approval from the IRT to supplementally plant 4.3 acres across the Site (Appendix F). The supplemental planting occurred on November 7, 2022.
