MONITORING YEAR 5 ANNUAL REPORT

BUCKWATER MITIGATION SITE

Orange County, NC
Neuse River Basin
HUC 03020201
DMS Project No. 97084
NCDEQ Contract No. 006829
USACE Action ID No. 2016-00873
DWR Project No. 2016-0406v2

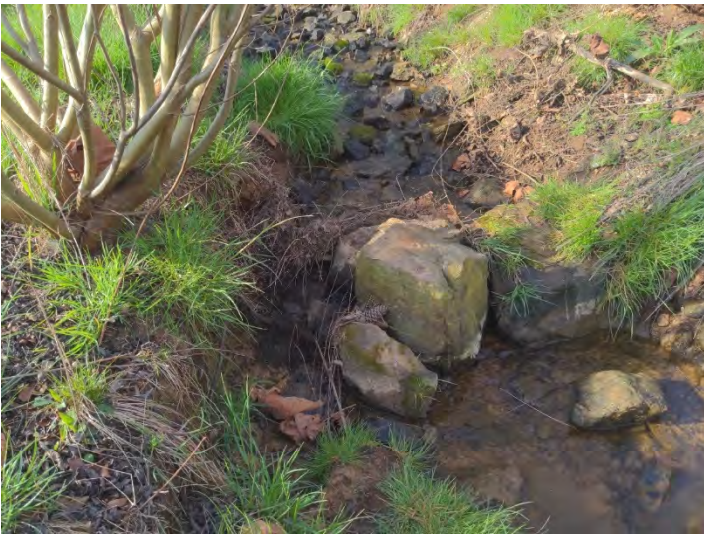
Several piping rock and log sills and a failed log riffle were observed along T3 Reach 2, T4, T4B Reach 1, and T6 Reach 3, as well as a perched culvert below a crossing on T4. Mechanical repairs of these structures were completed in August 2023. The locations of all stream repair areas and associated LODs are shown on Figures 1c and 1d. Details of the failed structures and repairs completed are included in Appendix F. All stream repairs are stable and functioning as intended.

T3 R2 STA 314+20 - 314+30 – Piping Rock Sill (3/24/2023)

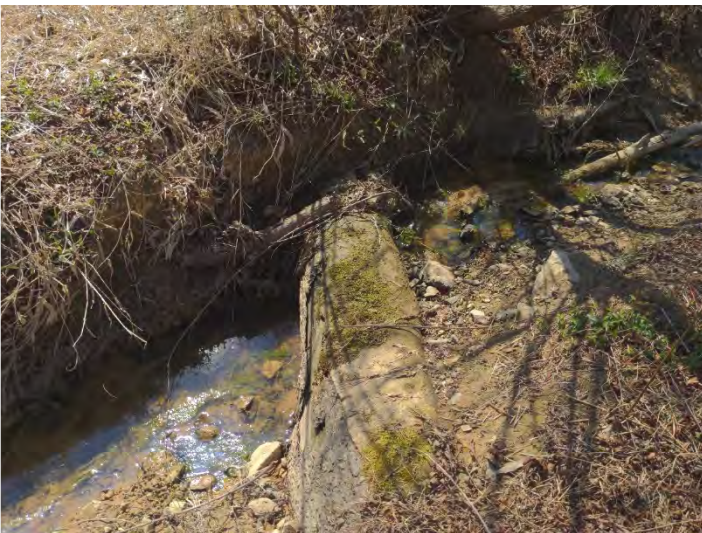
T6 R3 STA 517+80 – 518+20 – Piping Log Sills (3/24/2023)

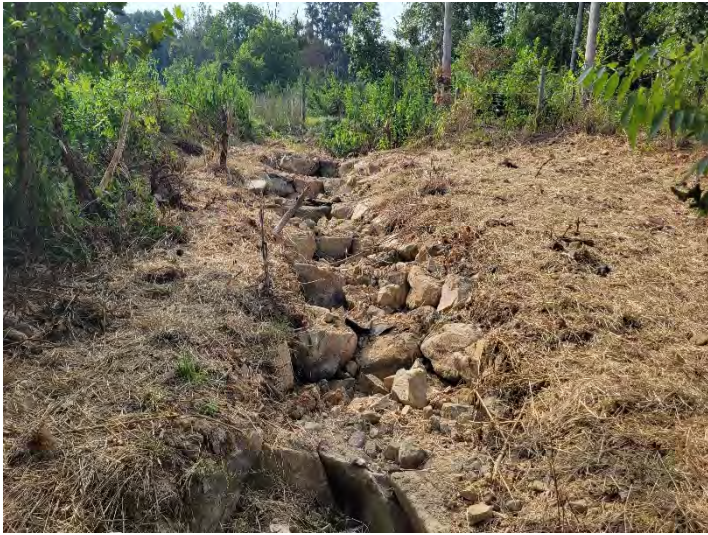
T4 STA 408+42 – 409+20 – Repaired Reach (8/22/2023)

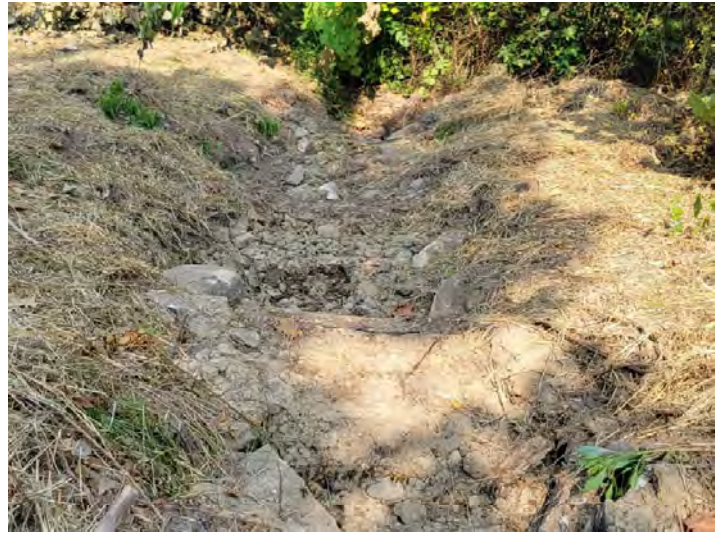
T4B R1 STA 453+00 – 453+50 – Repaired Area (8/22/2023)

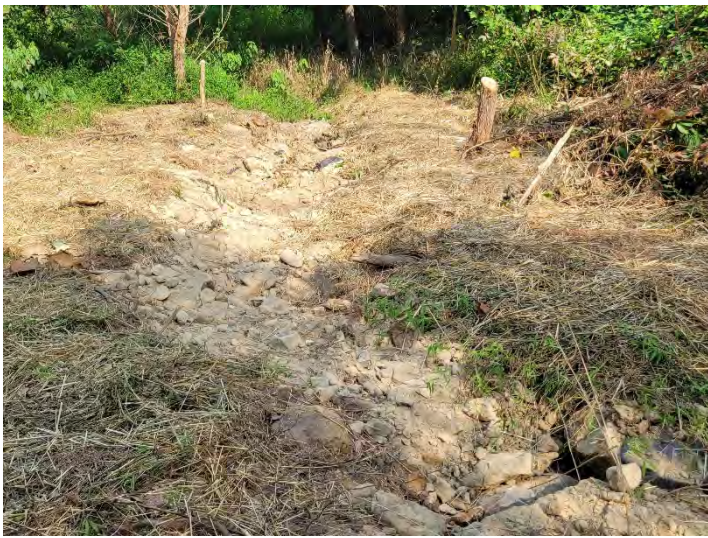
T4B R1 STA 451+40 – 451+70 – Repaired Area (8/22/2023)

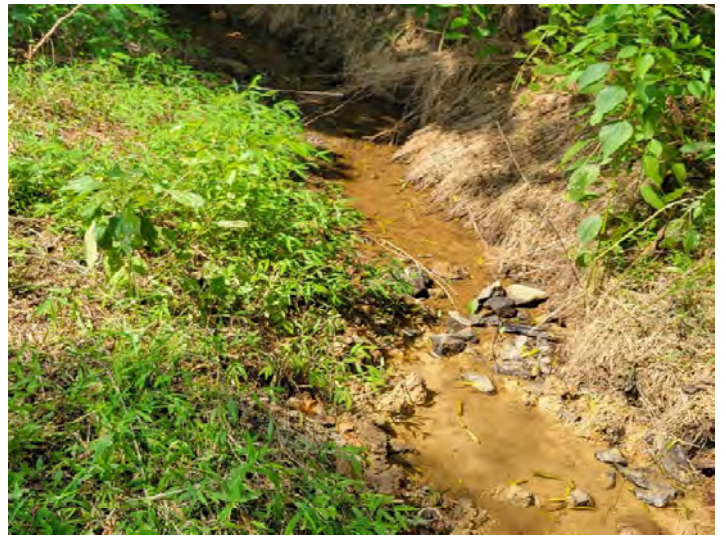
T3 R2 STA 314+20 – 314+30 – Repaired Area (8/22/2023)

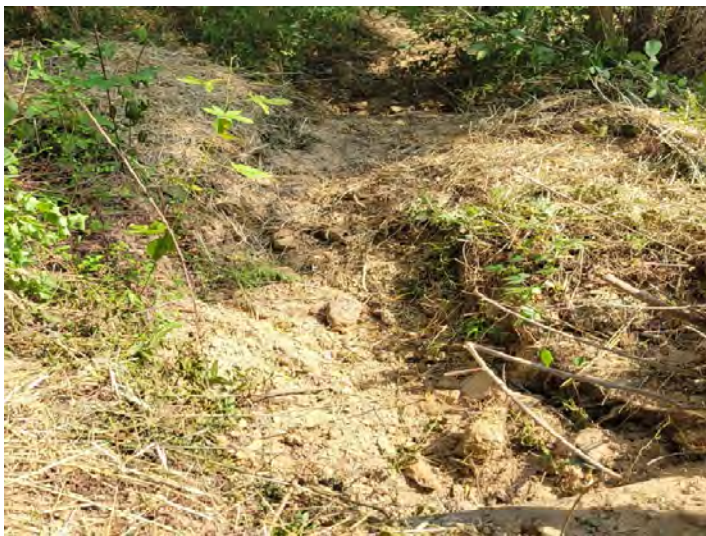
T6 R3 STA 517+80 – 518+20 – Repaired Area (8/22/2023)
