**Year 3 Monitoring Report**

**Bucky's Branch Mitigation Project**

**DMS Project #: 100109 | Contract #: 7861 | DWR # 2019-1404 | RFP: 16-007703**

**January 2023**

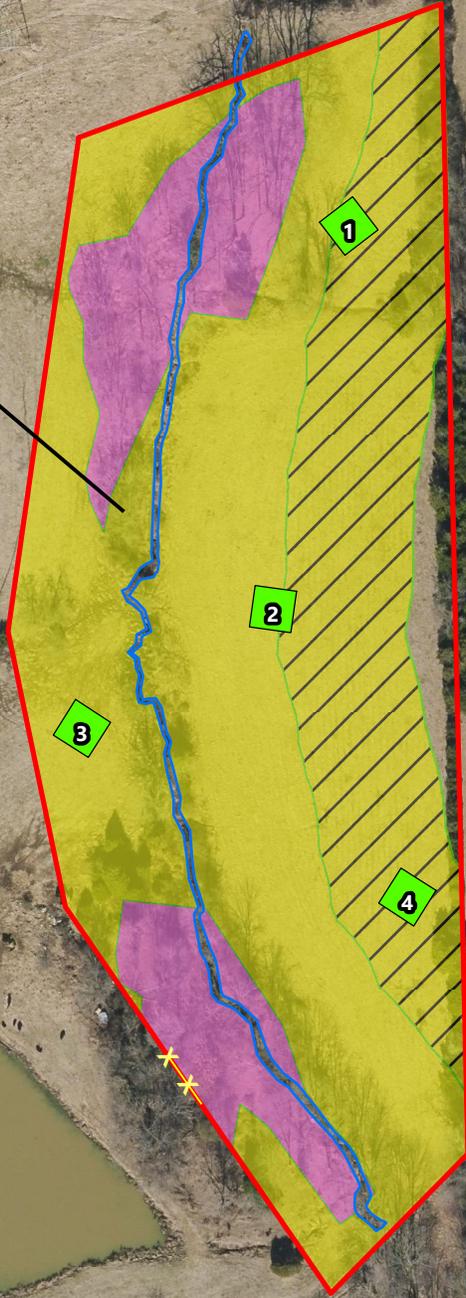
**Figure 2 - Current Conditions Plan View**

that were observed, mainly multiflora rose (*Rosa multiflora*), were treated via foliar spray in August 2022. Invasive species will continue to be monitored and treated as necessary. The fence is mostly in good condition; however, a tree fell on a portion of the fence along the western boundary, bending the frame. The tree has remained on the fence, creating a natural barricade, and therefore has maintained temporary cattle exclusion. This area of fencing will be repaired as soon as possible. Additionally, there were no signs of encroachment or concentrated flow in the easement area.
