Year 4 Monitoring Report

Bucky's Branch Mitigation Project

DMS Project #: 100109 | Contract #: 7861

Randolph County, North Carolina

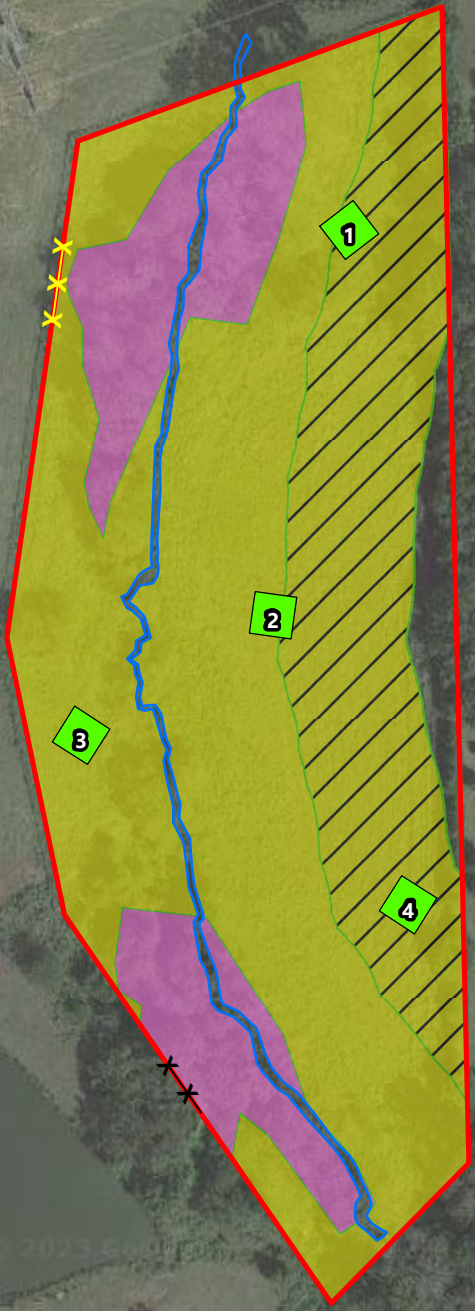
Figure 2 - Current Conditions Plan View

Visual assessment of vegetation outside of the monitoring plots indicates that the herbaceous vegetation is becoming well established throughout the project. Multiflora rose (*Rosa multiflora*), was treated via foliar

spray in August 2022. However, no invasive species were identified or treated in 2023 but RES will continue to monitor and treat as necessary. A small portion of the fence was fixed in November of 2022 from a tree falling on the fence, associated photos of this repair can be found in **Appendix C**. Another portion of the fence has damage to the top section of the fence and will be fixed as soon as possible. The area of damage can be found in **Figure 2** and photos of the damage can be found in **Appendix C**. The fence is overall in good condition and therefore has maintained cattle exclusion. Additionally, there were no signs of encroachment or concentrated flow in the easement area.

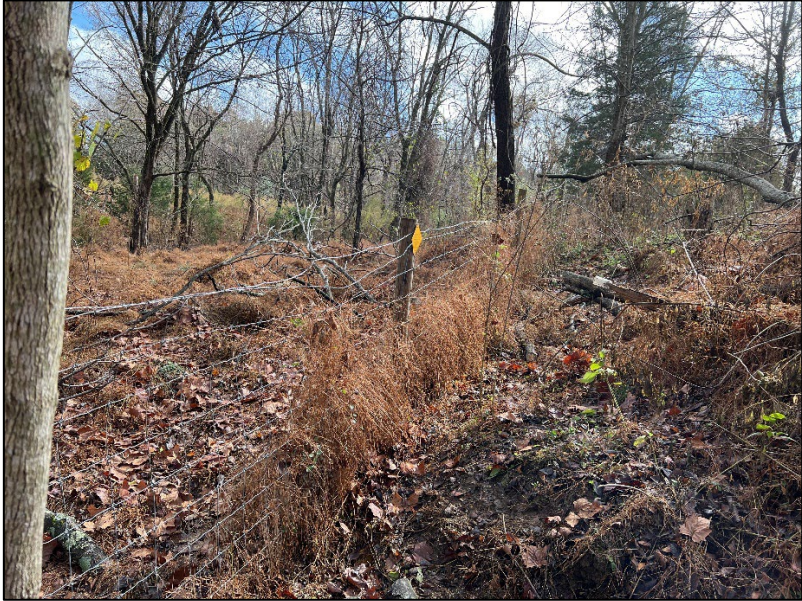
Fence repair (11/11/2022)

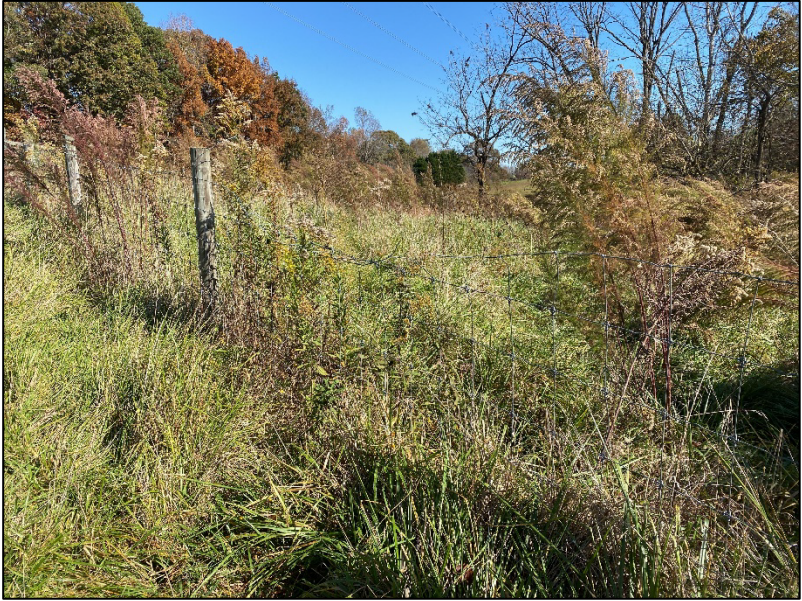
Fence Damage (11/01/2023)
