MY2 FINAL MONITORING REPORT
Buffalo Creek Tributaries Mitigation Project
Johnston County
Neuse River Basin
CU 03020201

DMS Project # 100042
DMS Contract # 7422
DMS RFP # 16-007279
USACE Action ID Number: SAW-2018-00425
DWR Project # 2018-0199 V2
Calendar Year of Data Collection: 2022

RE: WLS Responses to NCDEQ DMS Review Comments for Task 8 Submittal, Draft Monitoring Year 2 Report for the Buffalo Creek Tributaries Mitigation Project, DMS Full-Delivery Project ID #100042, Contract #7422, Neuse River Basin, Cataloging Unit 03020201, Johnston County, NC

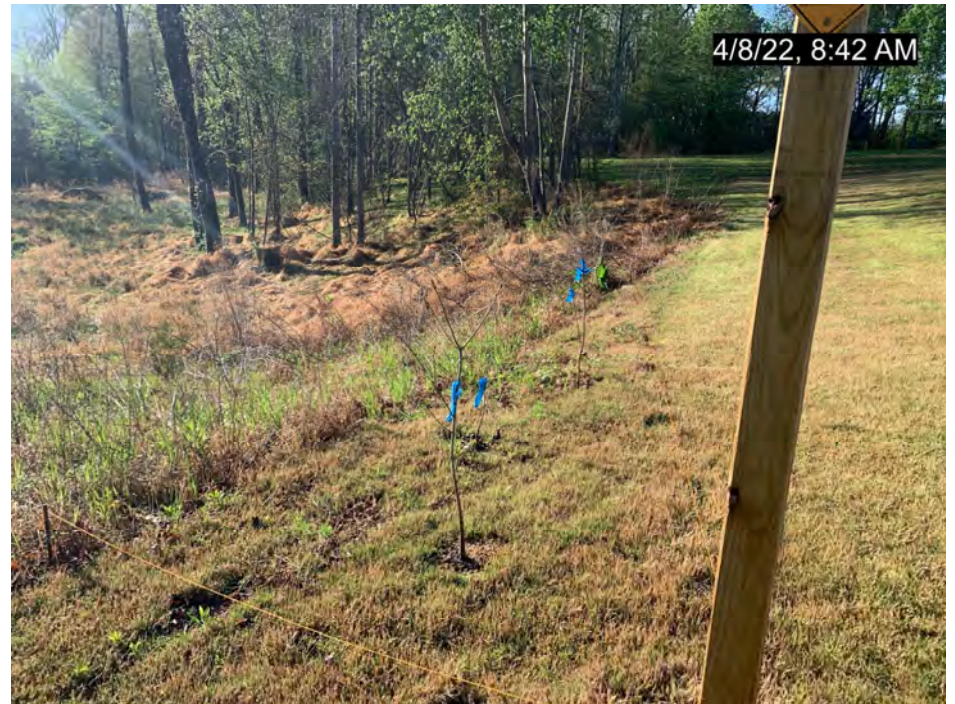
Encroachment Area 2, MS-R2, Downstream of Culvert (MY-02)

During MY1 there were two encroachments (~0.014 acres) observed near the southernmost culvert crossing on MS-R2. Both were recently sodded/planted grassy areas adjacent to new home construction. To prevent further encroachment, the homeowners were contacted, and the easement line was more clearly marked. Encroachment planting occurred on January 6th, 2022, using one-gallon trees (see planting list below). During MY2, no further encroachments have occurred in these areas. A new encroachment (~0.0005 acres) was noted on August 18th, 2022. The landowner was contacted, and the easement was more clearly marked to prevent future mowing (see photos in Appendix A).

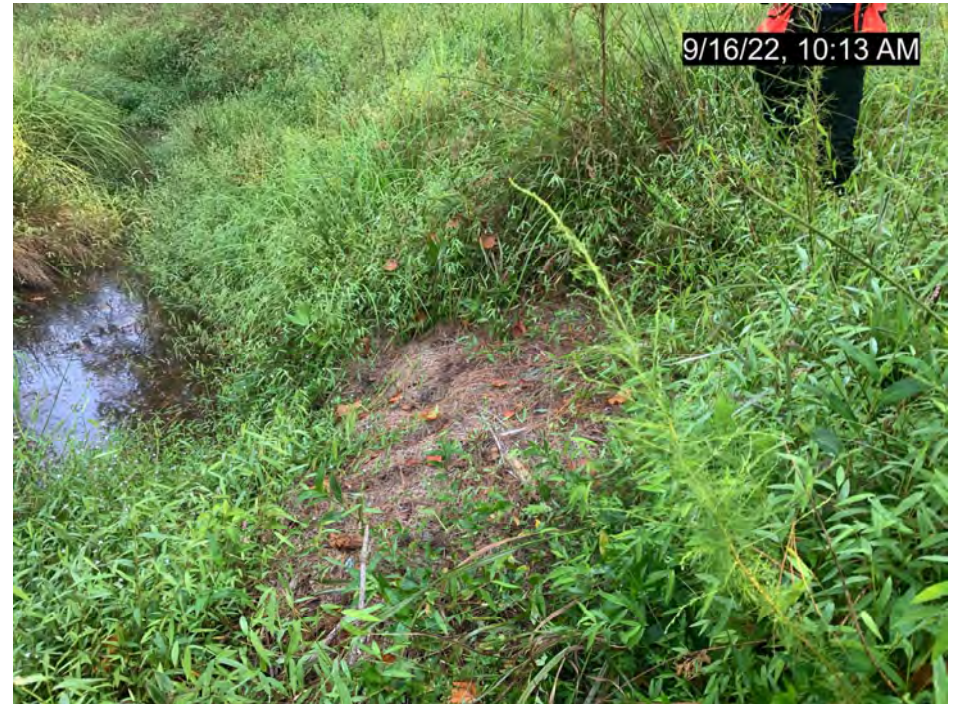
MS-R1, STA 15+00, BMP Overflow, Right Bank (MY-02)

An area of concern was noted during a DMS site visit on July 2nd, 2021, of overland flow occurring along MS-R1 from an offsite BMP. This area is stable with dense herbaceous vegetation preventing soil erosion and there are no significant impacts to the floodplain or the stream (see photos in Appendix A). This area will continue to be monitored and any remedial actions will be documented in future reports.

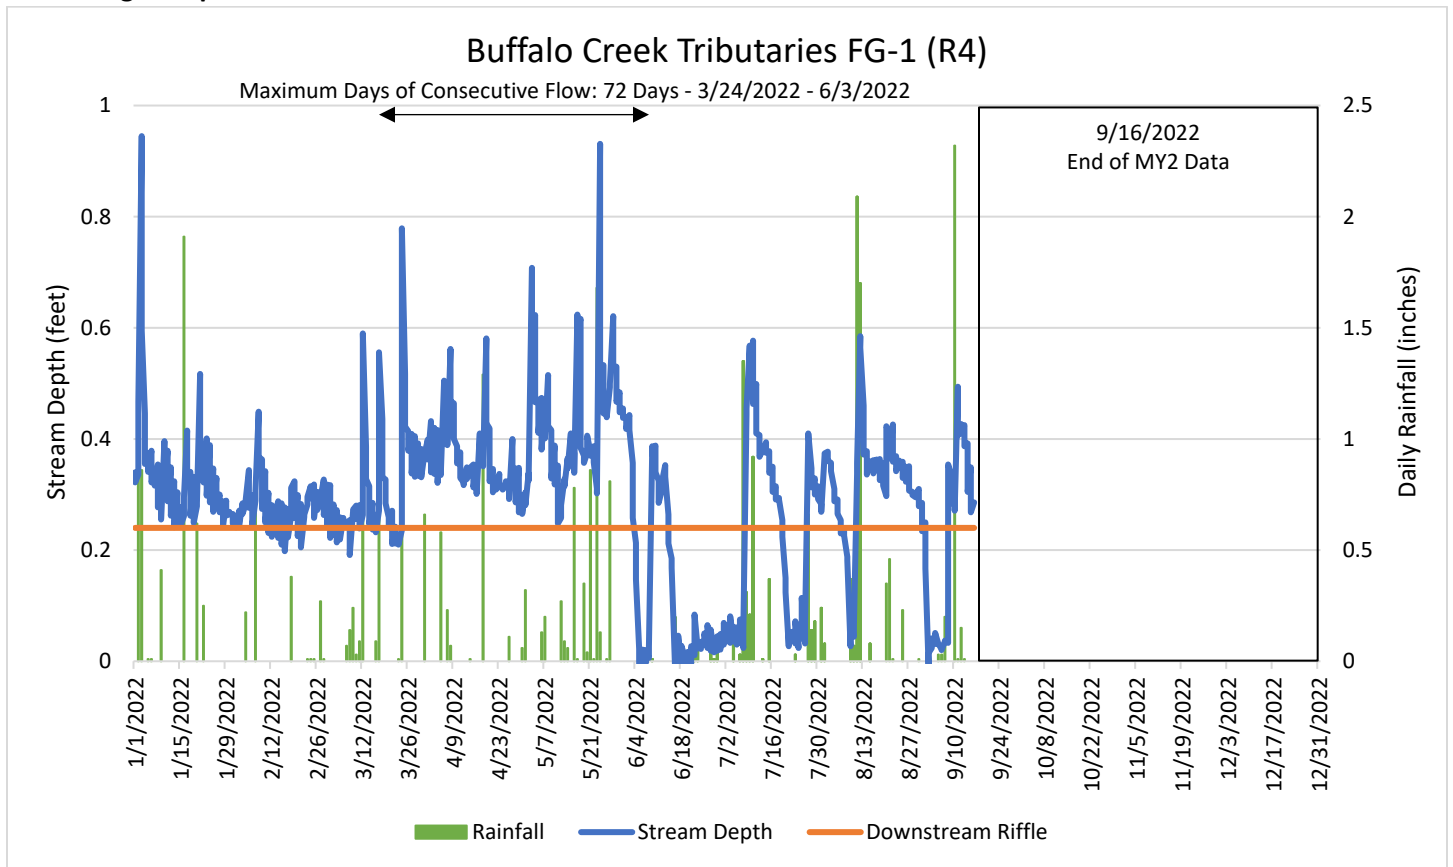
***FG-1:** 199 Cumulative days of flow, 60 days of no flow

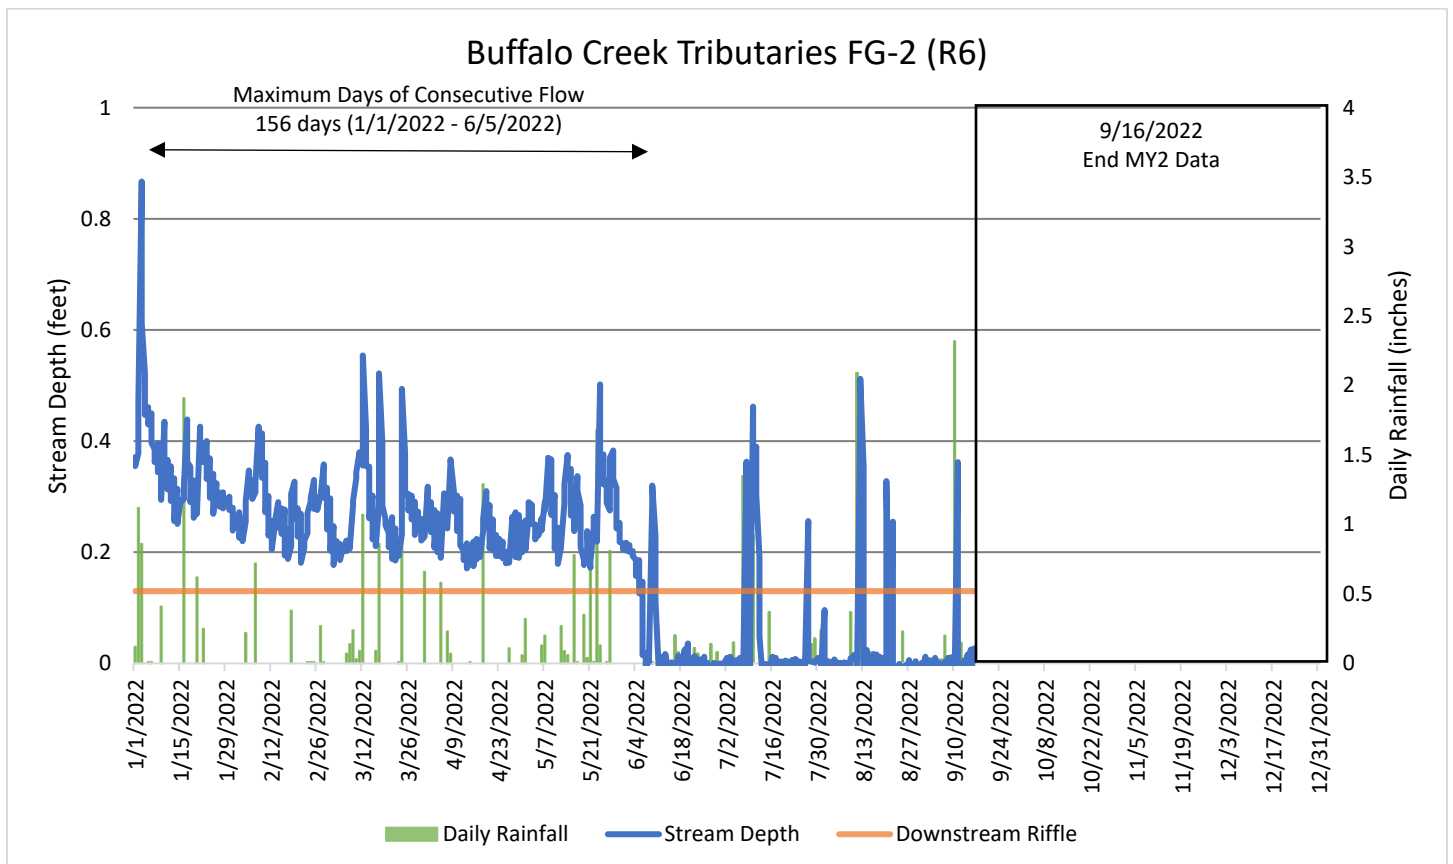
***FG-2:** 164 Cumulative days of flow, 95 days of no flow

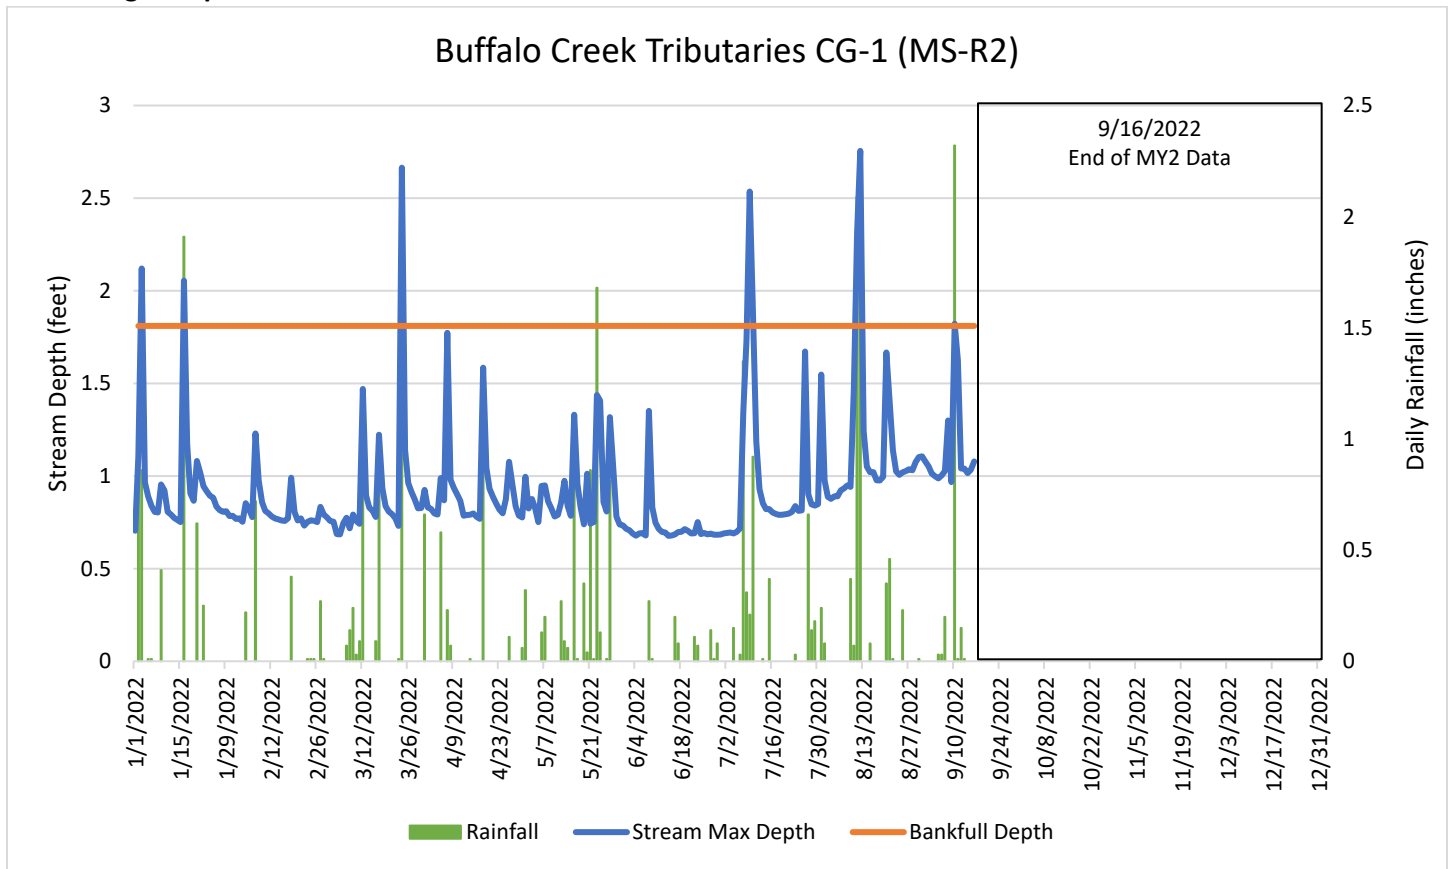
*CG-1: 5 bankfull events in MY2 with a maximum of 0.945' above bankfull
