MY3 FINAL MONITORING REPORT  
Buffalo Creek Tributaries Mitigation Project  
Johnston County  
Neuse River Basin  
CU 03020201

DMS Project # 100042  
DMS Contract # 7422  
DMS RFP # 16-007279  
USACE Action ID Number: SAW-2018-00425  
DWR Project # 2018-0199 V2  
Calendar Year of Data Collection: 2023

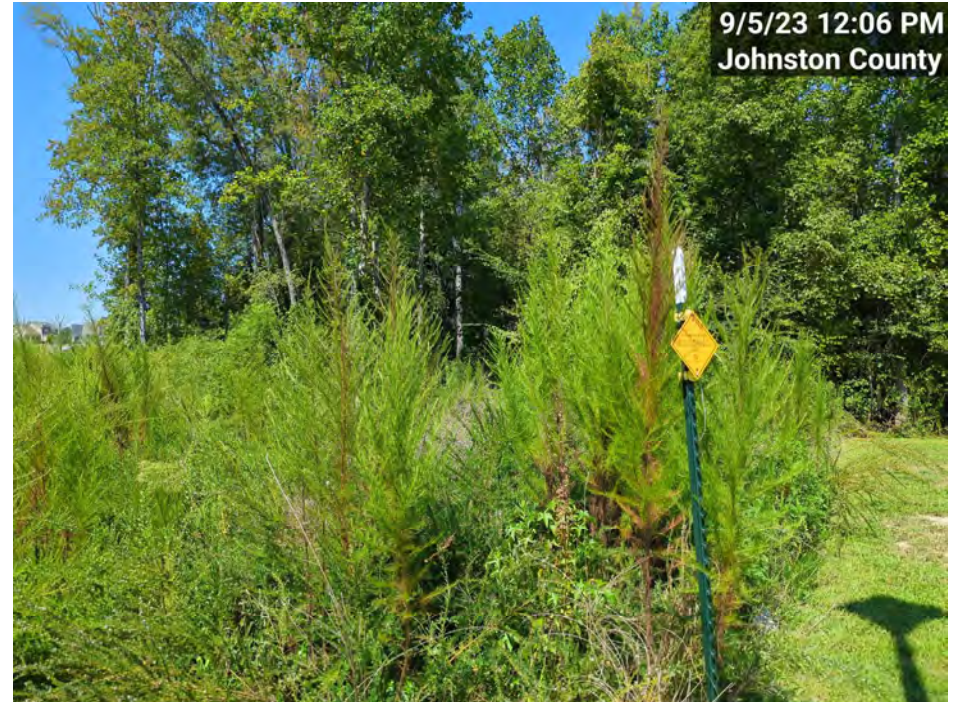
Encroachment Area 1, MS-R2, Upstream of Culvert (MY-03)

During MY1, there were two encroachments (~0.014 acres) observed near the southernmost culvert crossing on MS-R2. Both were sodded/planted grassy areas adjacent to new home construction. To prevent further encroachment, the homeowners were contacted, and the easement line was more clearly marked. Encroachment planting occurred on January 6<sup>th</sup>, 2022. During MY3, no further encroachments have occurred in these areas, and herbaceous and tree cover are doing well. These encroachments are resolved and WLS will continue to monitor the easement in these areas in MY4. No additional encroachments were noted during MY3.

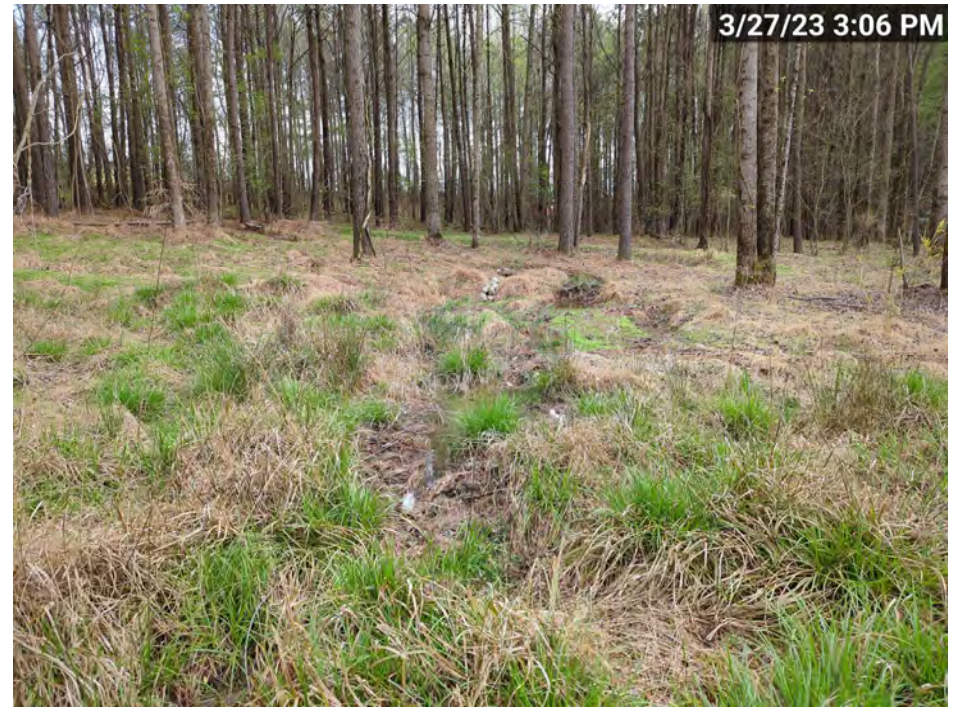
MS-R1, STA 15+00, BMP Overflow, Right Floodplain (MY-03)

An area of concern was noted during a DMS site visit on July 2<sup>nd</sup>, 2021, of overland flow occurring along MS-R1 from an offsite BMP. This area is stable with dense herbaceous vegetation preventing soil erosion, and there are no impacts to the floodplain or the stream (see photos in Appendix A).

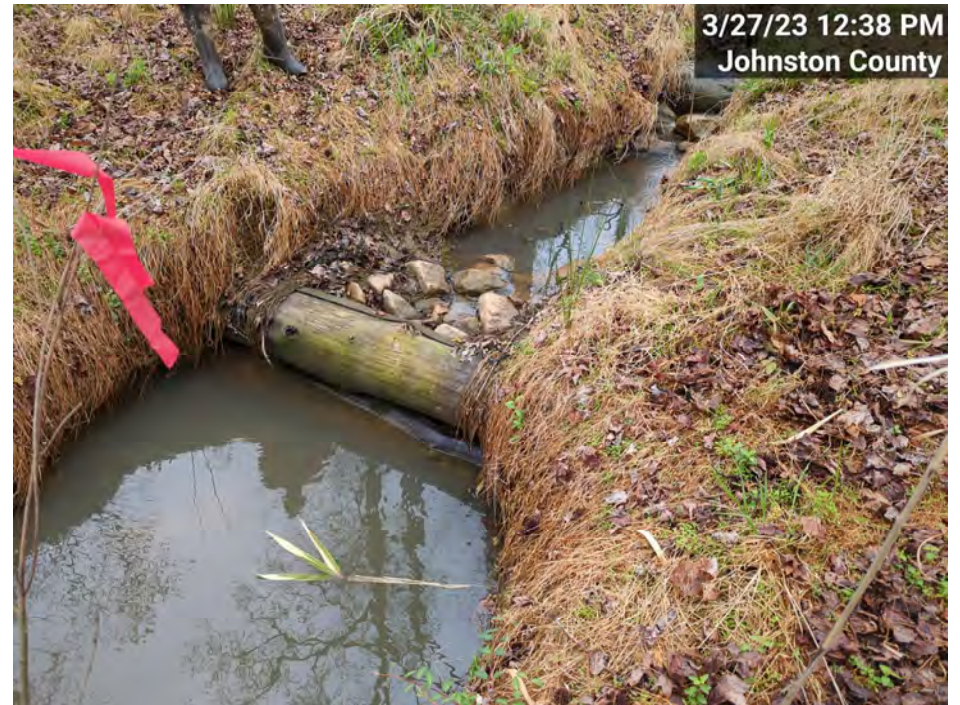
SPA-1, R6, STA 12+90, Upstream (MY-03)

One stream problem area (SPA-1) was noted during the spring site visit in MY3. One log step was noted to be piping on R6 at approximate station 12+90. The streambanks are stable above and below the structure, and the issue is isolated to one log step. WLS will continue to monitor this area in MY4. No remedial action is proposed at this time.

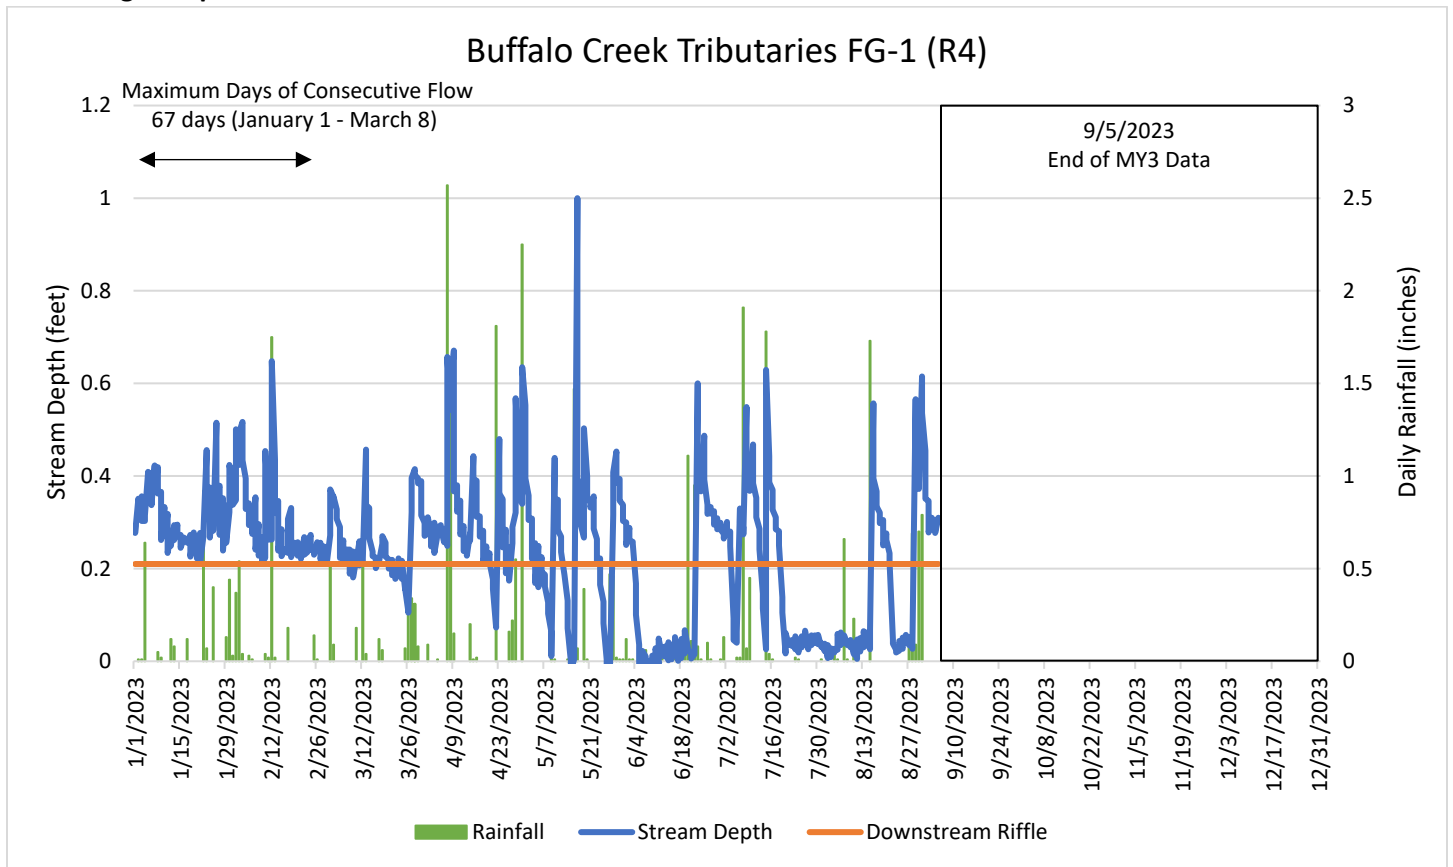
**\*FG-1:** 166 Cumulative days of flow, 82 days of no flow

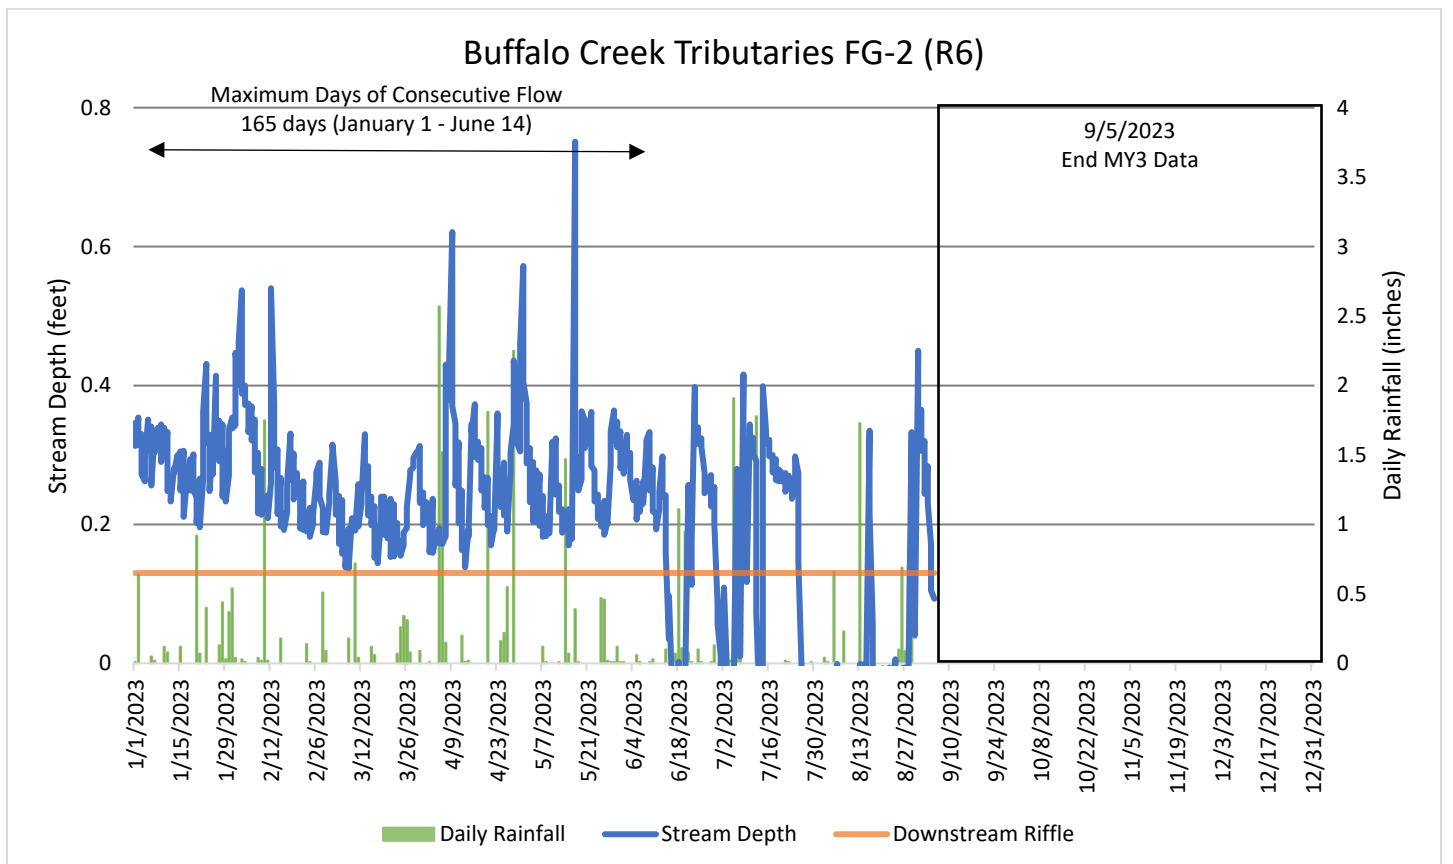
**\*FG-2:** 194 Cumulative days of flow, 54 days of no flow

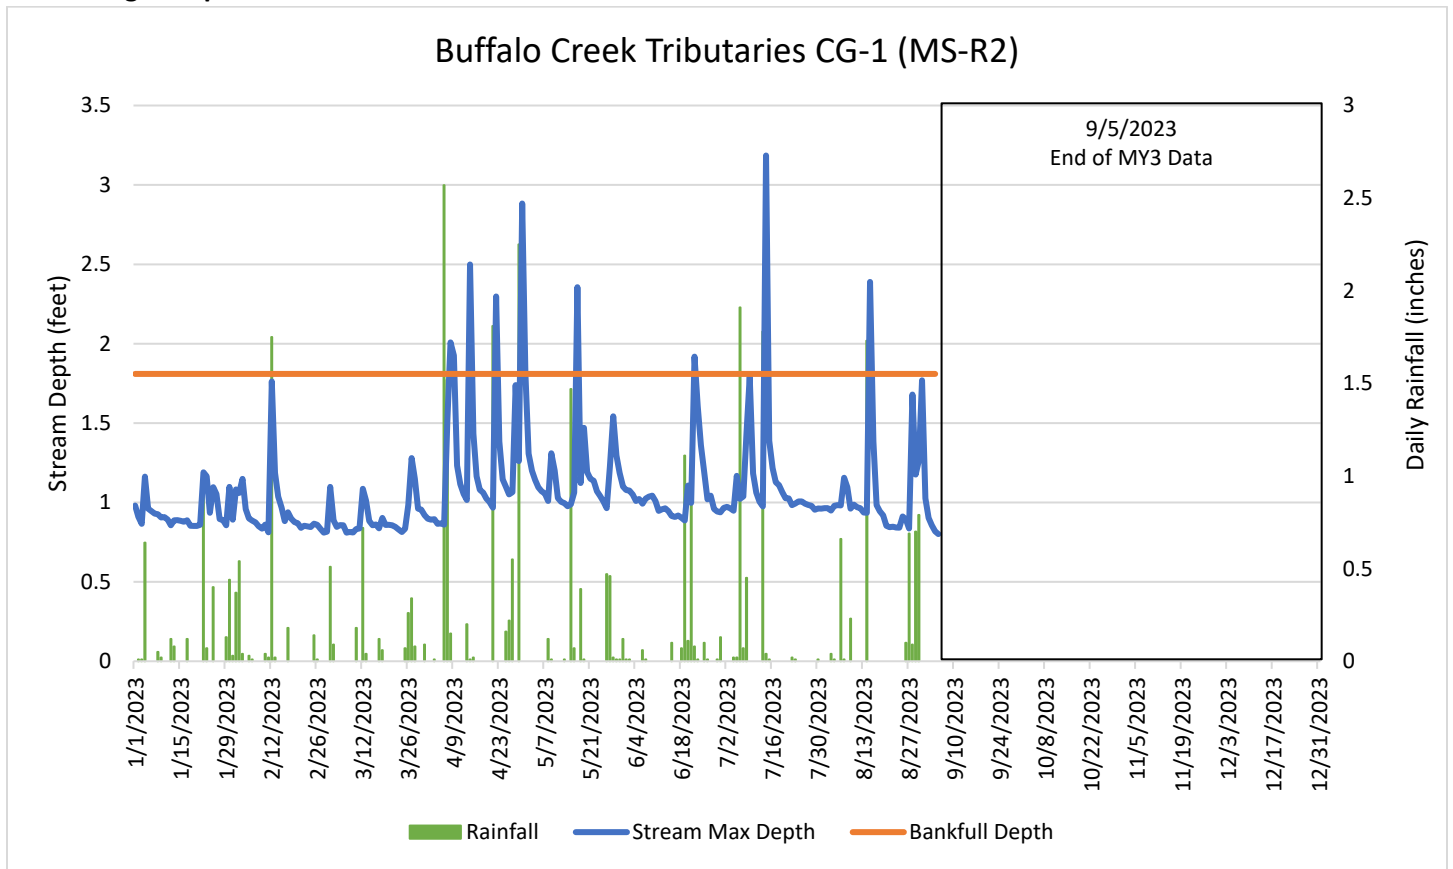
\*CG-1: 8 bankfull events in MY3 with a maximum of 1.375' above bankfull

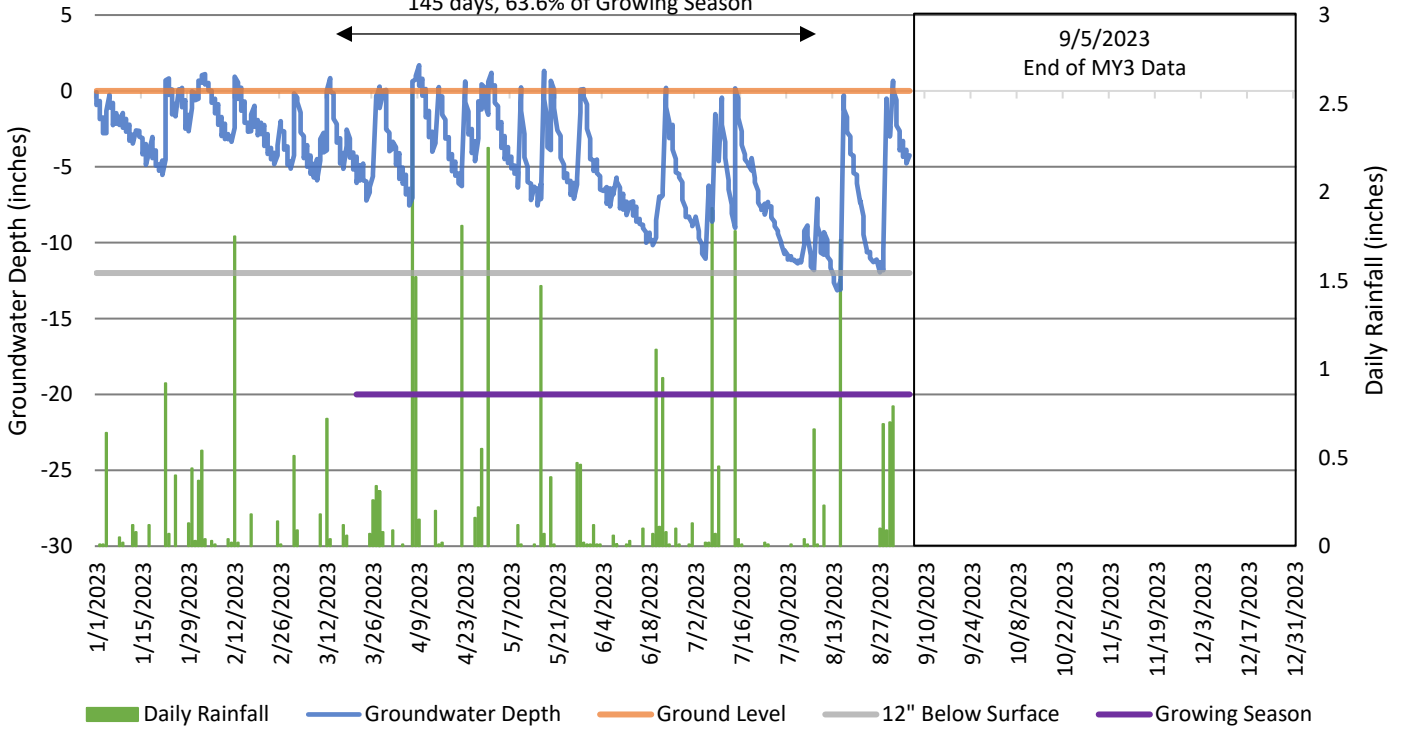
### Buffalo Creek Tributaries GW-5 (W2)

Hydrology Criteria Met  
145 days, 63.6% of Growing Season

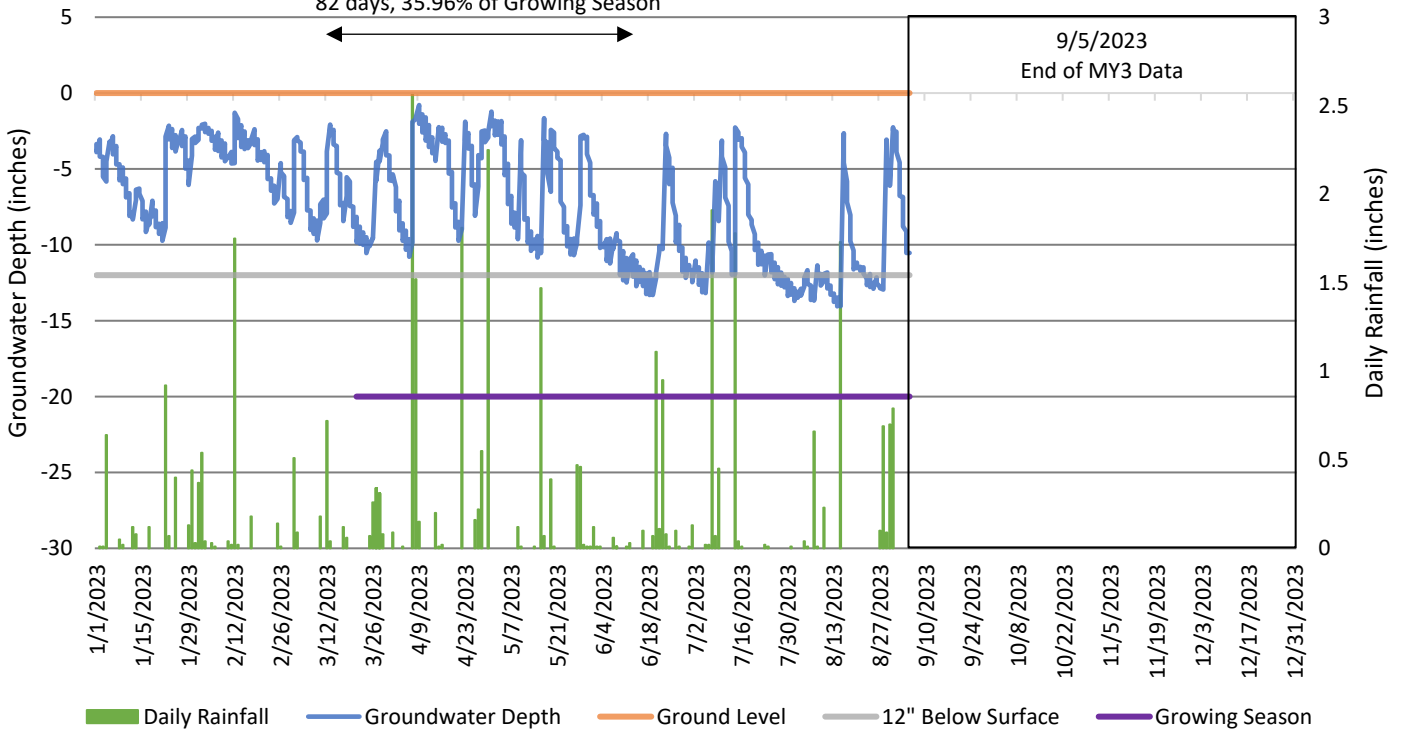
### Buffalo Creek Tributaries GW-6 (W2)

Hydrology Criteria Met:  
82 days, 35.96% of Growing Season
