# As-Built/Monitoring Year 1 Report

## LITTLE BUGABOO CREEK Wilkes County, North Carolina

June 2005

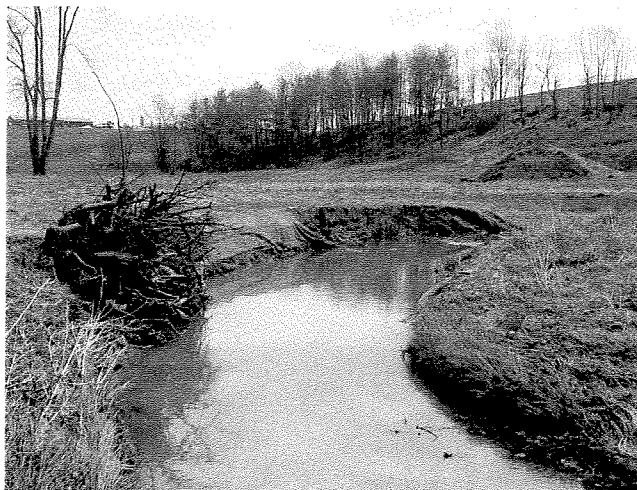
Lack of vegetation to hold the bank together.

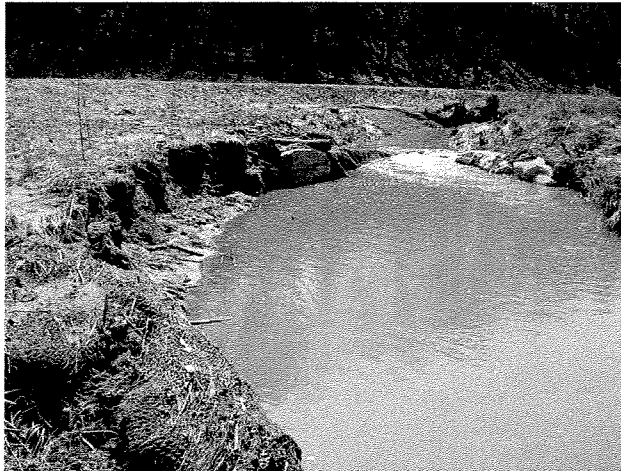
Lack of vegetation, leading to bank erosion also triggered by eddy downstream of structure (bowling effect).
