Bugaboo Stream Restoration 2005 Year One Monitoring Report

NCEEP Project Number 56

Prepared by: EcoLogic Associates, P.C.
4321-A S. Elm-Eugene St.
Greensboro, NC 27406

Submitted: September, 2006

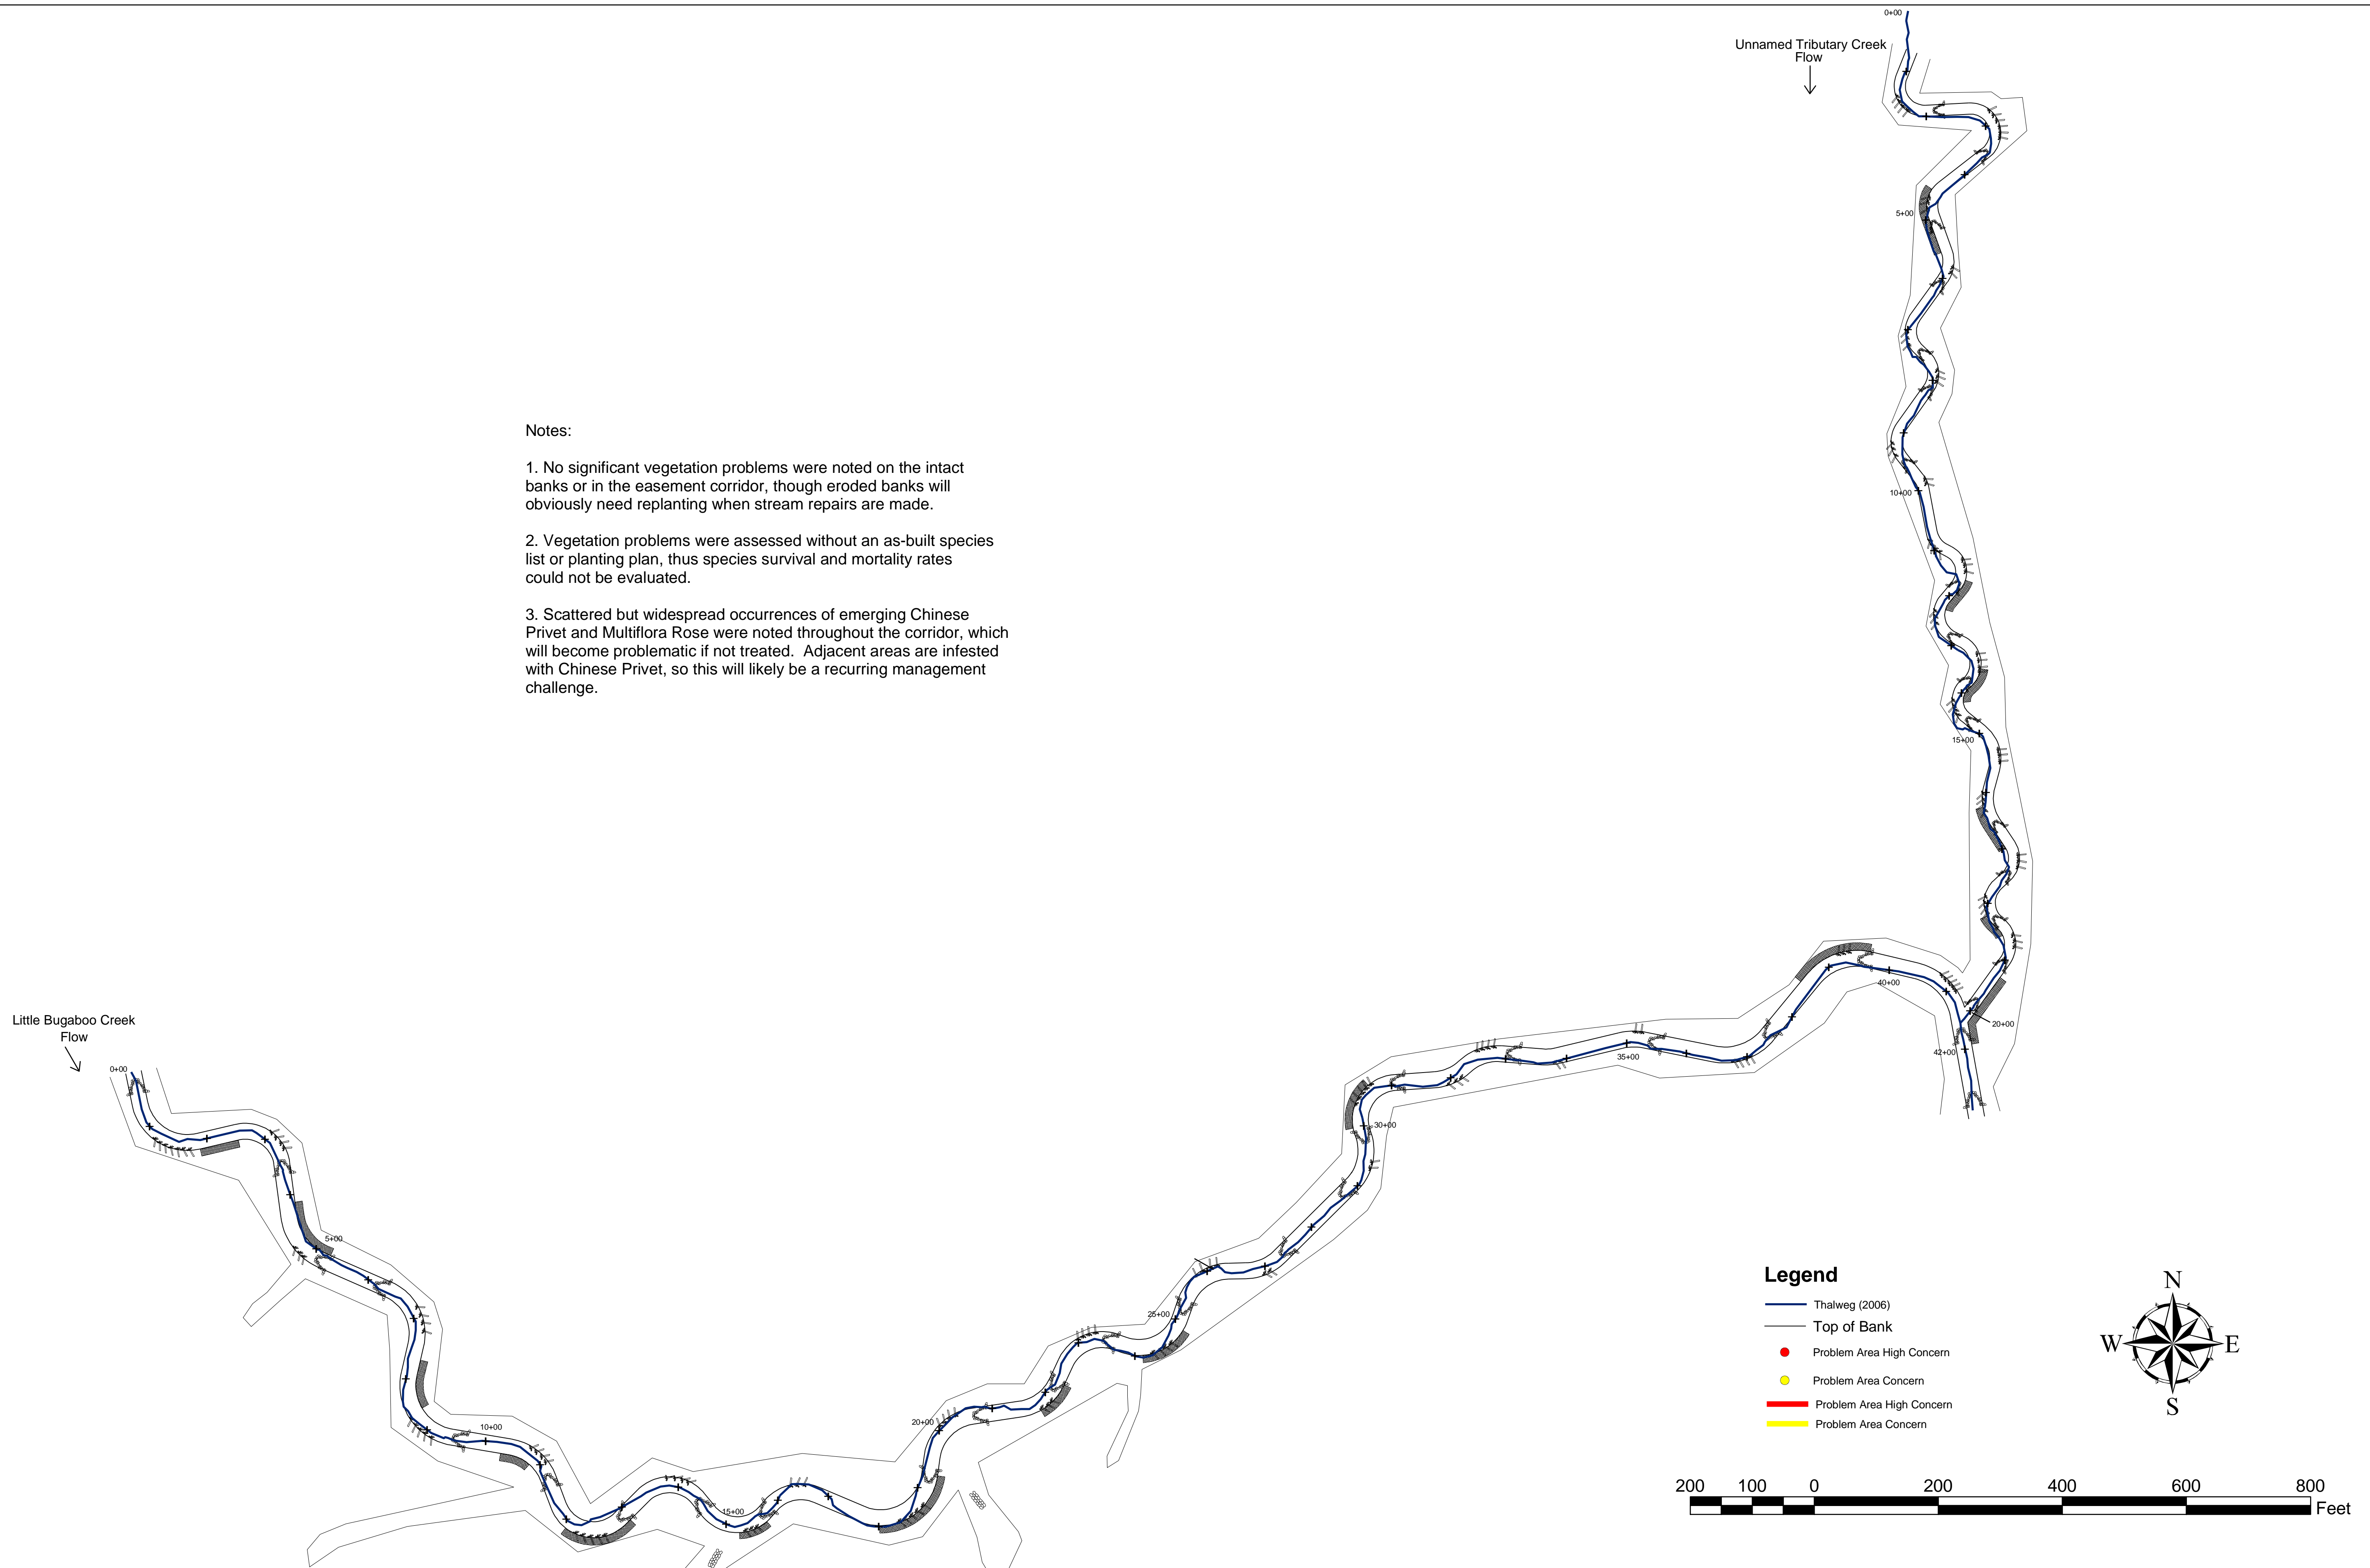
Appendix A. 1

1. No significant vegetation problems were noted on the intact banks or in the easement corridor, though eroded banks will obviously need replanting when stream repairs are made.
2. Vegetation problems were assessed without an as-built species list or planting plan, thus species survival and mortality rates could not be evaluated.
3. Scattered but widespread occurrences of emerging Chinese Privet and Multiflora Rose were noted throughout the corridor, which will become problematic if not treated. Adjacent areas are infested with Chinese Privet, so this will likely be a recurring management challenge.

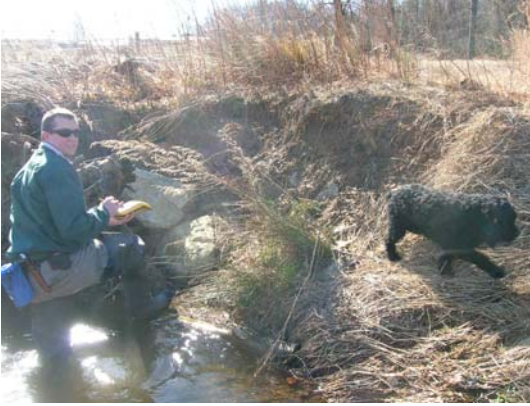
P656

Table IXb. Stream Problem Areas				
EEP Project Number: 56				
Segment Reach: UT to Little Bugaboo Creek				
Feature Issue	Station	Suspected Cause	Photo number	Severity
bank erosion	0+85	scour	p656	yellow
bank erosion	5+35	mass wasting	p659	yellow
bank erosion	5+40	scour	p658	yellow
structure degradation	5+95	high flow	p660	yellow
structure degradation	6+10	stability	p662	yellow
bank erosion	6+50	scour	p663	red
bank erosion	7+15	scour	p665	red
structure degradation	7+25	high flow	p666	red
bank erosion	7+55	mass wasting	p668	yellow
bank erosion	8+00	scour	p669	yellow
bank erosion	8+25	scour	p671	red
structure degradation	9+35	high flow	p672	red
bank erosion	11+00	scour	p674	yellow
bank erosion	11+75	mass wasting	p675	yellow
structure degradation	12+40	high flow	p677	red
bank erosion	12+60	scour	p678	yellow
bank erosion	14+50	mass wasting	p680	yellow
bank erosion	15+10	scour	p682	yellow
bank erosion	16+00	mass wasting	p683	yellow

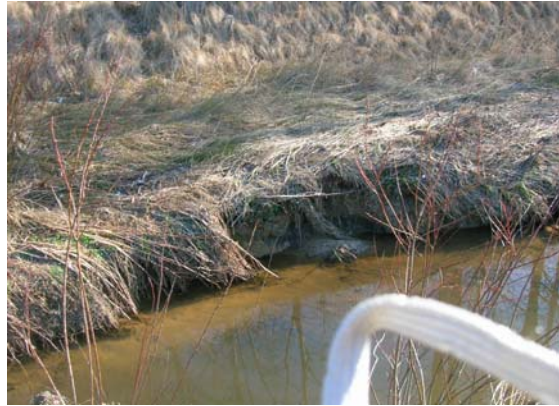
P684

bank erosion	16+40	Scour	p684-6	yellow
structure degradation	16+60	high flow	p688	red
structure degradation	17+50	scour	p689	red
bank erosion	18+15	scour	p690	yellow
bank erosion	18+75	scour	p692	yellow

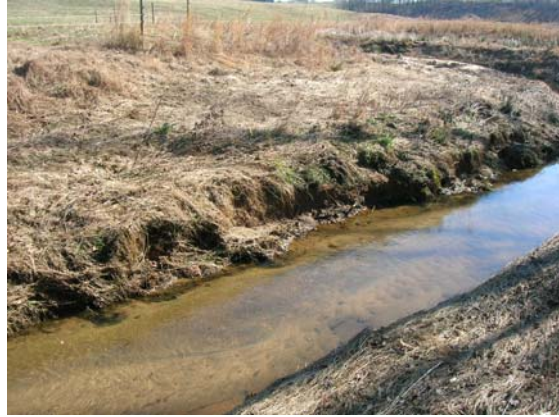
P697

Table IXa. Stream Problem Areas EEP Project Number: 56 Segment Reach: Little Bugaboo Creek				
Feature Issue	Station	Suspected Cause	Photo number	Severity
bank erosion	0+50	scour	p697	yellow
bank erosion	1+75	scour	p699-700	yellow
bank erosion	3+25	mass wasting	p701	red
bank erosion	4+20	scour	p702	red
structure degradation	4+90	mass wasting	p704	red
bank erosion	7+95	scour	p705	yellow
structure degradation	8+40	high flow	p707	yellow
bank erosion	9+00	mass wasting	p708	yellow
structure degradation	9+50	stability	p709	red
bank erosion	11+10	scour	p710	red
channel	11+35	stability	p711	red
bank erosion	14+25	scour	p712	red
structure degradation	16+00	scour	p713	red
bank erosion	16+25	stability	p714	red
structure degradation	17+05	mass wasting	p715	red
bank erosion	21+60	overland flow	p716	yellow
bank erosion	21+90	scour	p717	yellow
bank erosion	23+25	mass wasting	p719	yellow
bank erosion	24+90	scour	p721	red
structure degradation	25+25	stability	p722	yellow
