**Little Bugaboo Creek Stream Restoration
2006 Monitoring Report
Monitoring Year Two**

Ecosystem Enhancement Program Project Number 00056

Submitted: January 19, 2007

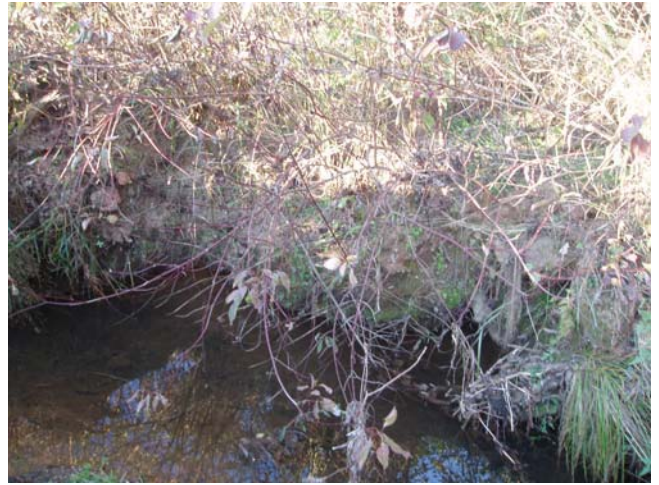
UTVPA1 facing left bank

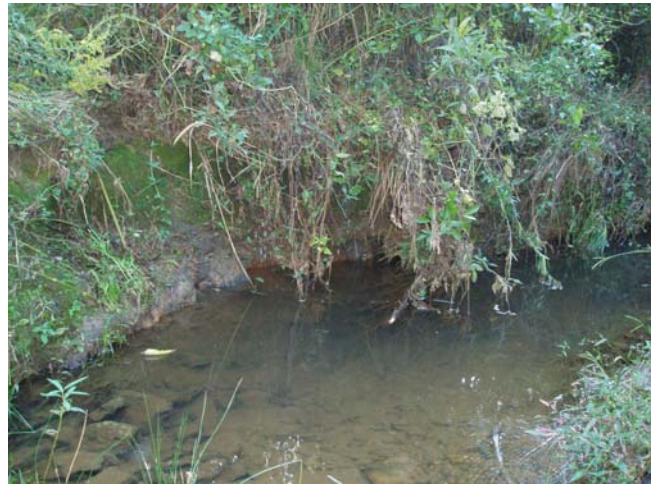
UTVPA3 facing right bank

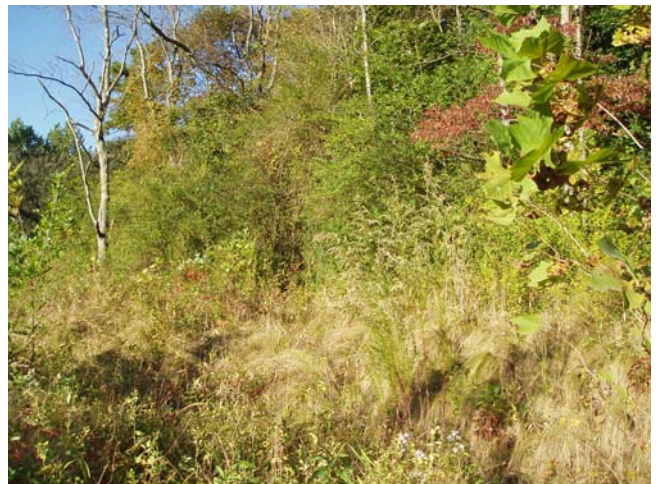
UTVPA5 facing right bank

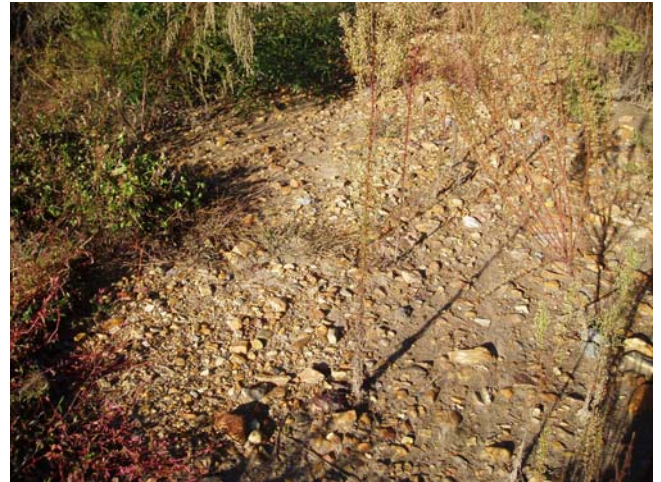
VPA5 facing left bank

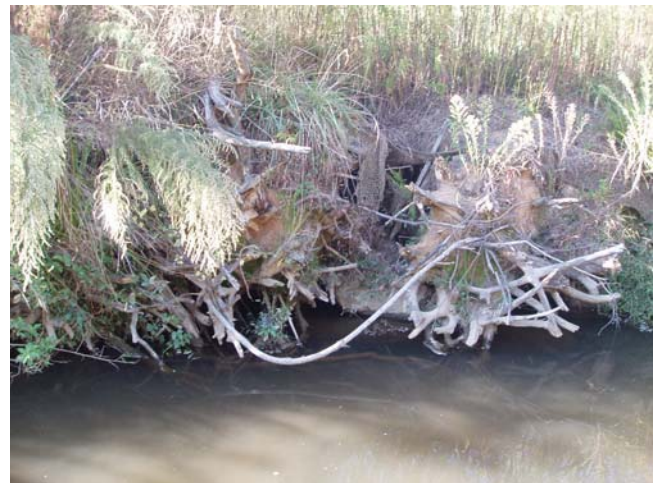
VPA7 facing left bank

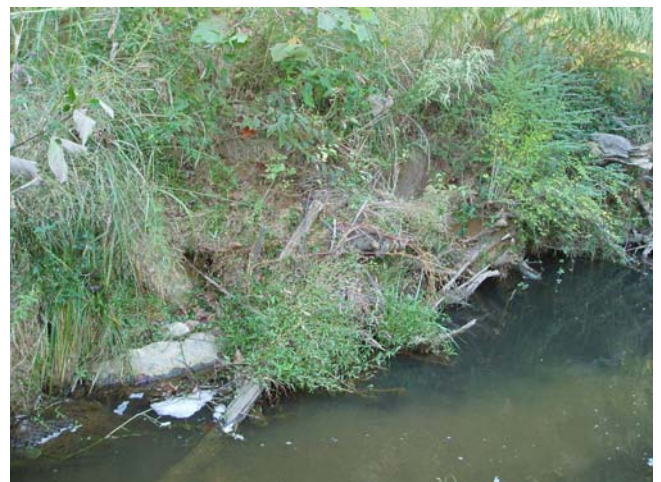
VPA9 facing left bank

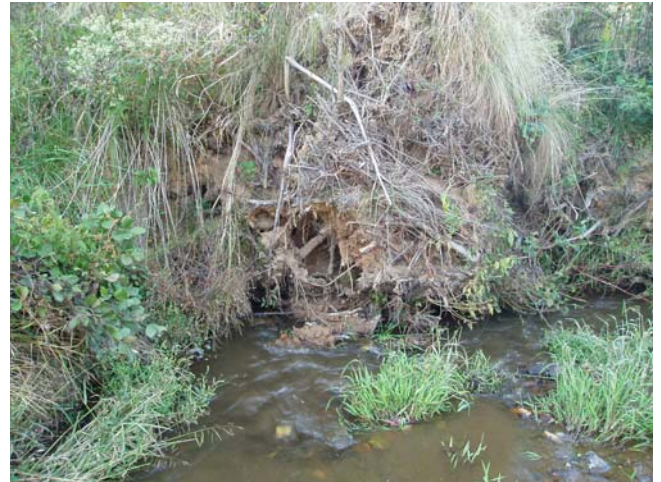
VPA11 facing right bank

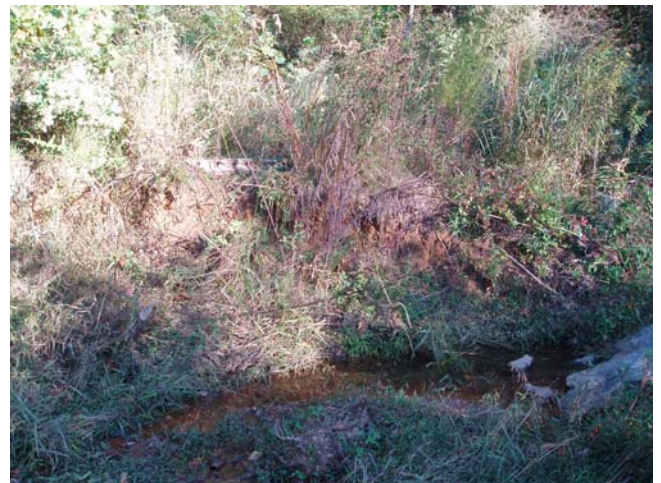
VPA13 on right bank

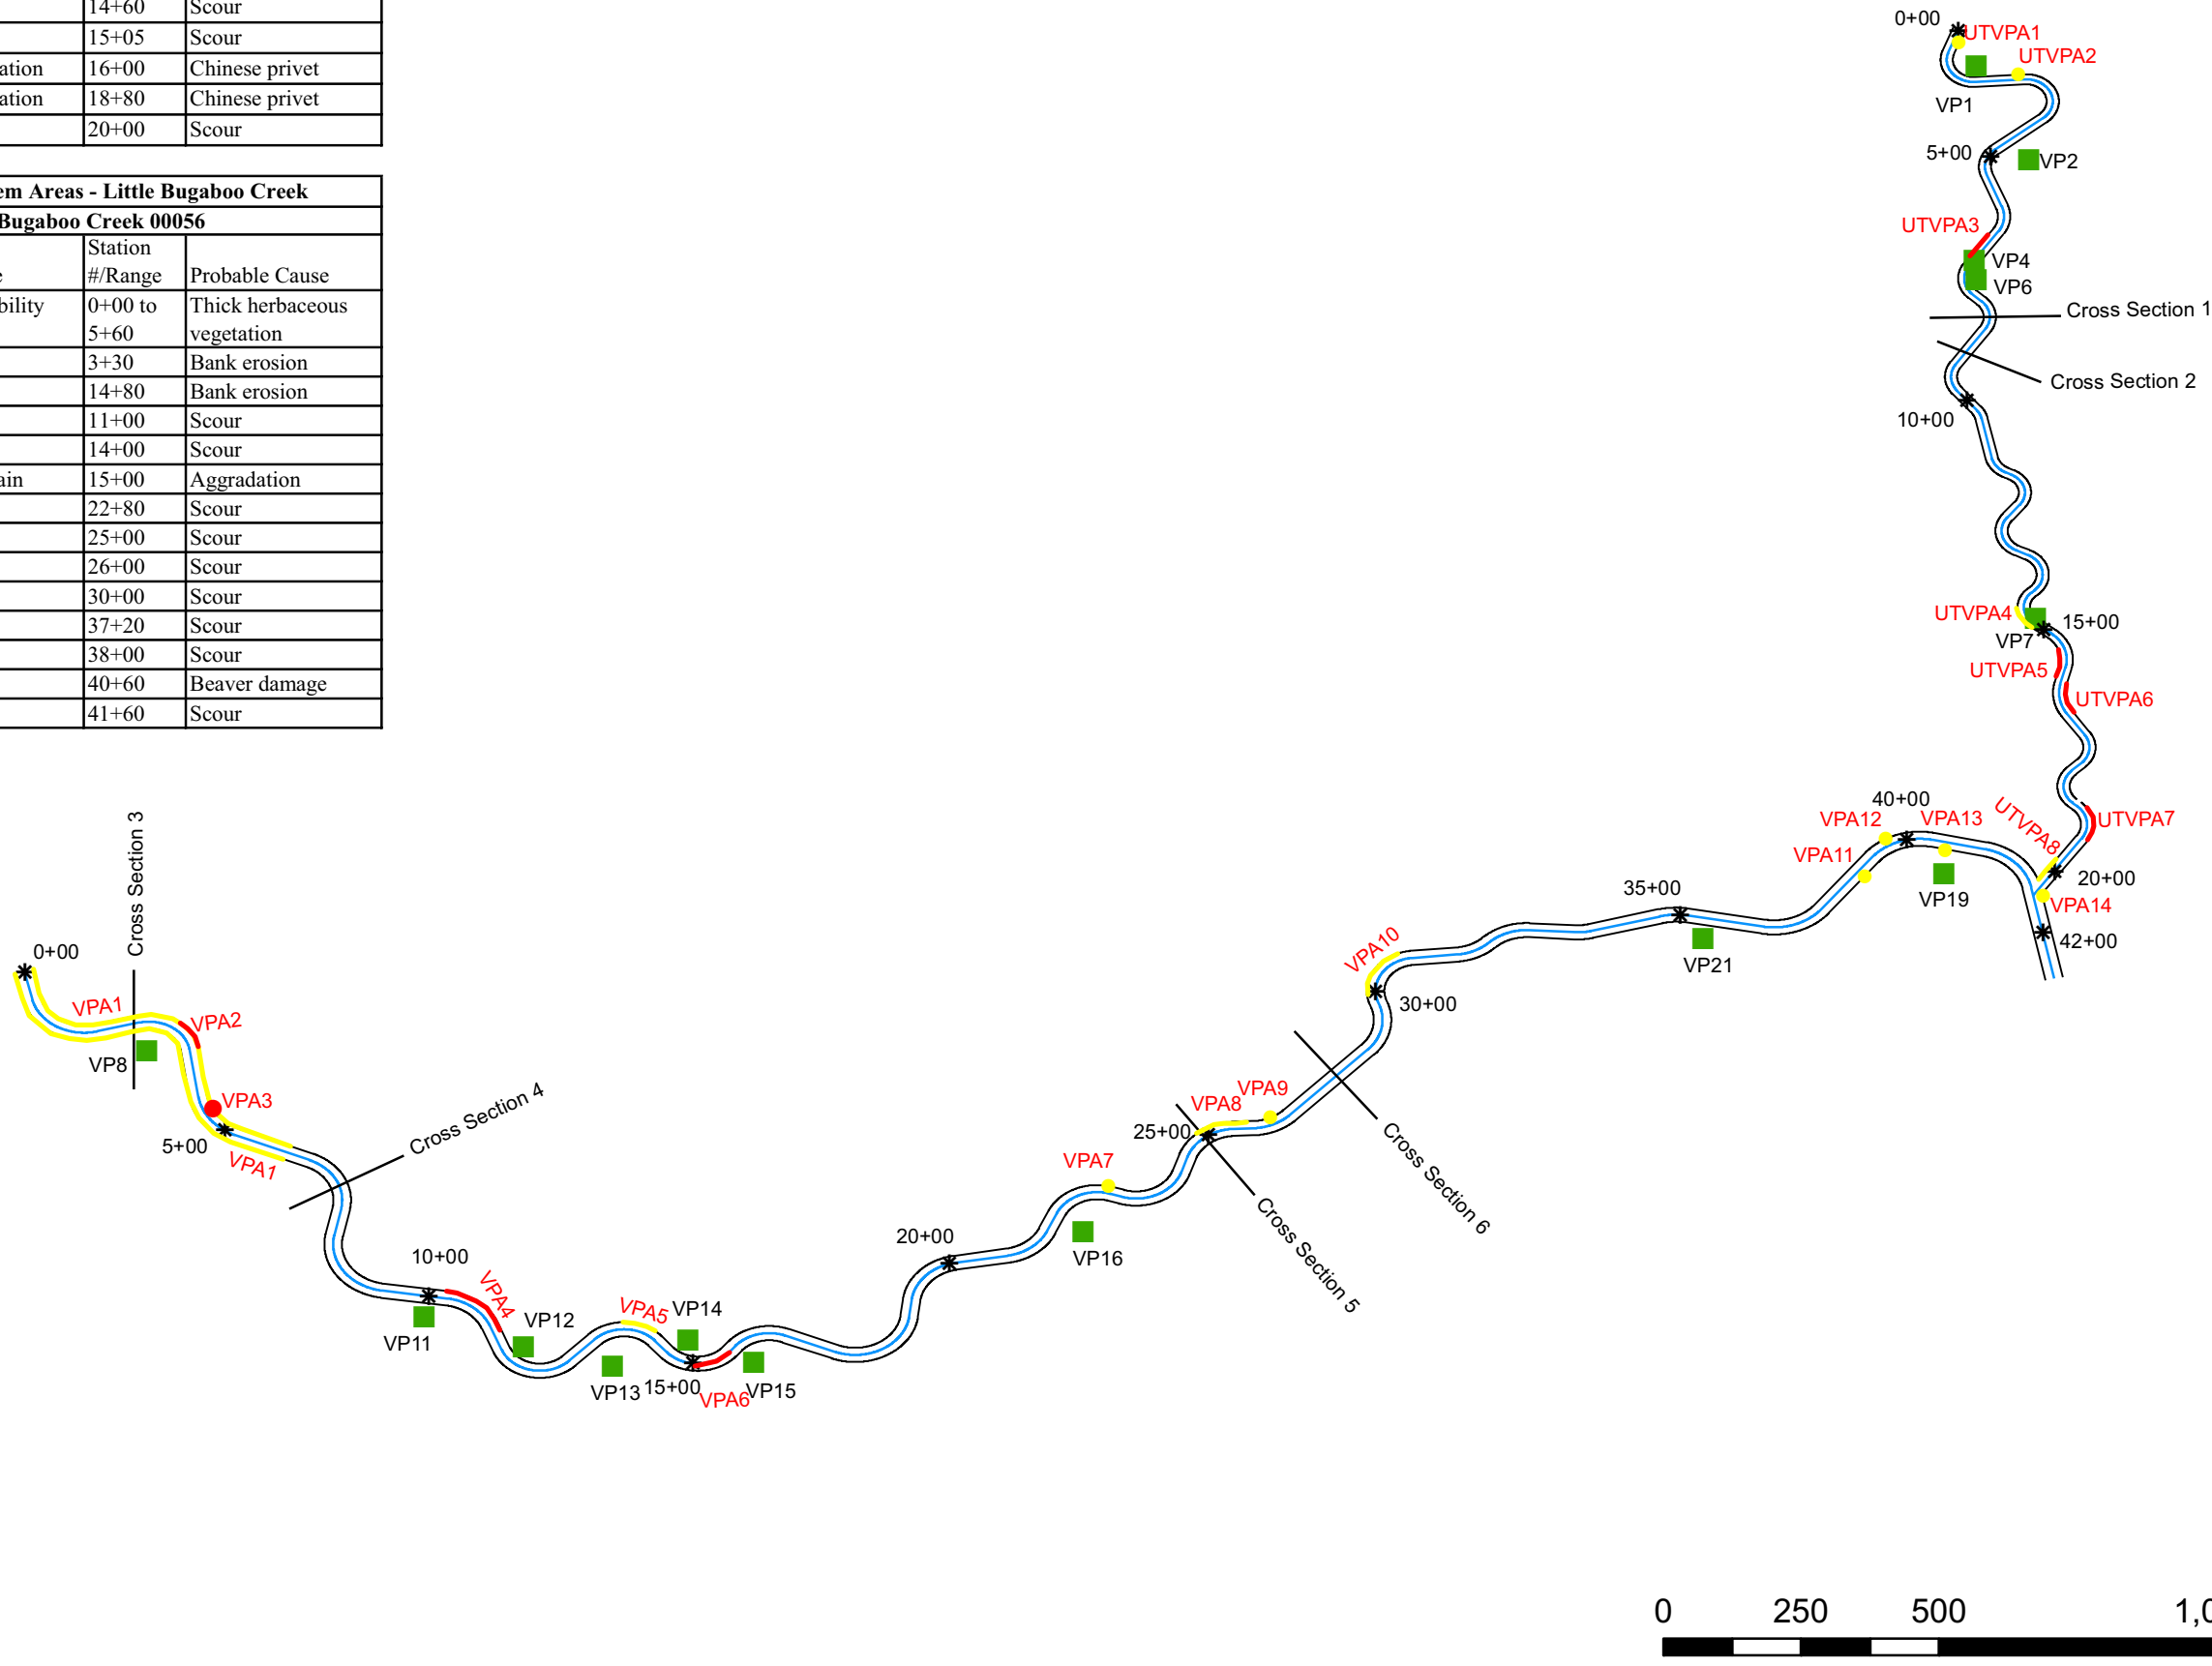
Figure 3
 Vegetative
 Problem Areas
 Plan View

Twenty-two Vegetative Problem Areas were found at the Little Bugaboo site during the 2006 Year 2 monitoring. Major issues included bare banks as a result of erosion and scour and poor survivability. Herbaceous grasses and herbs dominated much of the buffer area during the 2006 Year Two monitoring event. Thick mats of herbaceous vegetation were observed. Common species include wiregrass (*Aristida* spp.), dogfennel (*Eupatorium capillifolium*), goldenrod (*Solidago* spp.), and bluestem (*Andropogon* spp.). It is likely that the presence and density of the above-mentioned native herbs is to blame for size and survivability issues. The small planted stems are not successfully competing for space, light, and nutrients. The Vegetative Problem Areas Tables are located in Appendix A-I. Vegetative Problem Area Photos are located in Appendix A-II.

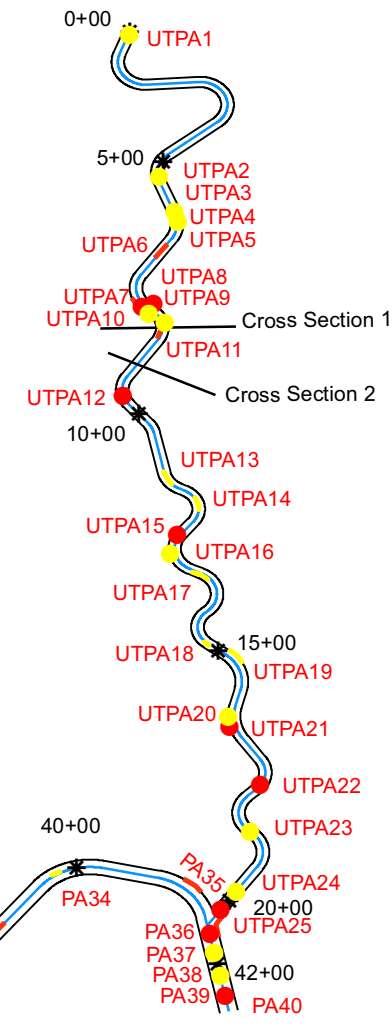
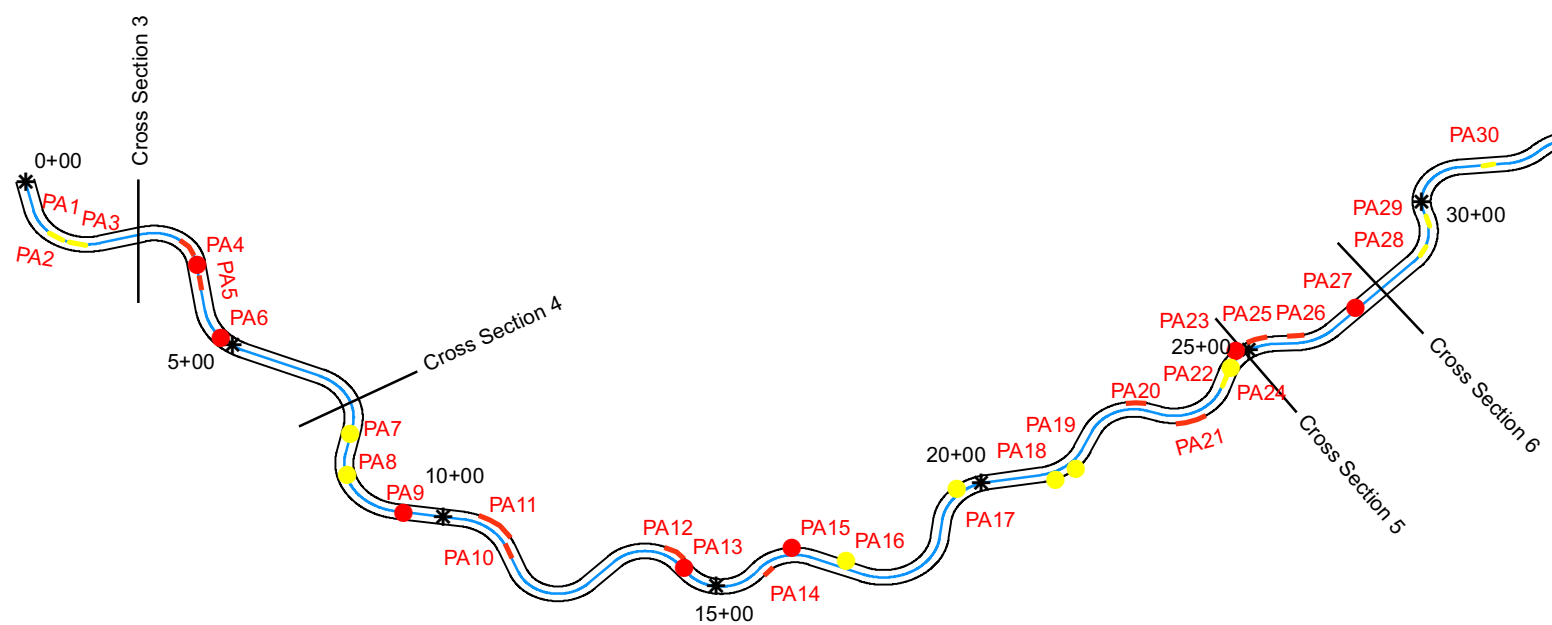
Figure 5
 Stream
 Problem Areas
 Plan View

Field observations show that in many areas, not captured by the cross sections, the channel size is increasing laterally. Bank erosion in the form of mass wasting and scour was prevalent in Little Bugaboo Creek and the Unnamed Tributary. Underlying causes of erosional problems are difficult to determine at this stage since URS was not involved with the design, construction, or follow-up maintenance phases of this project. Immediate causes are attributed to easily erodible, sandy substrate that dominates the streambank soils. Insufficient vegetative protection has likely contributed to erosion problems as well. Ultimate causes for the erosion problems may be attributed to problems with the project design and/or the implementation of the design during construction activities.

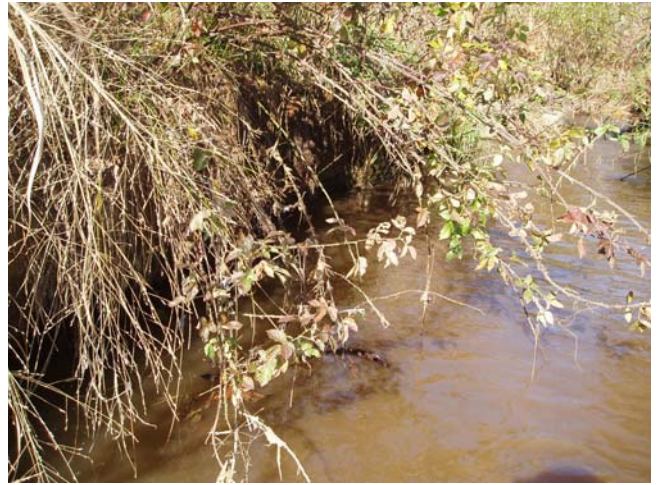
UTPA1 facing right bank

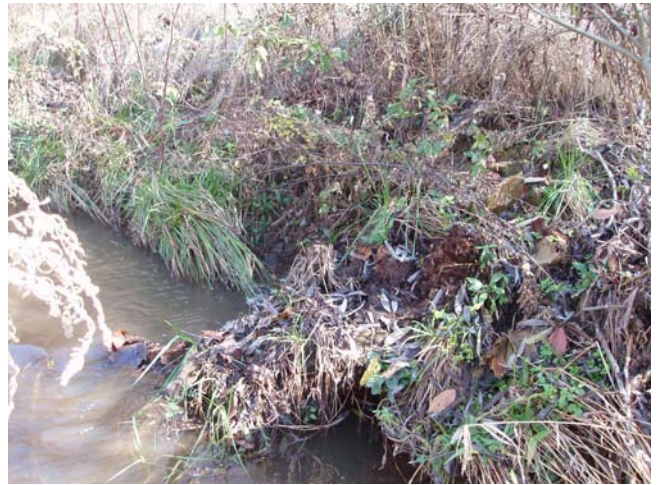
UTPA3 facing downstream

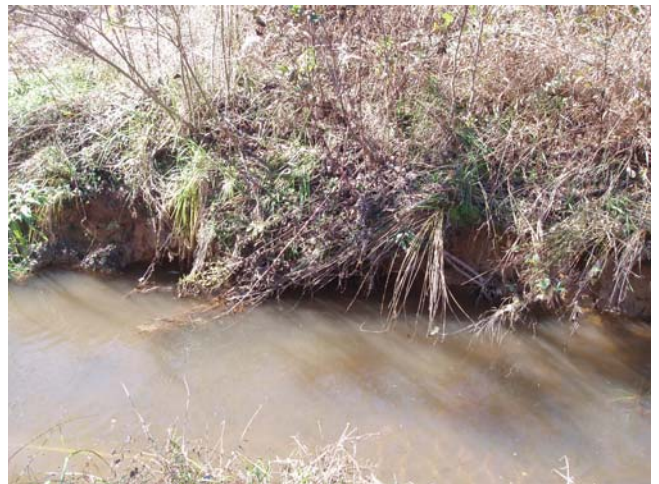
UTPA5 facing downstream

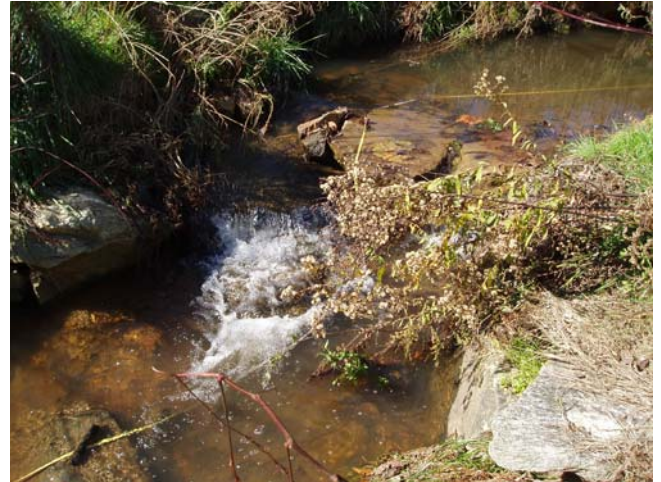
UTPA7 facing right bank

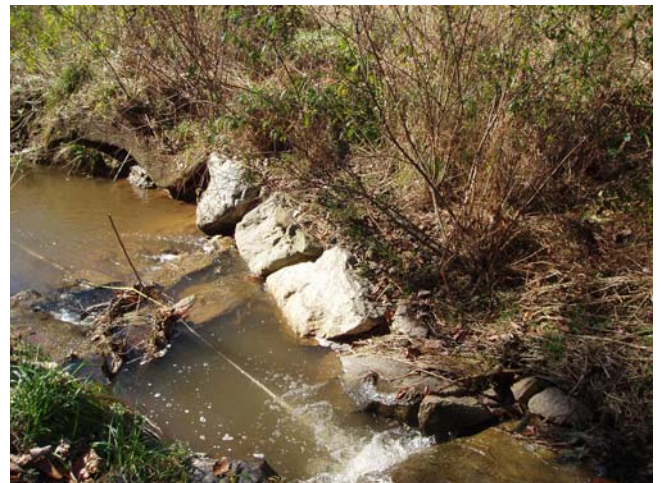
UTPA9 facing upstream

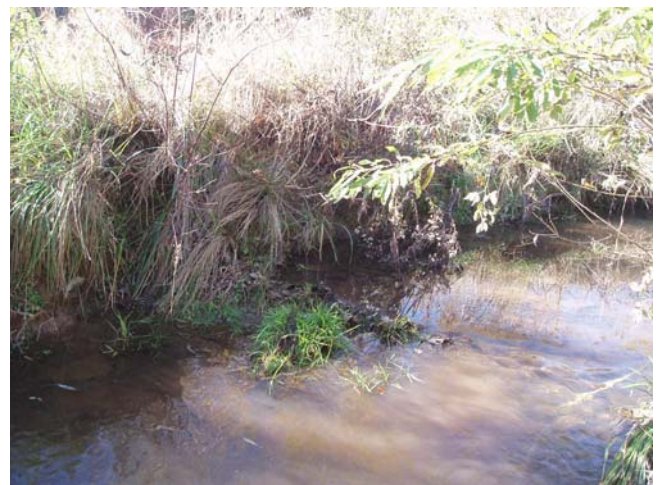
UTPA11 facing right bank

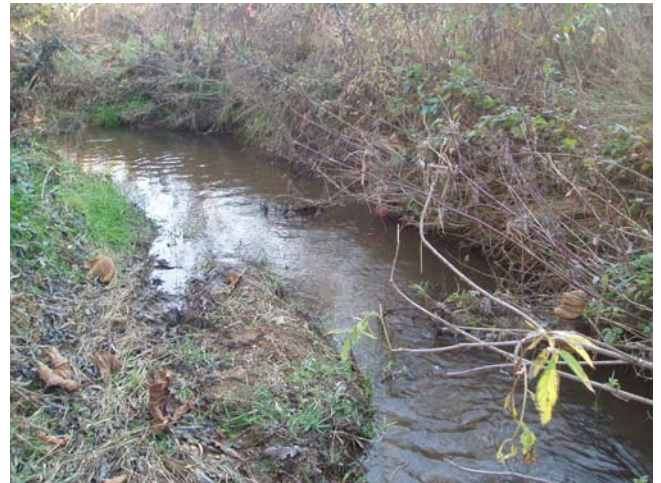
UTPA15 facing right bank

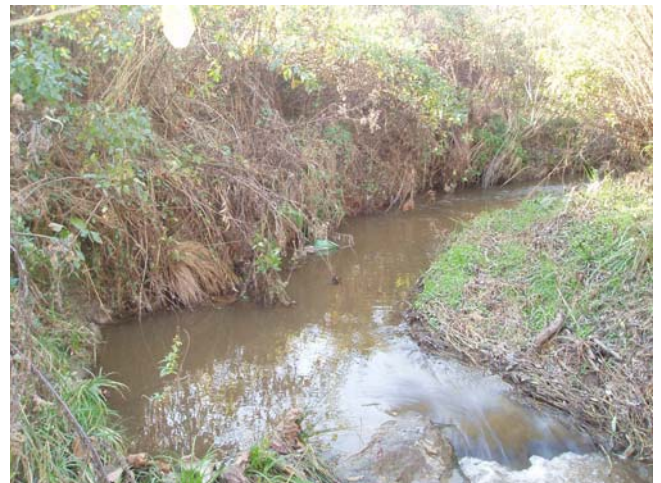
UTPA17 facing downstream

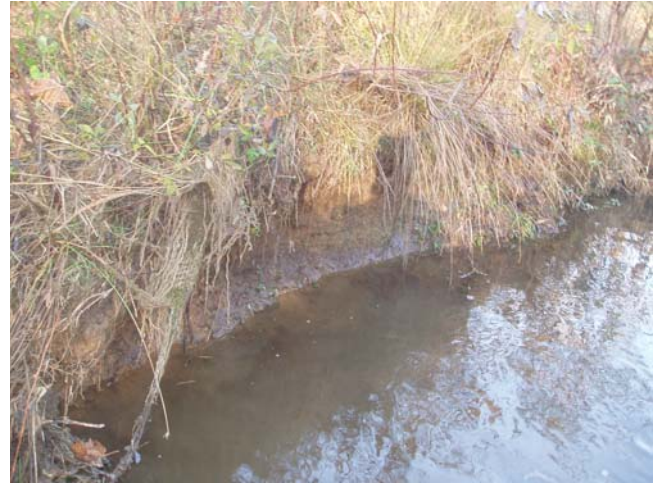
UTPA19 facing left bank

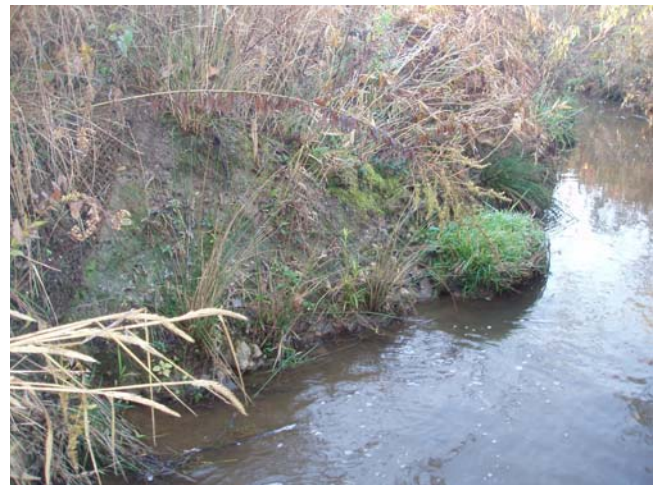
UTPA21 facing downstream, right bank

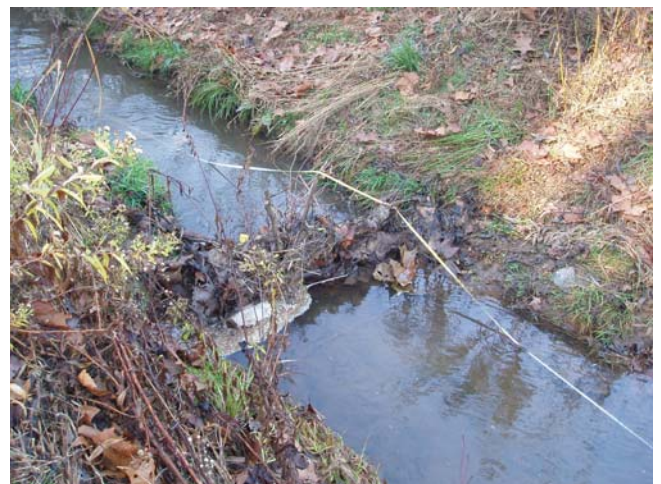
UTPA23 facing upstream

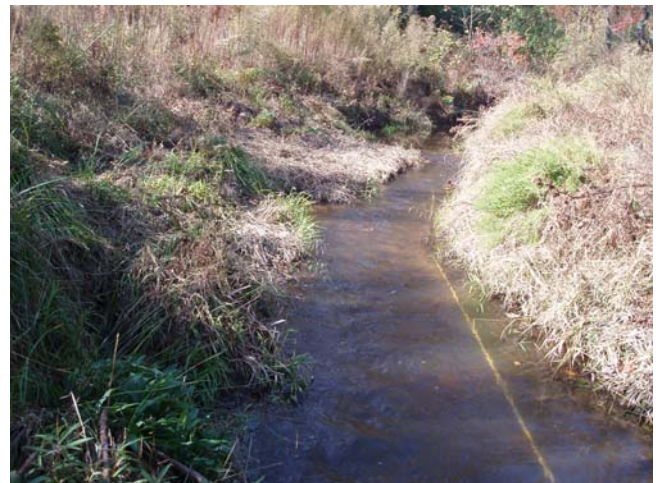
PA1 facing right bank

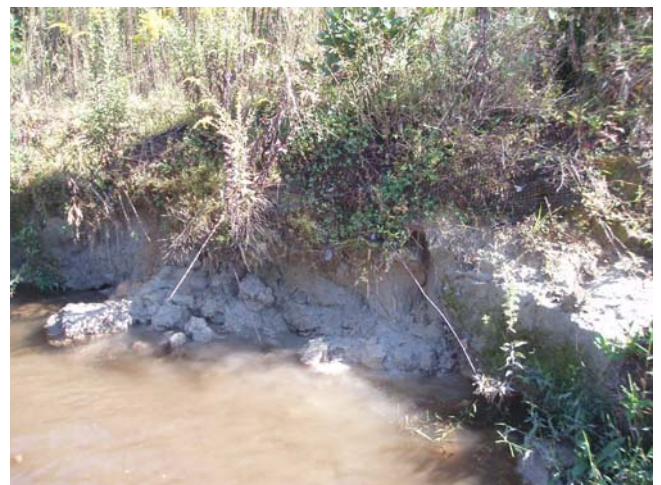
PA3 facing downstream, left bank

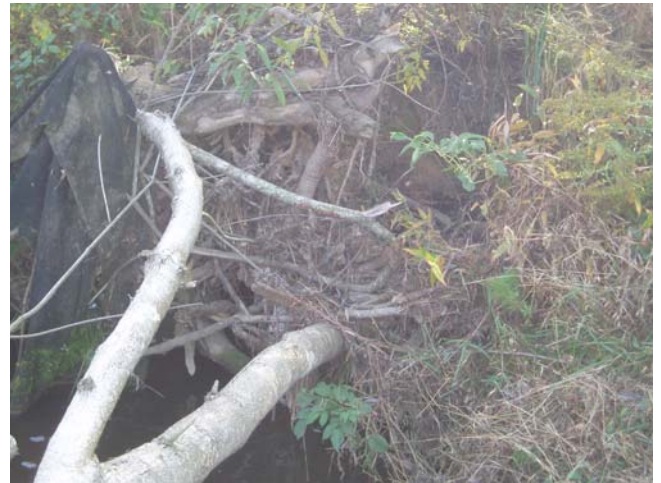
PA7 facing right bank

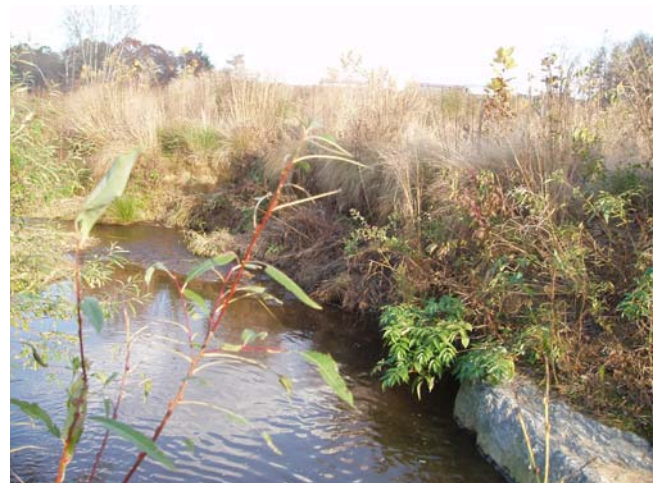
PA13 facing downstream

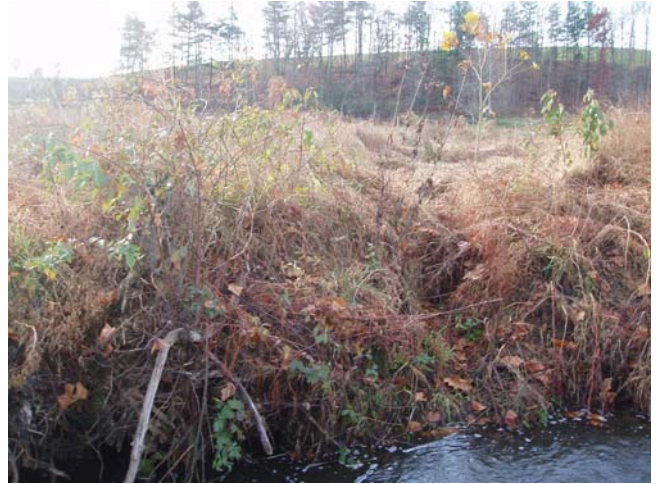
PA17 facing left bank

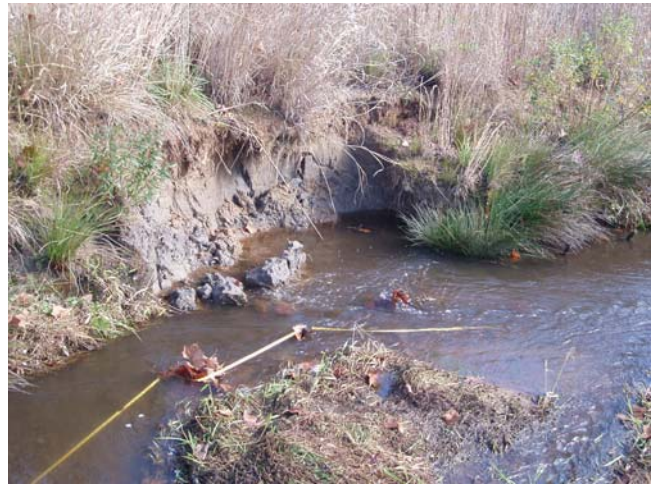
PA19 facing right bank

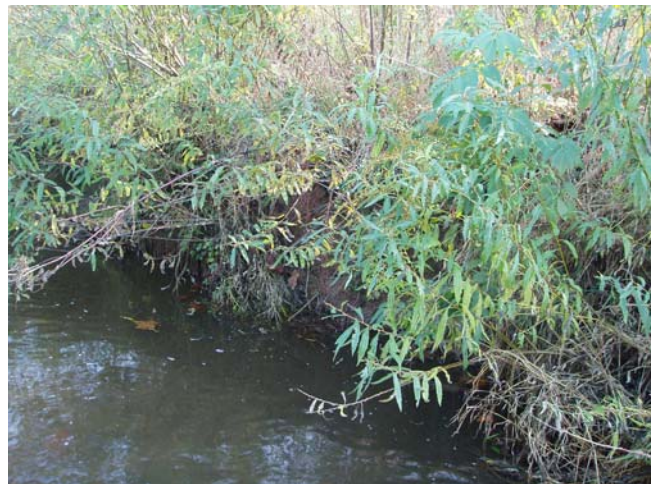
PA21 facing right bank

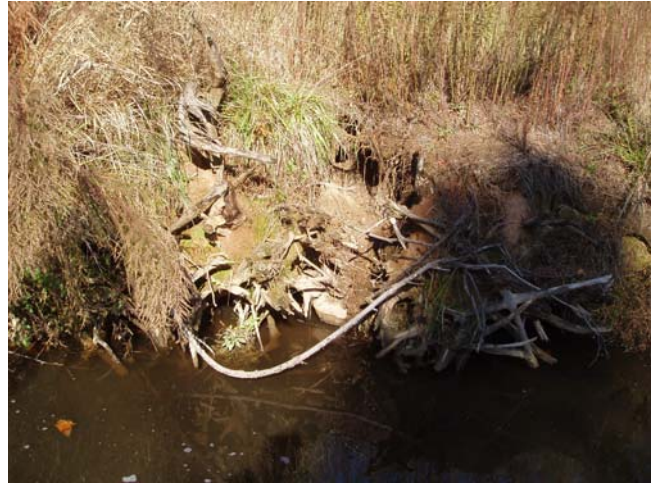
PA23 facing downstream from left bank

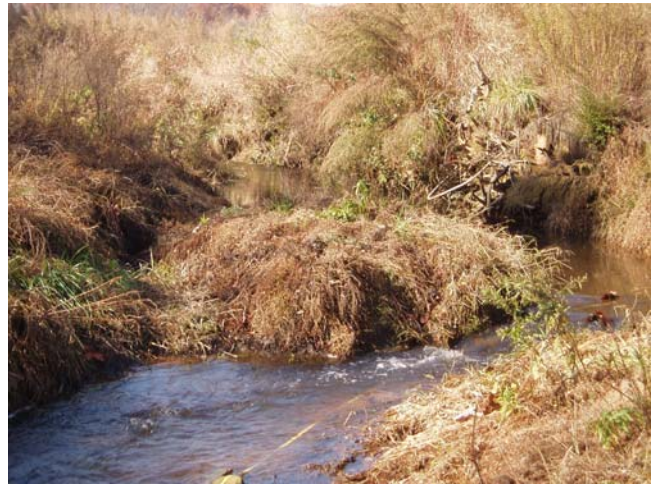
PA25 facing left bank

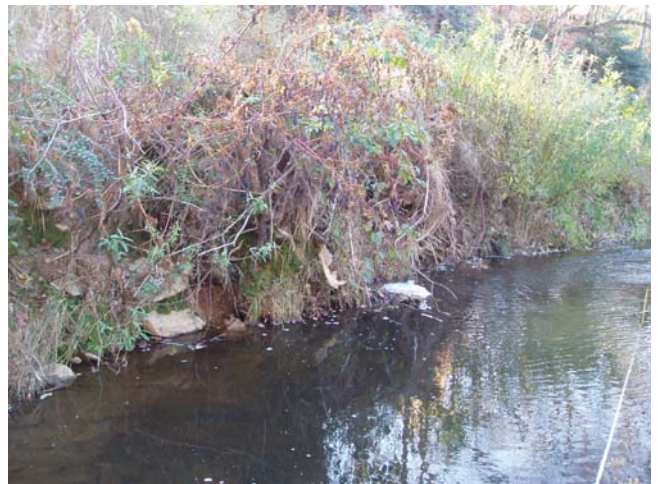
PA27 facing left bank

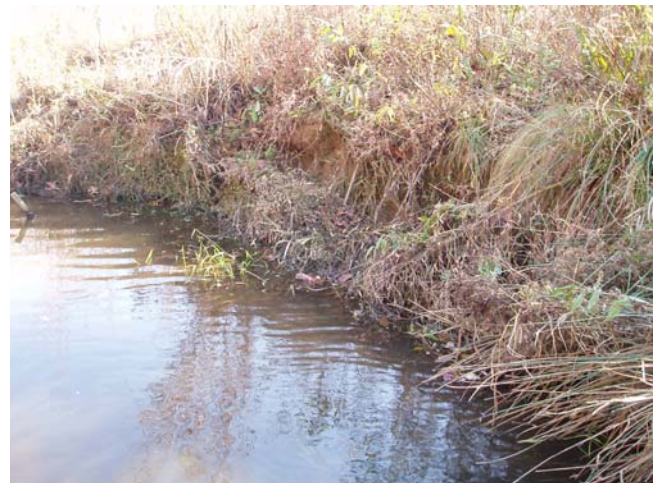
PA31 facing left bank

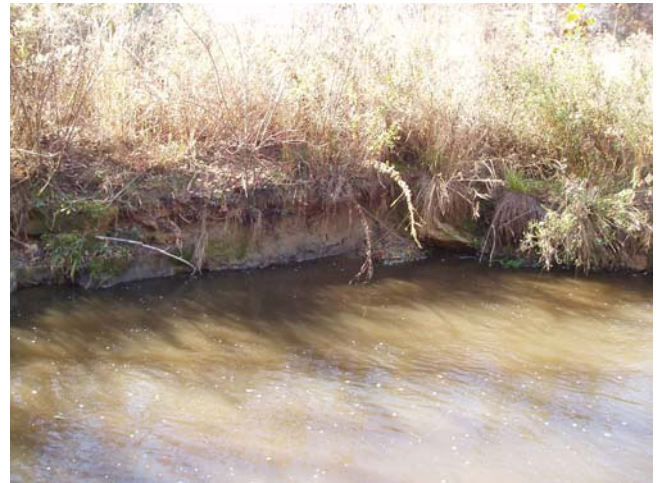
PA37 facing upstream at junction with UT
