**Little Bugaboo Creek Stream Restoration  
2007 Final Monitoring Report  
Monitoring Year Three**

**Ecosystem Enhancement Program Project Number 00056**

Submitted: February 26, 2008

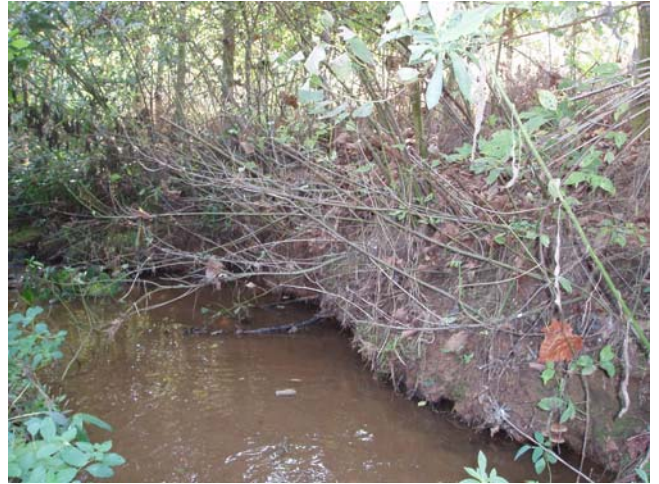
UTVPA1 facing right bank

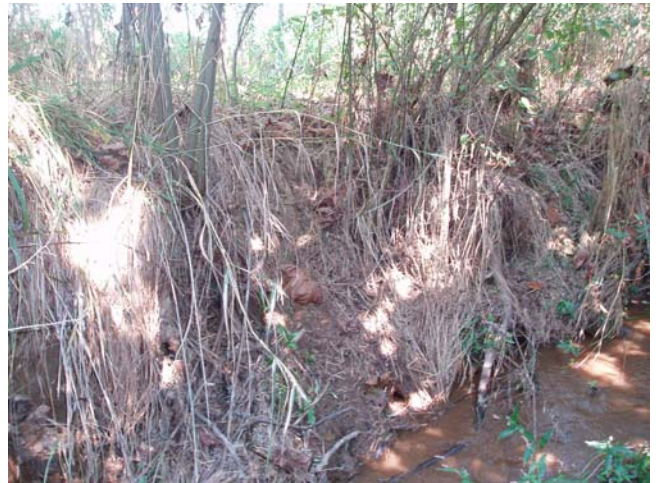
UTVPA3 facing right bank

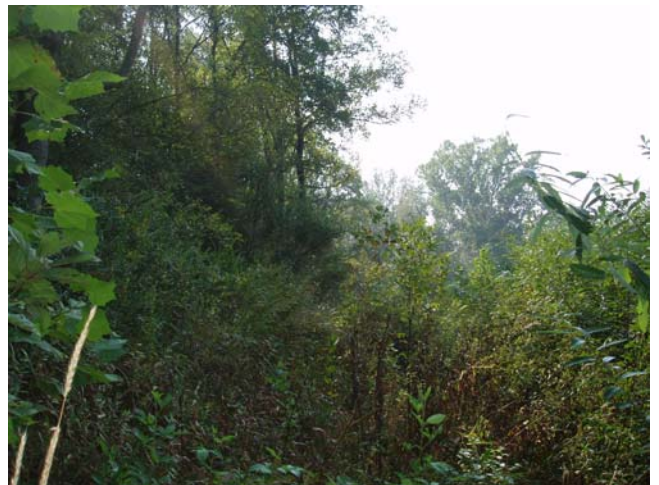
UTVPA5 facing right bank, upstream

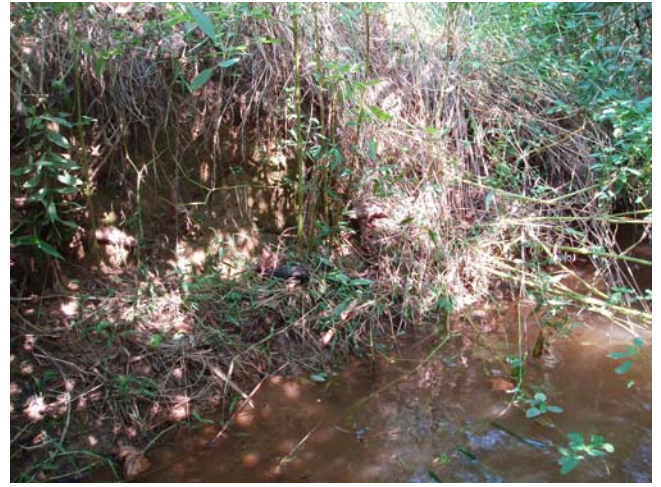
UTVPA7 facing left bank, downstream

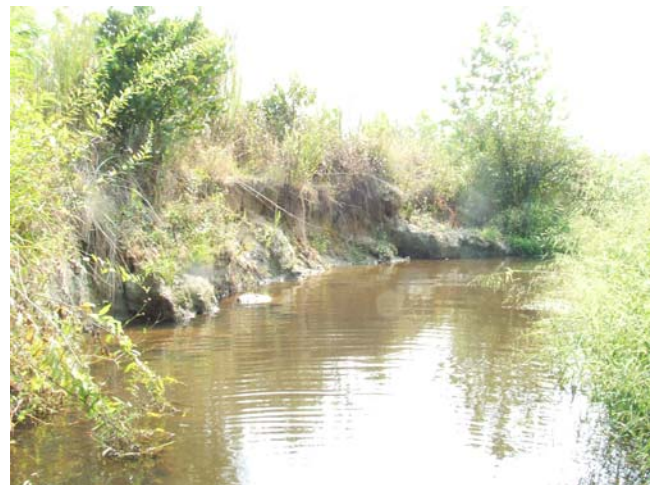
VPA1 on left bank, facing downstream (11/2/06)

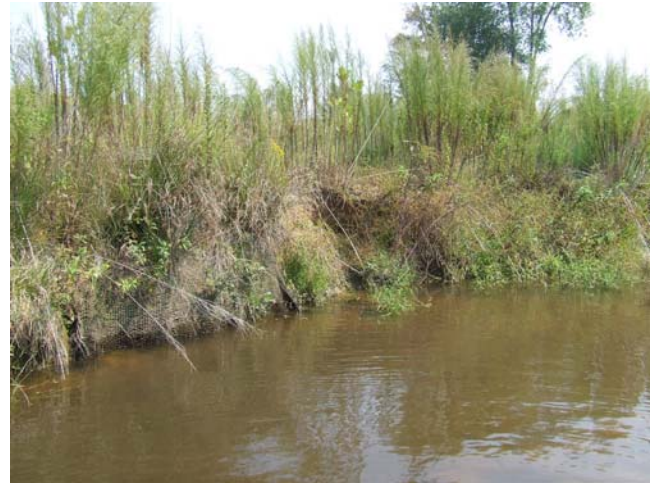
VPA3 facing left bank

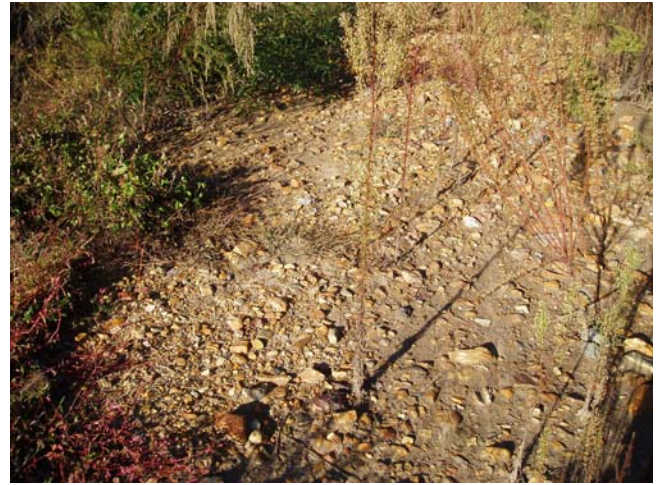
VPA5 facing right bank

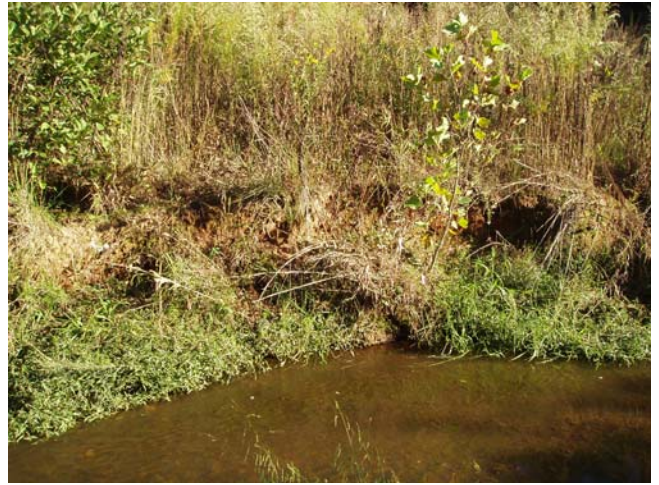
VPA10 facing left bank

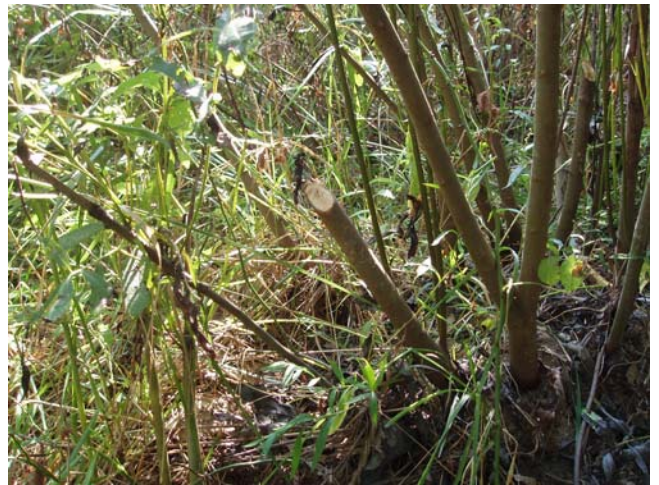
VPA12 facing left bank

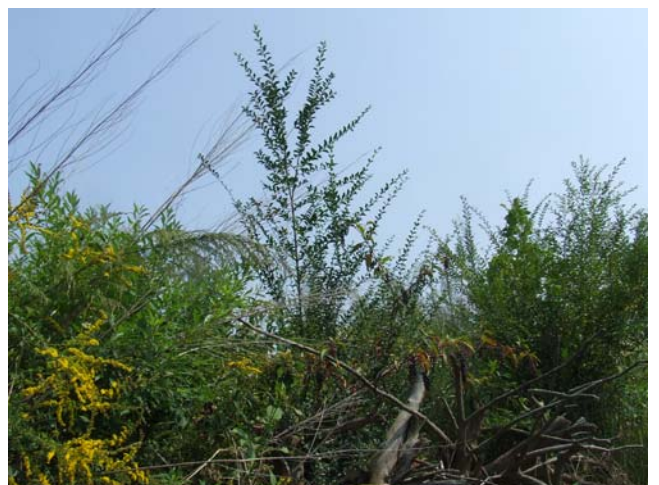
VPA14 facing left bank

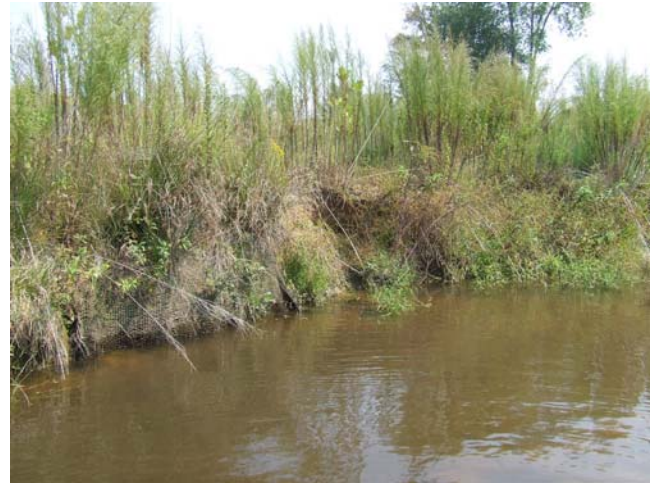
NVPA2 on left bank

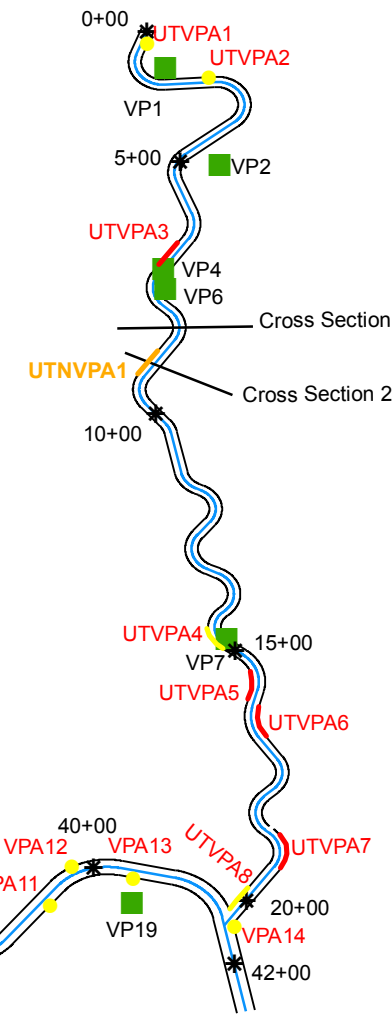
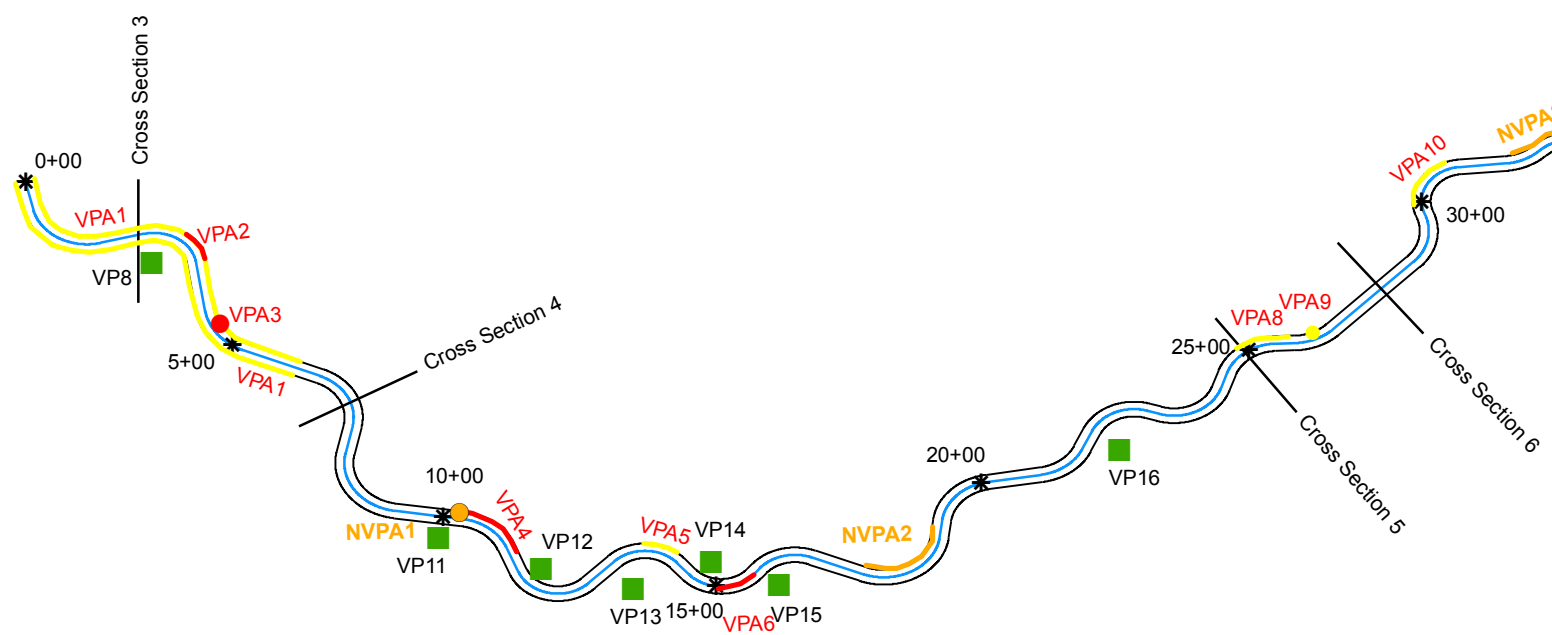
**Vegetative  
Problem Areas  
Plan View**

Vegetative Problem Areas - Unnamed Tributary Little Bugaboo Creek 00056			
Feature #	Feature/Issue	Station #/Range	Probable Cause
UTVPA1	Bare bank	0+15	Scour
UTVPA2	Bare bank	1+90	Scour
UTVPA3	Bare bank	8+00	Scour
UTVPA4	Bare bank	14+60	Scour
UTVPA5	Bare bank	15+05	Scour
UTVPA6	Exotic population	16+00	Chinese privet
UTVPA7	Exotic population	18+80	Chinese privet
UTVPA8	Bare bank	20+00	Scour
UTNVPA1	Bare bank	8+90	Scour

Vegetative Problem Areas - Little Bugaboo Creek Little Bugaboo Creek 00056			
Feature #	Feature/Issue	Station #/Range	Probable Cause
VPA1	Poor survivability	0+00 to 5+60	Thick herbaceous vegetation
VPA2	Bare bank	3+30	Bank erosion
VPA3	Bare bank	14+80	Bank erosion
VPA4	Bare bank	11+00	Scour
VPA5	Bare bank	14+00	Scour
VPA6	Bare floodplain	15+00	Aggradation
VPA8	Bare bank	25+00	Scour
VPA9	Bare bank	26+00	Scour
VPA10	Bare bank	30+00	Scour
VPA11	Bare bank	37+20	Scour
VPA12	Bare bank	38+00	Scour
VPA13	Bare bank	40+60	Beaver damage
VPA14	Bare bank	41+60	Scour
NVPA1	Exotic population	5+60	Chinese privet
NVPA2	Bare bank	16+40	Scour
NVPA3	Bare bank	31+10	Scour

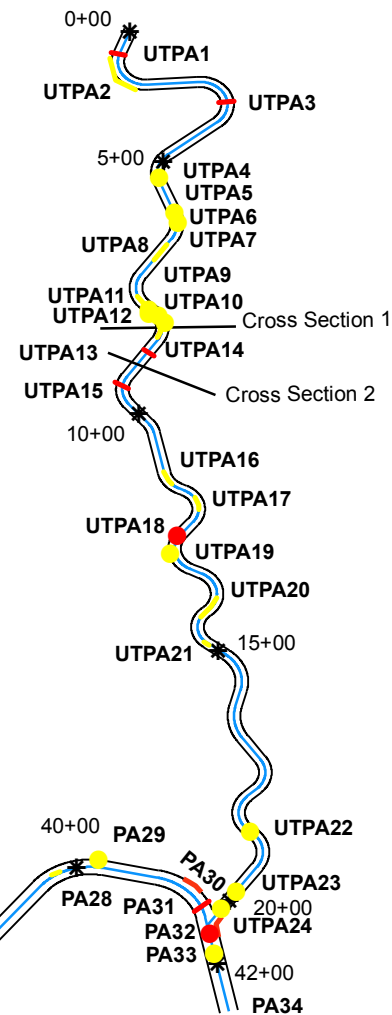
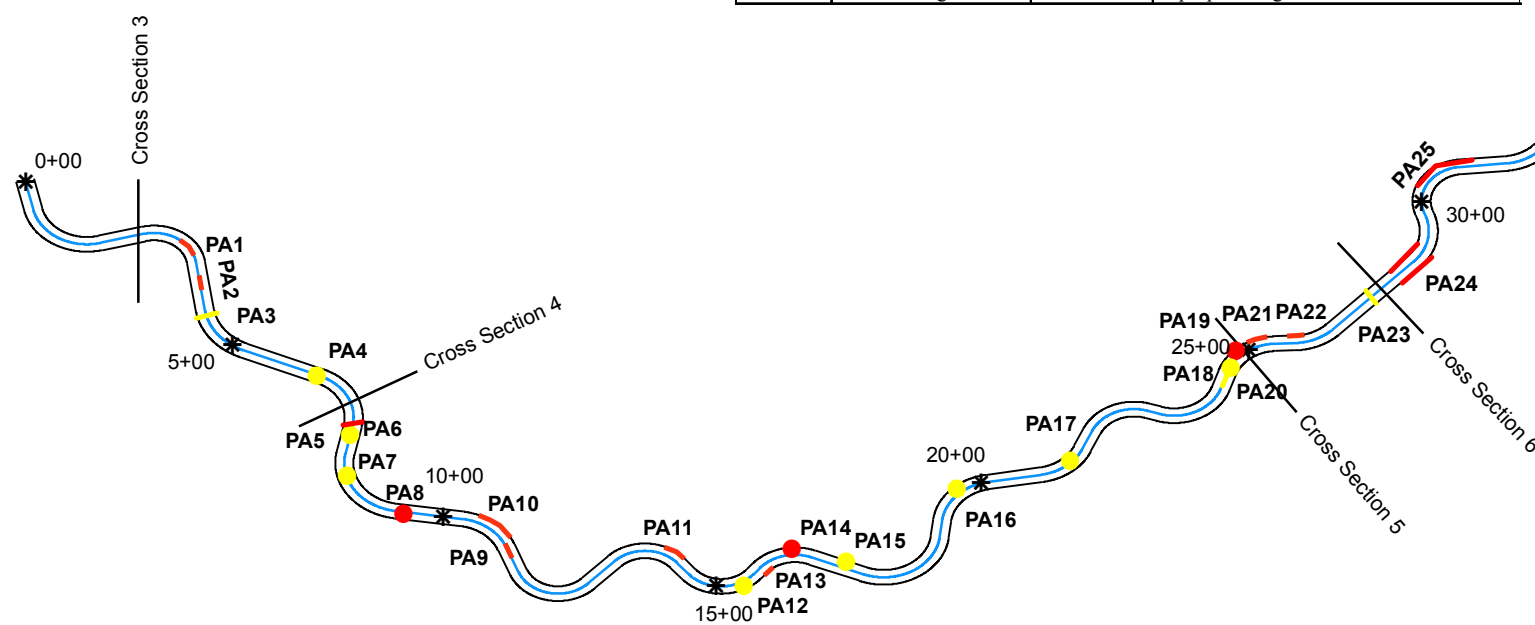
Stream  
 Current Condition  
 Plan View

Stream Problem Areas – Unnamed Tributary			
Little Bugaboo Creek			
Feature #	Feature/Issue	Station	Probable Cause
UTPA1	Beaver dam	0+60	Beaver
UTPA2	Structure failure	1+00	Improper design and/or construction
UTPA3	Beaver dam	2+80	Beaver
UTPA4	Bank erosion/scour	5+35	Improper design and/or construction
UTPA5	Structure degradation	5+95	Improper design and/or construction
UTPA6	Structure degradation	6+10	Improper design and/or construction
UTPA7	Bank erosion/scour	6+50	Improper design and/or construction
UTPA8	Bank erosion/scour	7+15	Improper design and/or construction
UTPA9	Structure degradation	7+25	Improper design and/or construction
UTPA10	Structure failure	7+40	Improper design and/or construction
UTPA11	Bank erosion/scour	7+55	Improper design and/or construction
UTPA12	Bank erosion/scour	8+00	Improper design and/or construction
UTPA13	Beaver dam	7+60	Beaver
UTPA14	Bank erosion/scour	8+25	Improper design and/or construction

UTPA15	Beaver dam	9+00	Beaver
UTPA16	Bank erosion/scour	11+75	Improper design and/or construction
UTPA17	Bank erosion/scour	12+40	Improper design and/or construction
UTPA18	Bank erosion/scour	12+60	Improper design and/or construction
UTPA19	Channel widening	13+40	Scour
UTPA20	Structure degradation	14+50	Improper design and/or construction
UTPA21	Bank erosion/scour	15+10	Improper design and/or construction
UTPA22	Bank erosion/scour	18+15	Improper design and/or construction
UTPA23	Debris jam	18+50	Debris jam
UTPA24	Bank erosion/scour	19+20	Improper design and/or construction

Stream Problem Areas – Little Bugaboo Creek			
Little Bugaboo Creek			
Feature #	Feature/Issue	Station #/Range	Probable Cause
PA1	Bank erosion	3+10	Root wad failure
PA2	Bank erosion/scour	3+70	Improper design and/or construction
PA3	Beaver dam	4+20	Beaver
PA4	Structure degradation	6+80	Scour behind rootwad
PA5	Beaver dam	7+40	Beaver
PA6	Bank erosion/scour	7+50	Improper design and/or construction
PA7	Structure degradation	8+45	Improper design and/or construction
PA8	Structure failure	9+20	Erosion behind arm
PA9	Beaver dam	11+00	Beaver
PA10	Channel failure	10+60 to	Improper design and/or construction
PA11	Bank erosion/scour	14+00	Improper design and/or construction
PA12	Structure degradation	15+10	Scour behind rootwad
PA13	Bar formation	16+15	Aggradation
PA14	Bank erosion/scour	16+50	Improper design and/or construction
PA15	Structure degradation	17+80	Mass wasting
PA16	Structure failure	19+90	Bank erosion
PA17	Bank erosion/scour	21+10	Improper design and/or construction

PA18	Bank erosion/scour	24+00	Improper design and/or construction
PA19	Structure degradation	24+50	Bank erosion
PA20	Structure degradation	24+90	Piping behind wads
PA21	Bank erosion/scour	25+00	Improper design and/or construction
PA22	Bank erosion/scour	25+10	Improper design and/or construction
PA23	Beaver dam	27+00	Beaver
PA24	Bank erosion/scour	27+20	Improper design and/or construction
PA25	Bank failure	30+00	Improper design and/or construction
PA26	Bank erosion/scour	32+30	Wildlife crossing
PA27	Bank erosion/scour	34+90	Scour behind rootwad
PA28	Bank erosion/scour	39+90	Structure placement
PA29	Bank erosion/scour	40+05	Improper design and/or construction
PA30	Bank erosion/scour	41+00	Improper design and/or construction
PA31	Beaver dam	41+20	Beaver
PA32	Bank erosion/scour	41+30	Improper design and/or construction
PA33	Structure degradation	41+60	Improper design and/or construction
PA34	Structure degradation	42+76	Improper design and/or construction

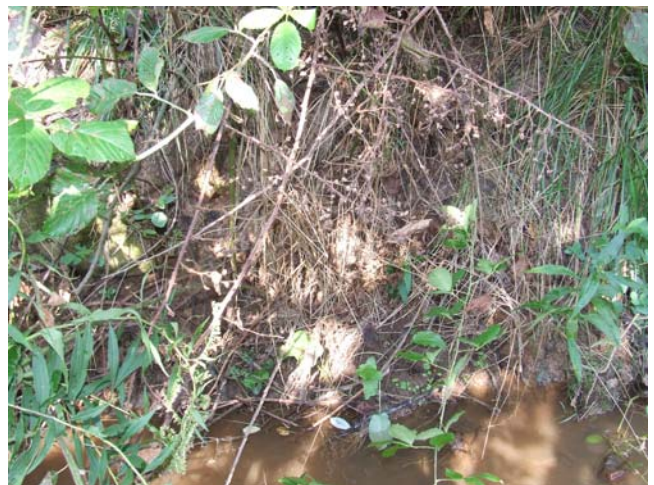
UTPA7 facing left bank

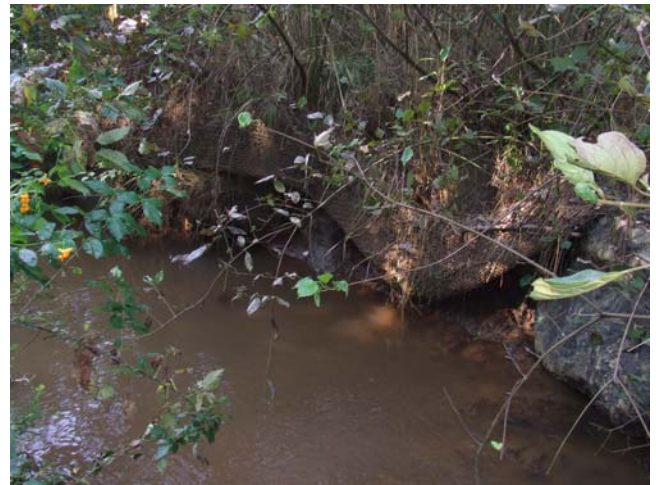
UTPA11 facing left bank

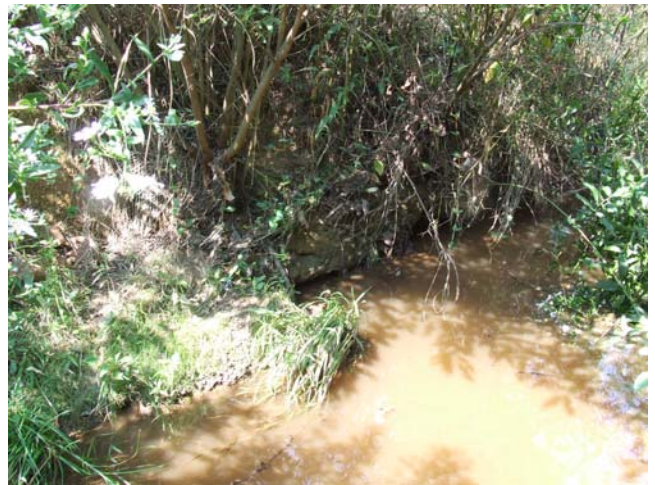
UTPA19 facing right bank

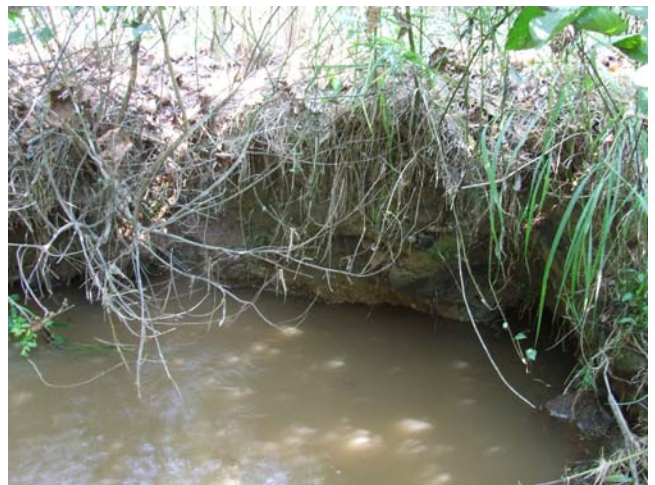
UTPA21 facing upstream

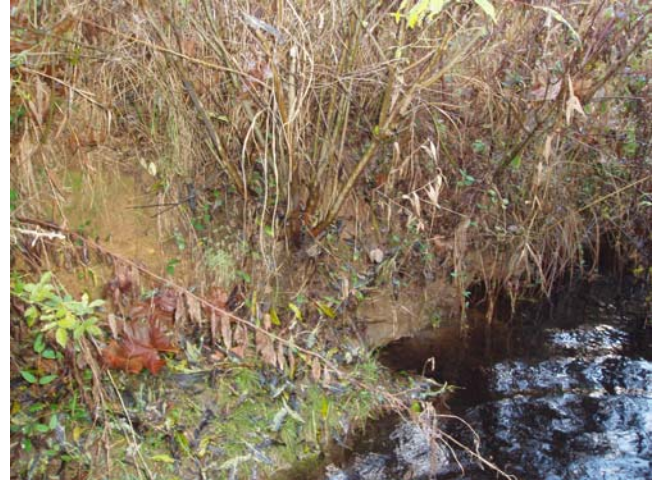
UTPA23 facing downstream

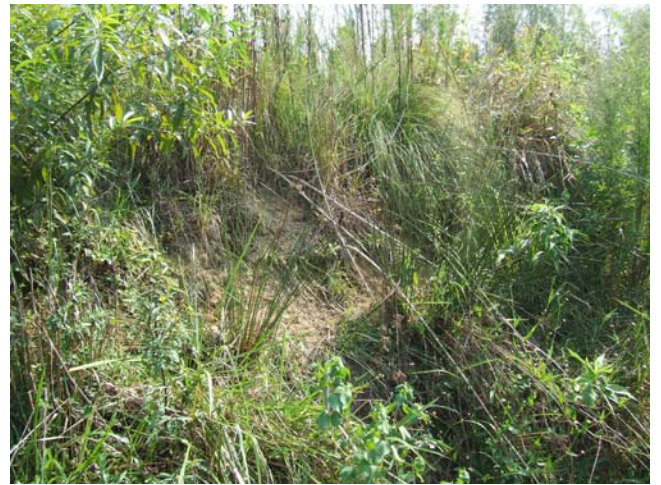
PA1 facing left bank

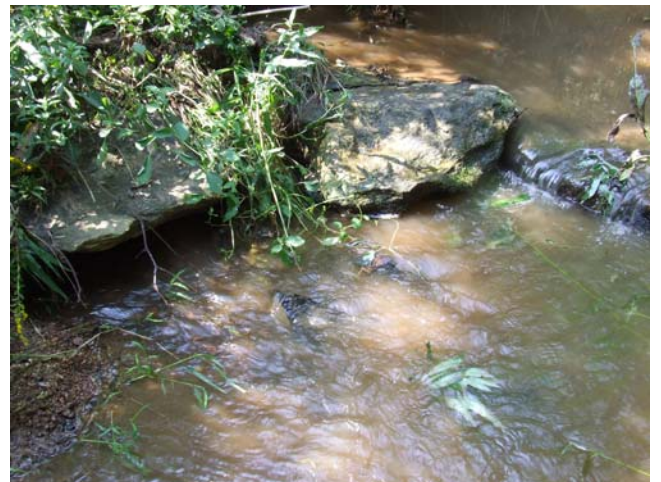
PA3 facing downstream

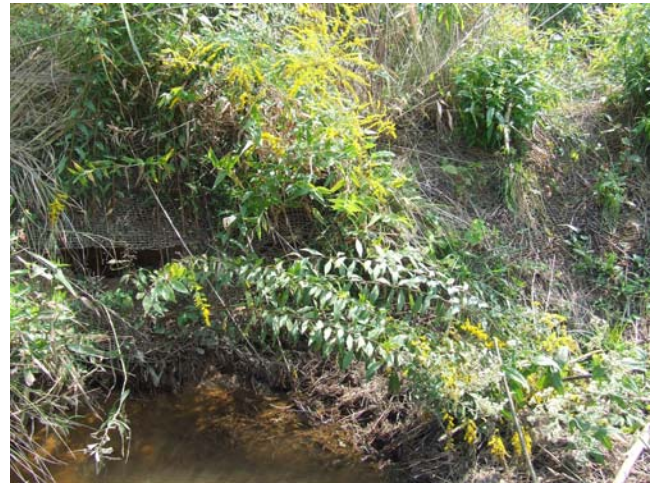
PA5 facing upstream

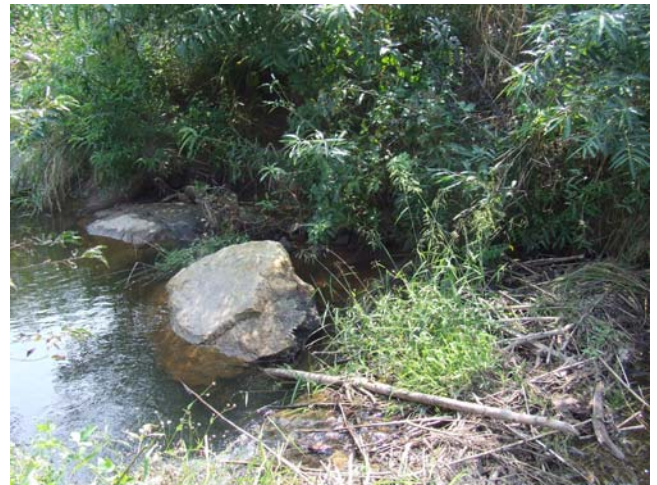
PA7 facing right bank

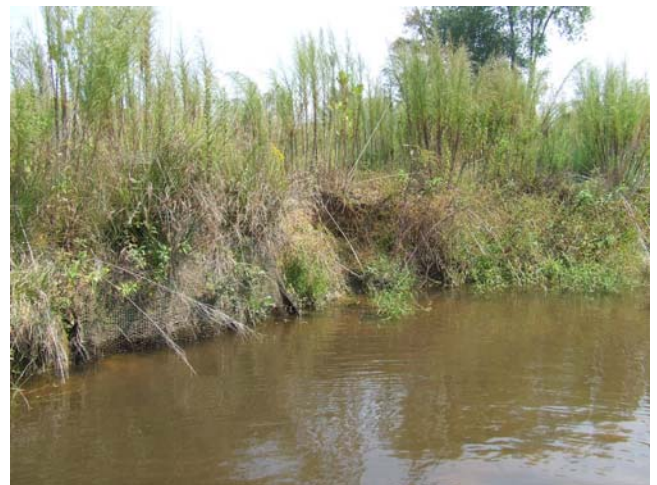
PA9 facing upstream (11/15/07)

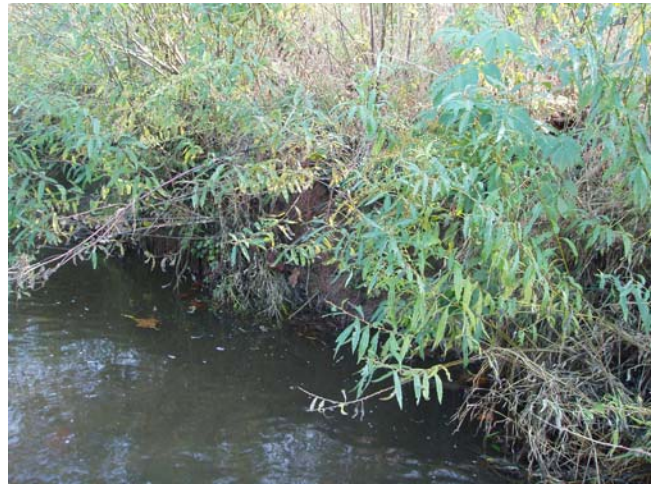
PA17 facing right bank

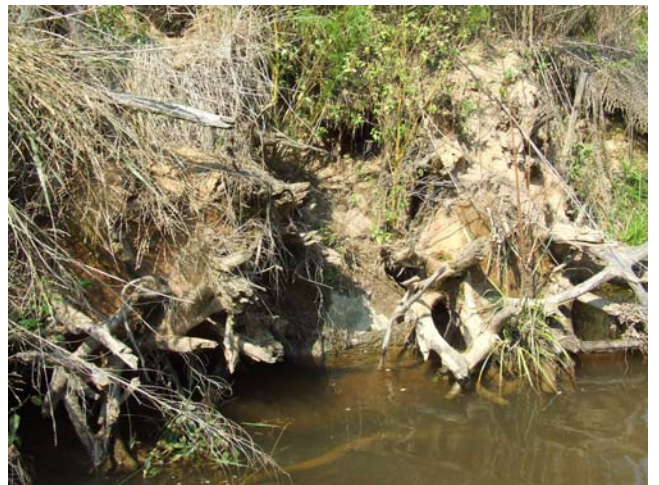
PA19 facing downstream

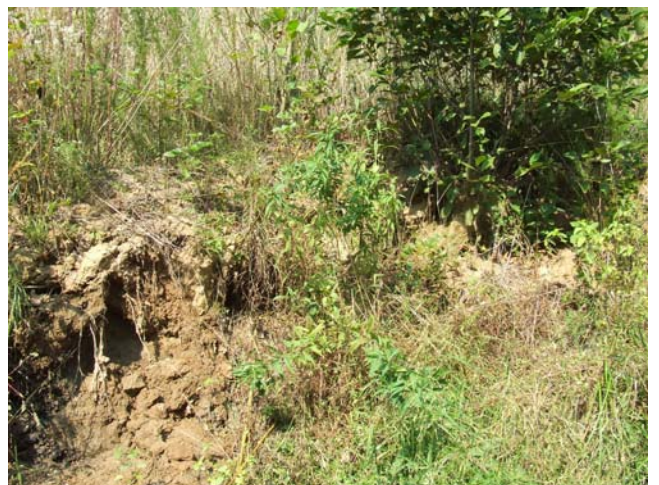
PA21 facing upstream

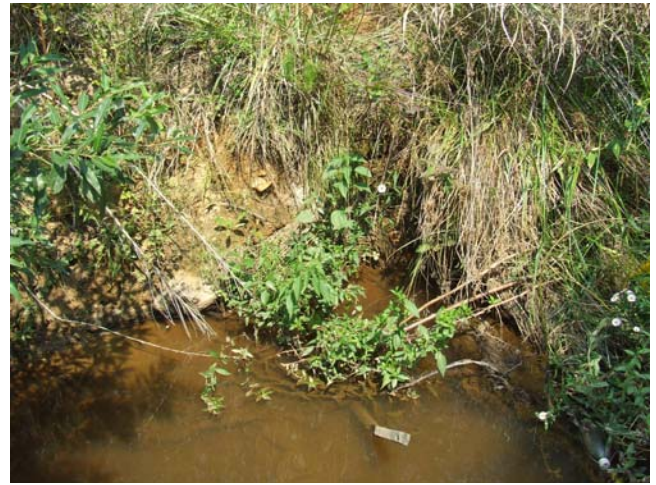
PA23 facing downstream

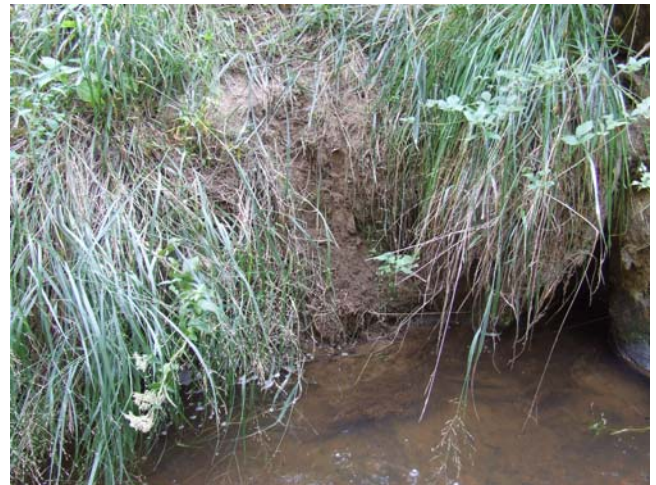
PA25 facing right bank

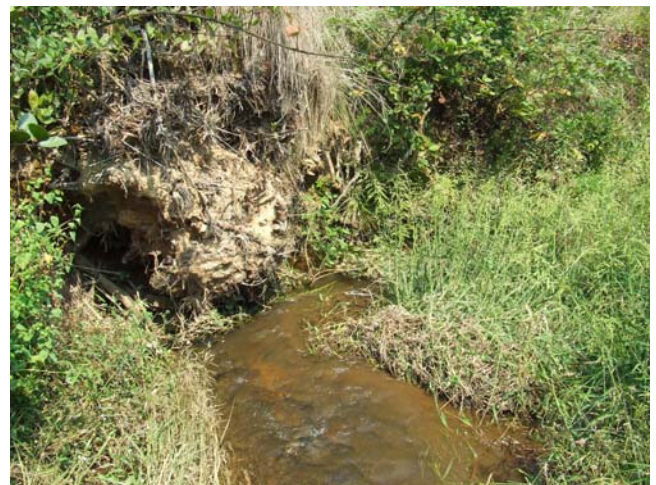
PA27 facing left bank
