**Little Bugaboo Creek Stream Restoration
2008 Final Monitoring Report
Monitoring Year Four**

Ecosystem Enhancement Program Project Number 00056

Submitted: February 17, 2009

URS Corporation – North Carolina
1600 Perimeter Park Drive, Suite 400
Morrisville, NC 27560

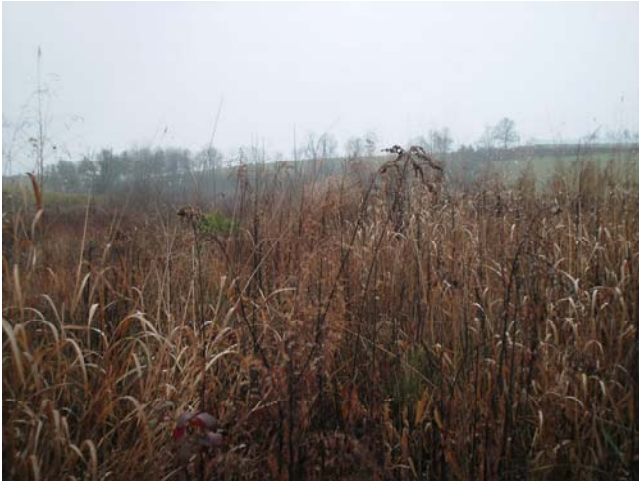
VPA1 facing upstream (12/16/08)

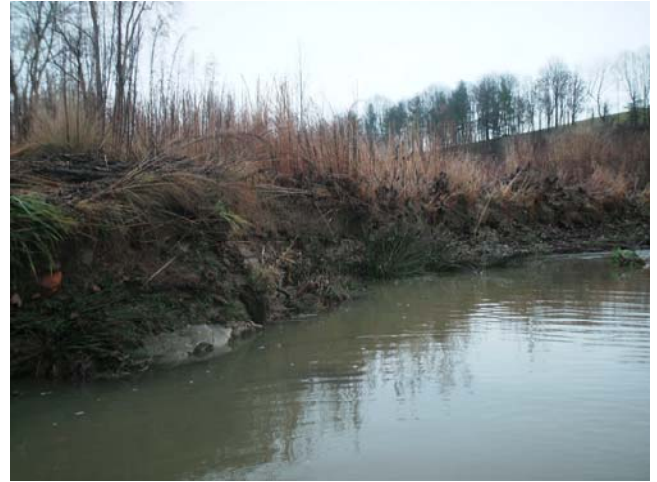
VPA4 facing downstream (12/16/08)

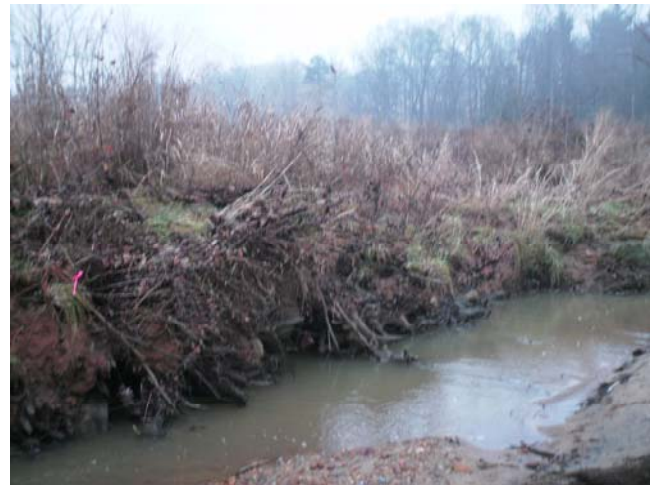
VPA13 facing downstream (12/15/08)

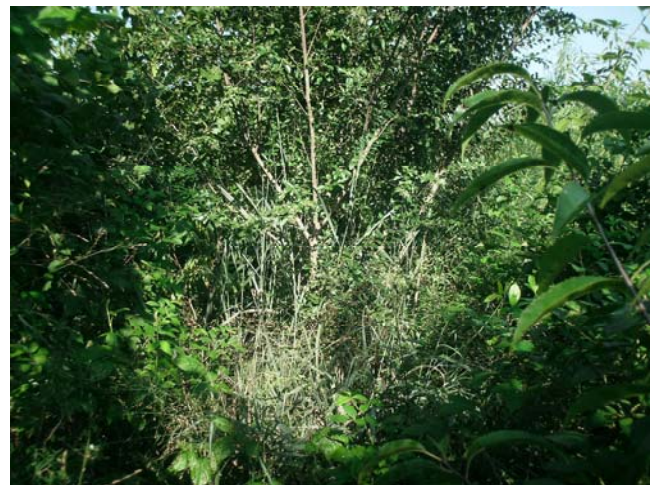
VPA15 facing left bank (9/4/08)

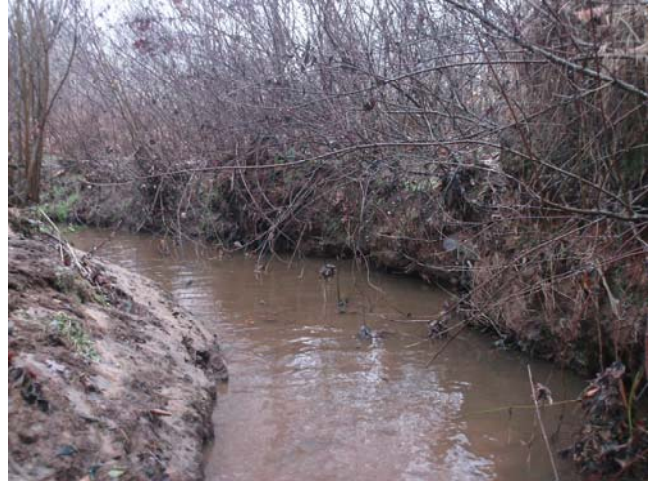
UTVPA2 facing downstream (12/15/08)

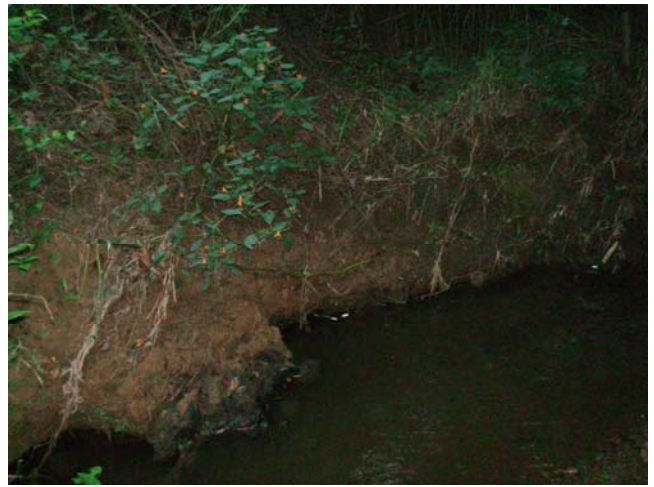
UTVPA4 facing left bank, upstream (9/4/08)

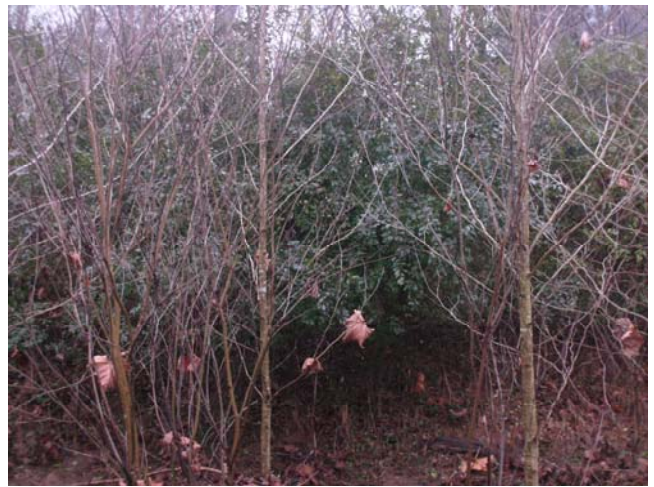
UTVPA6 on left bank (12/15/08)

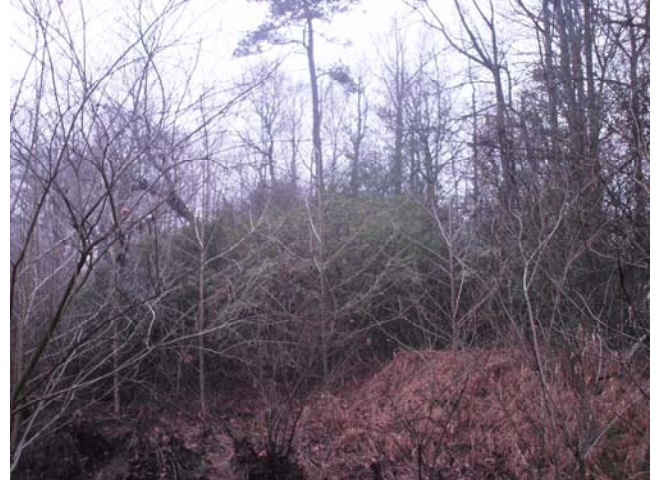
UTVPA9 on left bank (12/15/08)

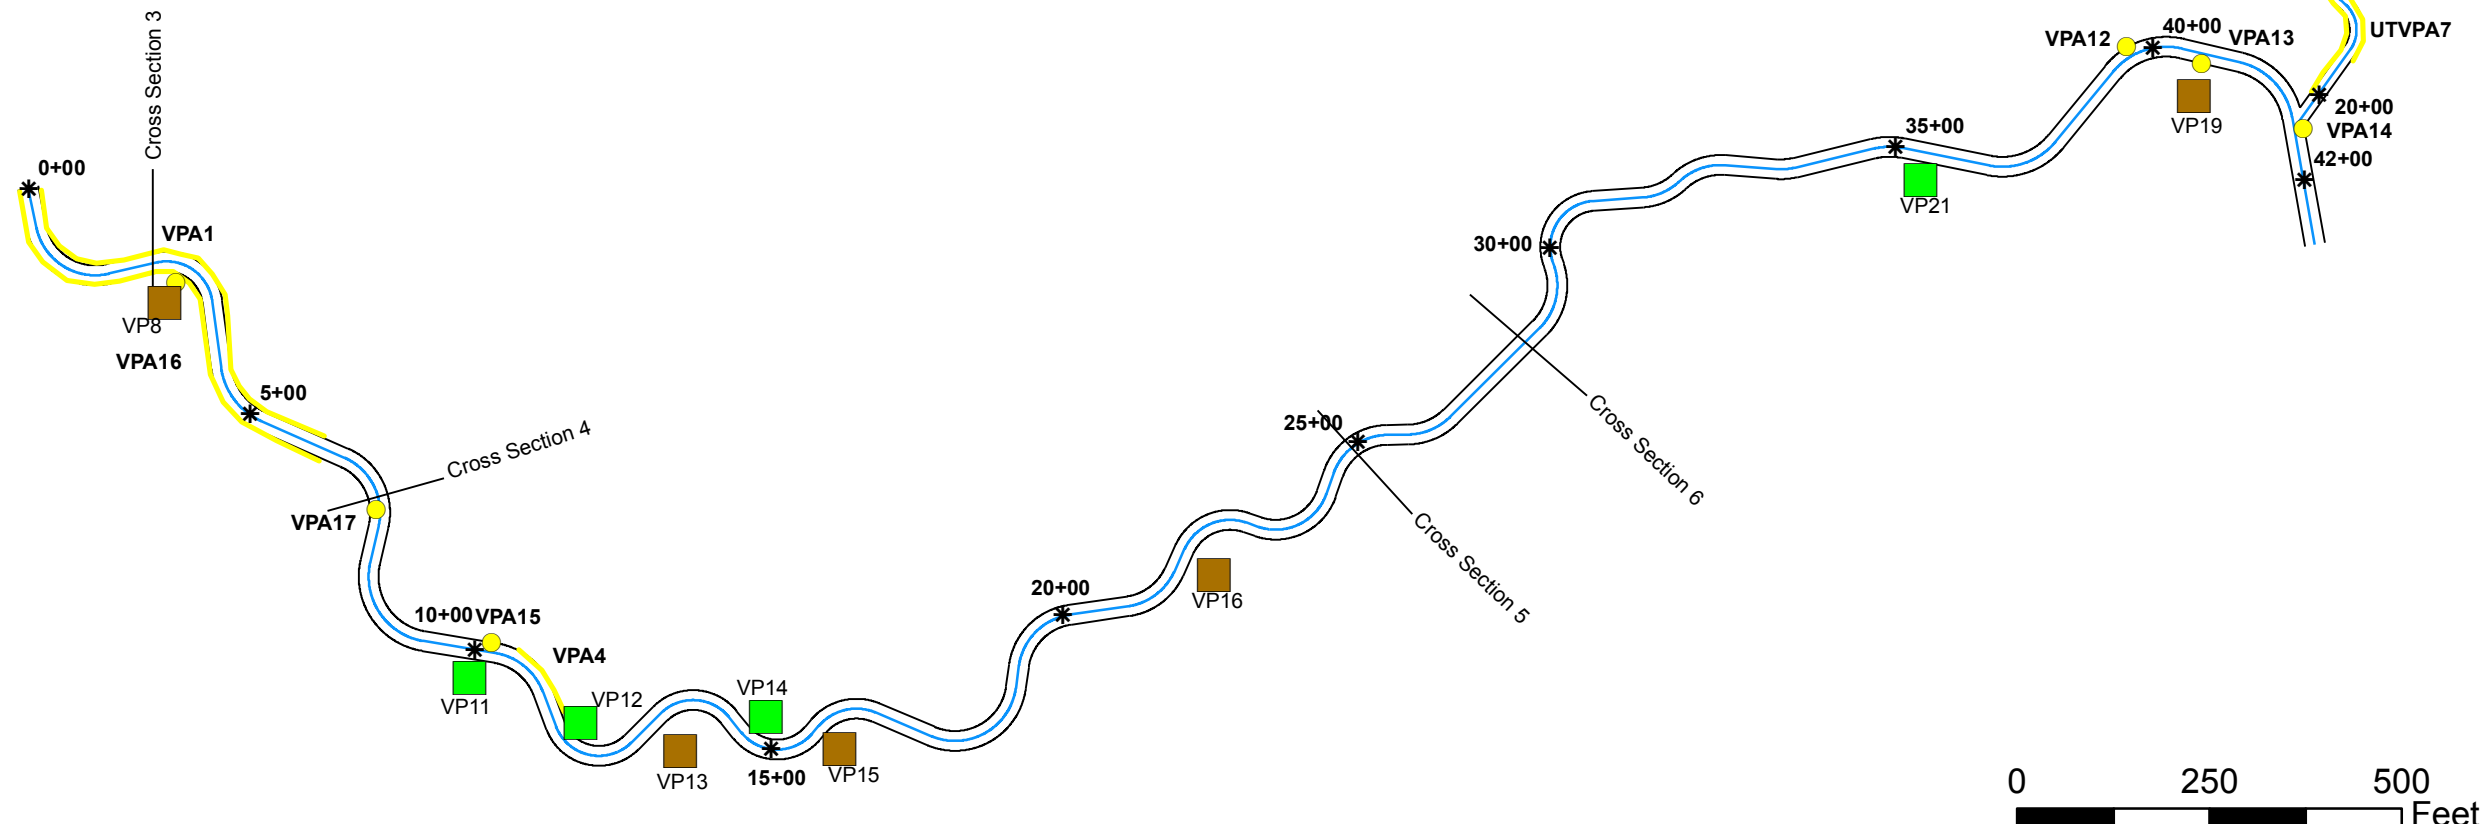
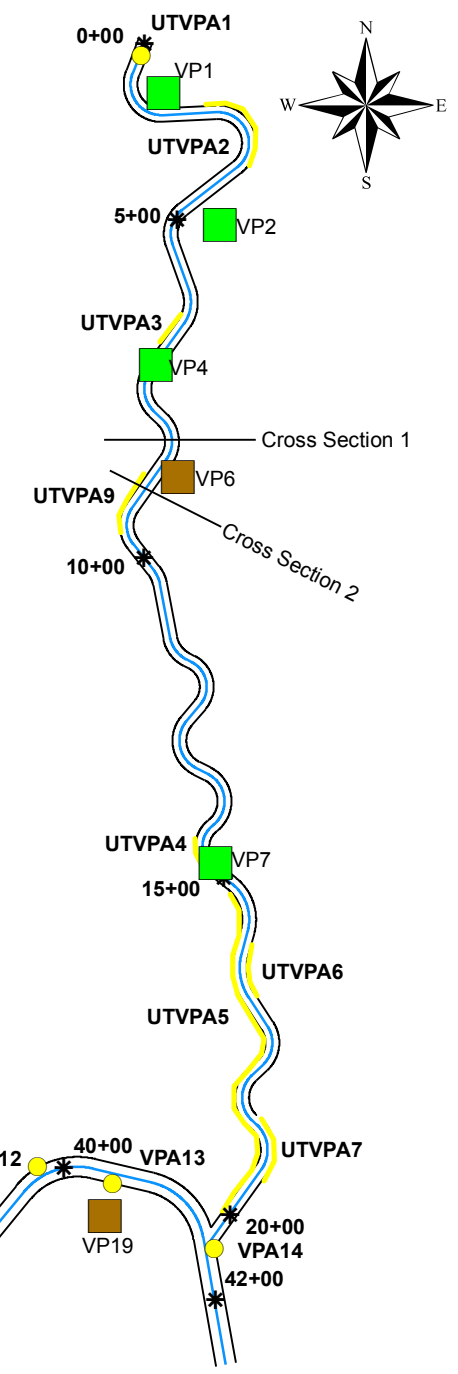
**Vegetation
 Current Condition
 Plan View**

Little Bugaboo Creek Vegetative Problem Areas			
EEP Project Number 00056			
Little Bugaboo Creek			
Feature #	Feature Issue	Station # / Range	Suspected Cause
VPA1	Poor survivability	0+00 to 5+60	Thick herbaceous vegetation
VPA4	Bare bank	10+40 to 11+90	Scour
VPA12	Bare bank	38+80	Scour
VPA13	Bare bank	40+60	Beaver damage
VPA14	Bare bank	41+60	Scour
VPA15	Invasive/exotic plant	10+10	Chinese privet
VPA16	Poor survivability	3+20	Beaver damage
VPA17	Poor survivability	7+00	Beaver damage
Unnamed Tributary			
UTVPA1	Bare bank	0+15	Scour
UTVPA2	Bare bank	1+90 to 3+10	Scour
UTVPA3	Bare bank	7+20 to 7+40	Scour
UTVPA4	Bare bank	14+70 to 14+80	Scour
UTVPA5	Poor survivability	15+05 to 20+00	Beaver damage
UTVPA6	Invasive/exotic plant	16+00 to 16+80	Chinese privet
UTVPA7	Invasive/exotic plant	18+60 to 18+90	Chinese privet
UTVPA9	Invasive/exotic plant	8+90 to 9+40	Chinese privet

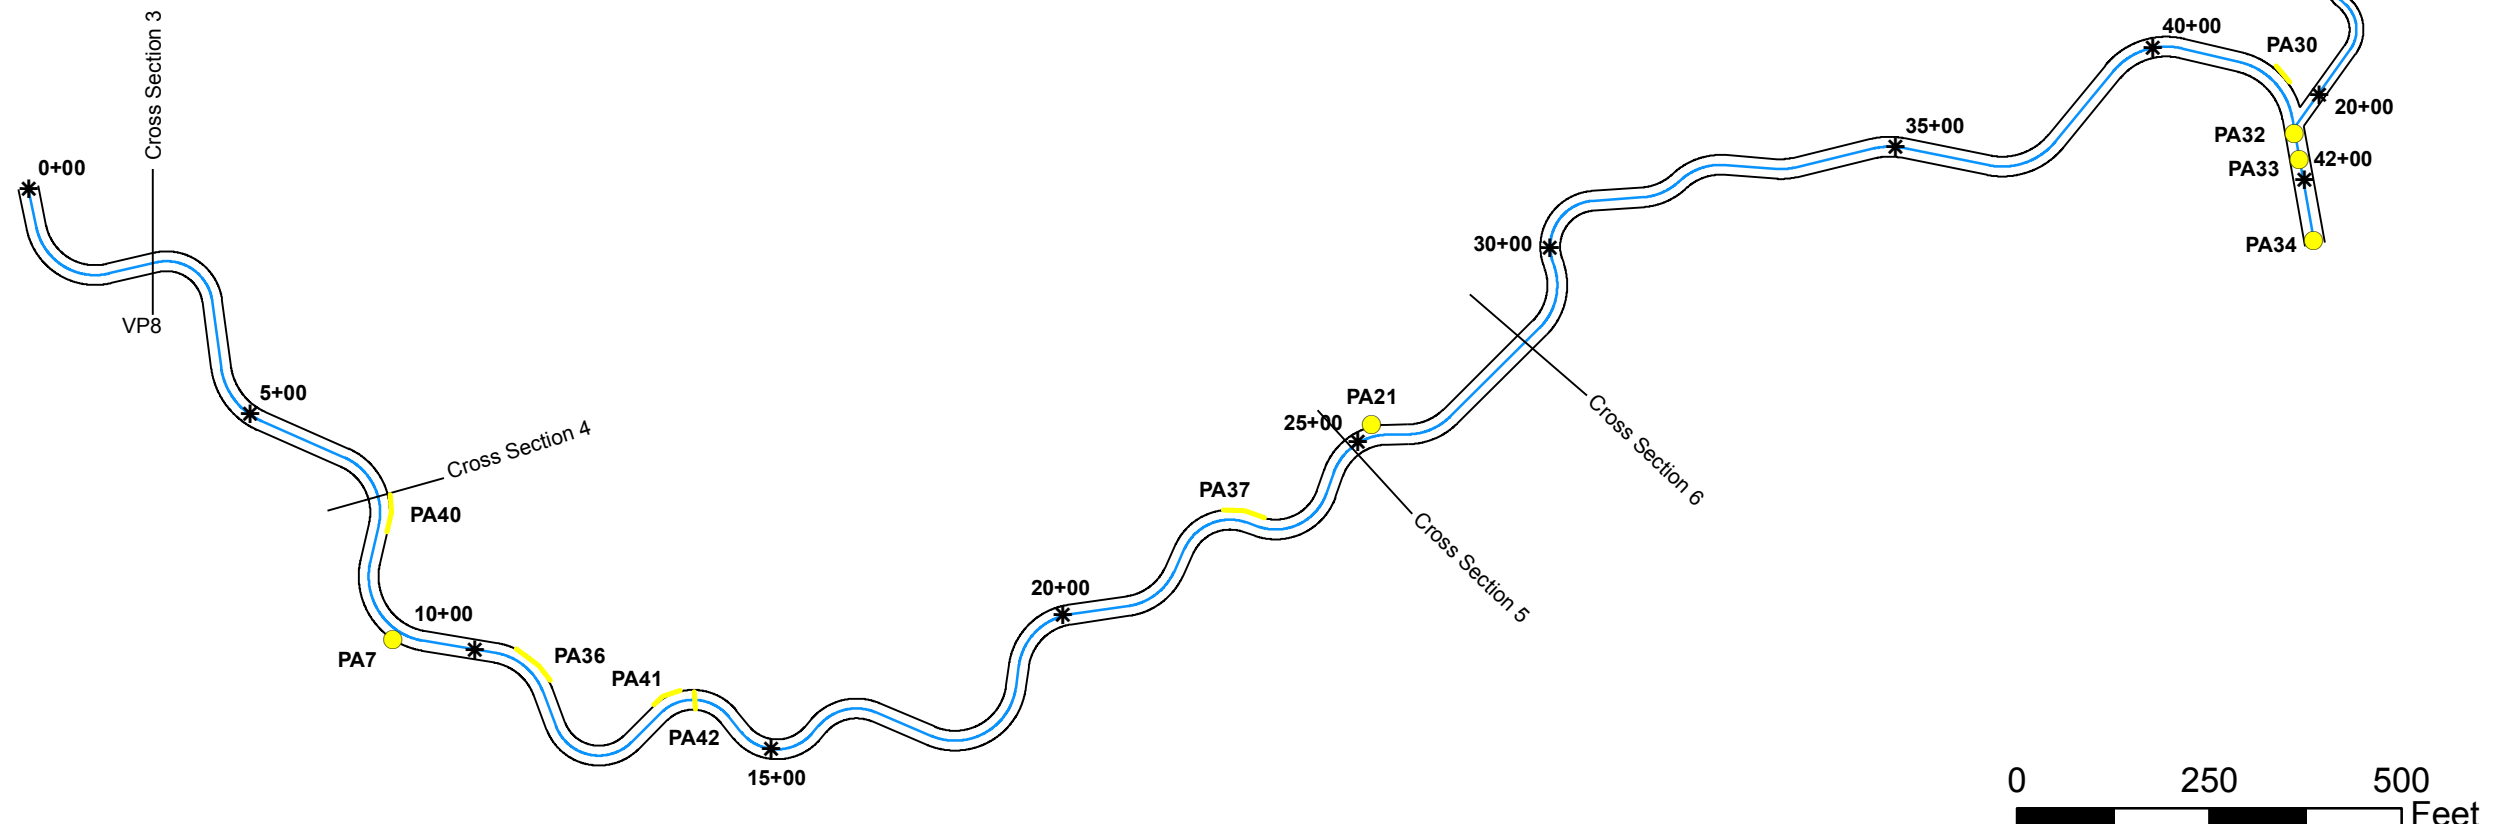
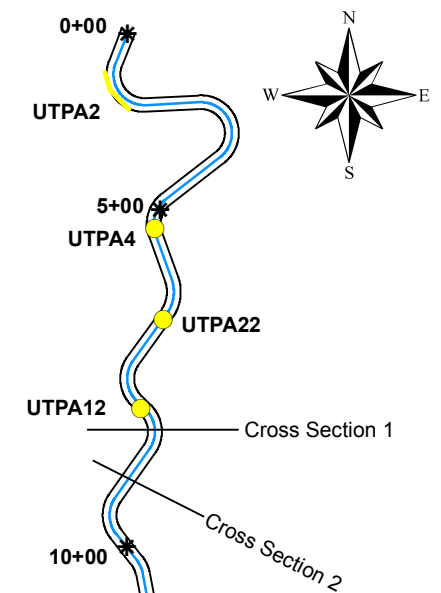
Stream
 Current Condition
 Plan View

Little Bugaboo Creek Stream Problem Areas			
EEP Project Number 00056			
Little Bugaboo Creek			
Feature #	Feature Issue	Station # / Range	Suspected Cause
PA7	Structure degradation	8+45	Thalweg flowing through vane arm, not center of structure
PA21	Bank erosion	25+10	Scour
PA30	Bank erosion	41+00 to 41+10	Scour
PA32	Bank erosion	41+30	Scour
PA33	Structure degradation	41+60	Boulders shifted
PA34	Structure degradation	42+76	Bank scour behind vane arm
PA36	Aggradation	10+40 to 10+70	Bank erosion and scour
PA37	Bank erosion	22+80 to 23+10	Scour
PA40	Bank erosion	7+20 to 7+40	Scour
PA41	Bank erosion	14+00 to 14+30	Scour
PA42	Beaver Dam	14+35	Beaver
Unnamed Tributary			
UTPA2	Bank erosion	1+60 to 2+00	Scour
UTPA4	Bank erosion	5+35	Scour
UTPA12	Bank erosion	8+00	Scour
UTPA16	Bank erosion	11+75	Scour
UTPA17	Bank erosion	12+40	Scour
UTPA21	Bank erosion	15+10	Scour
UTPA22	Structure degradation	6+80	Scour behind vane arm

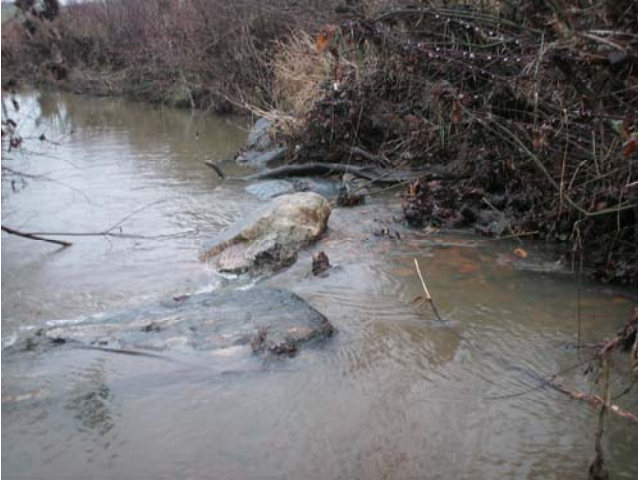
Little Bugaboo Creek EEP Project Number 00056				
Feature #	Feature/Issue	Station # / Range	Probable Cause	Photo #
PA7	Structure degradation	8+45	Thalweg flowing through vane arm, not center of structure	PA7
PA21	Bank erosion	25+10	Scour	PA21
PA30	Bank erosion	41+00 to 41+10	Scour	PA30
PA32	Bank erosion	41+30	Scour	PA32
PA33	Structure degradation	41+60	Boulders shifted	PA33
PA34	Structure degradation	42+76	Bank scour behind vane arm	PA34
PA36	Aggradation	10+40 to 10+70	Bank erosion and scour	PA36
PA37	Bank erosion	22+80 to 23+10	Scour	PA37
PA40	Bank erosion	7+20 to 7+40	Scour	PA40
PA41	Bank erosion	14+00 to 14+30	Scour	PA41
PA42	Beaver dam	14+35	Beaver	PA42
Unnamed Tributary EEP Project Number 00056				
UTPA2	Bank erosion	1+60 to 2+00	Scour	UTPA2
UTPA4	Bank erosion	5+35	Scour	UTPA4
UTPA12	Bank erosion	8+00	Scour	UTPA12
UTPA16	Bank erosion	11+75	Scour	UTPA16
UTPA17	Bank erosion	12+40	Scour	UTPA17
UTPA21	Bank erosion	15+10	Scour	UTPA21

PA7 facing downstream

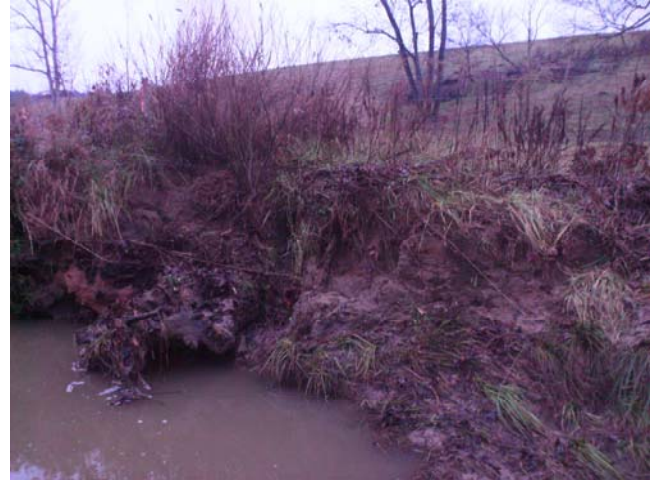
PA21 facing upstream

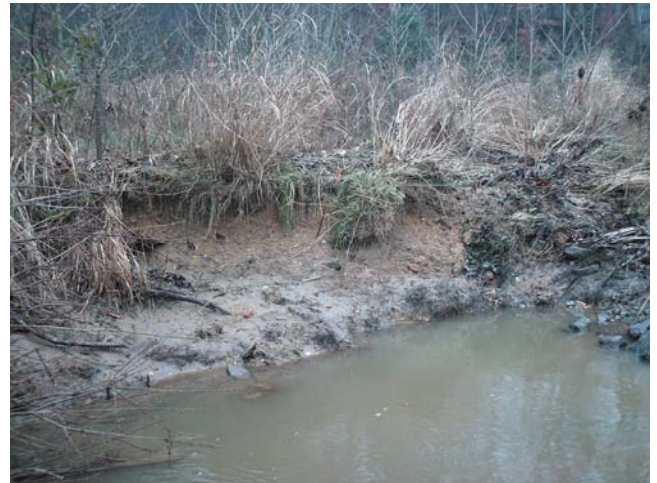
PA32 facing downstream

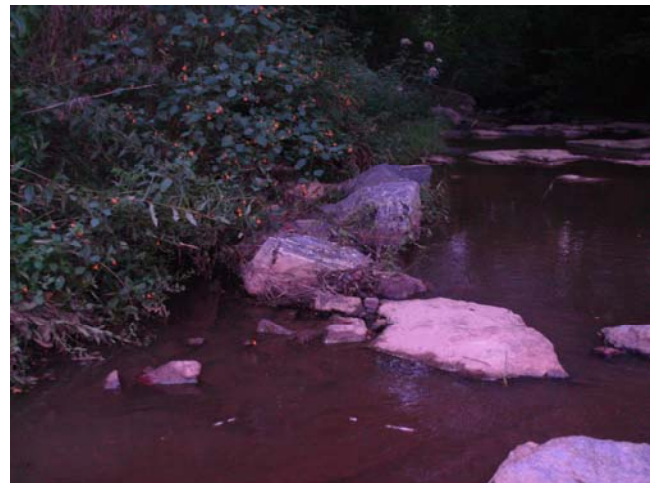
PA34 facing downstream (9/4/08)

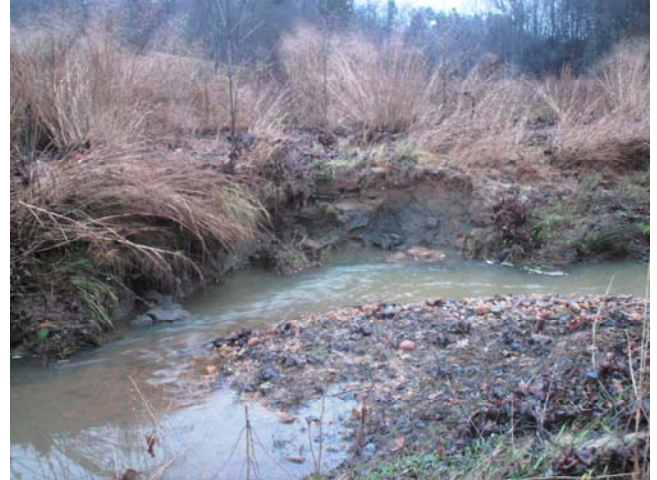
PA37 facing left bank, downstream

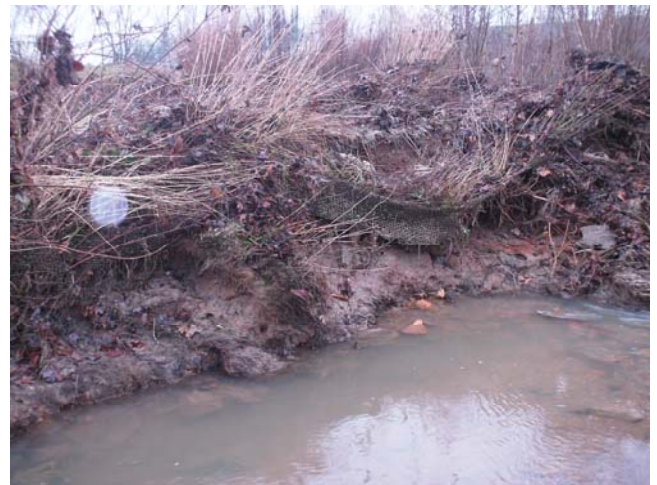
PA41 facing left bank

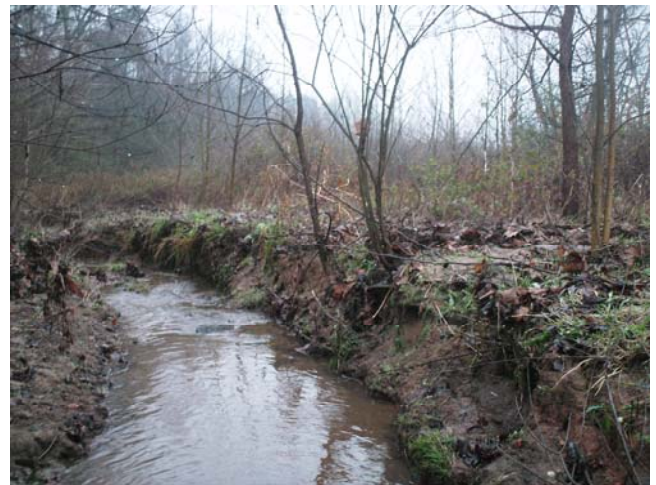
UTPA16 facing downstream

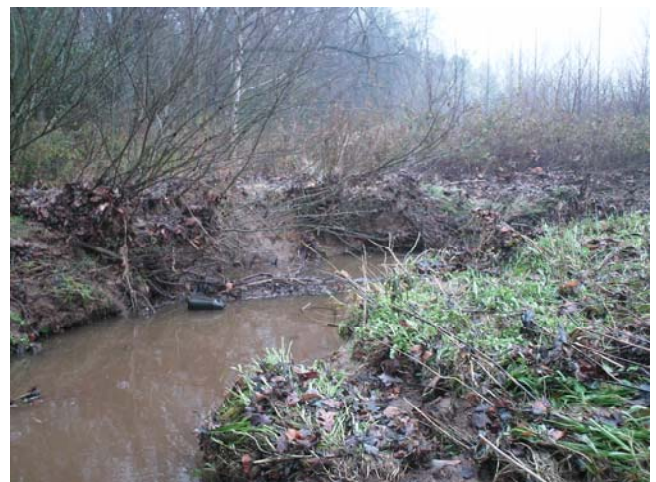
UTPA21 facing downstream
