**Bugaboo Creek Stream Restoration
2009 Final Monitoring Report
Monitoring Year Five**

Ecosystem Enhancement Program Project Number 00056

Submitted: April 23, 2010

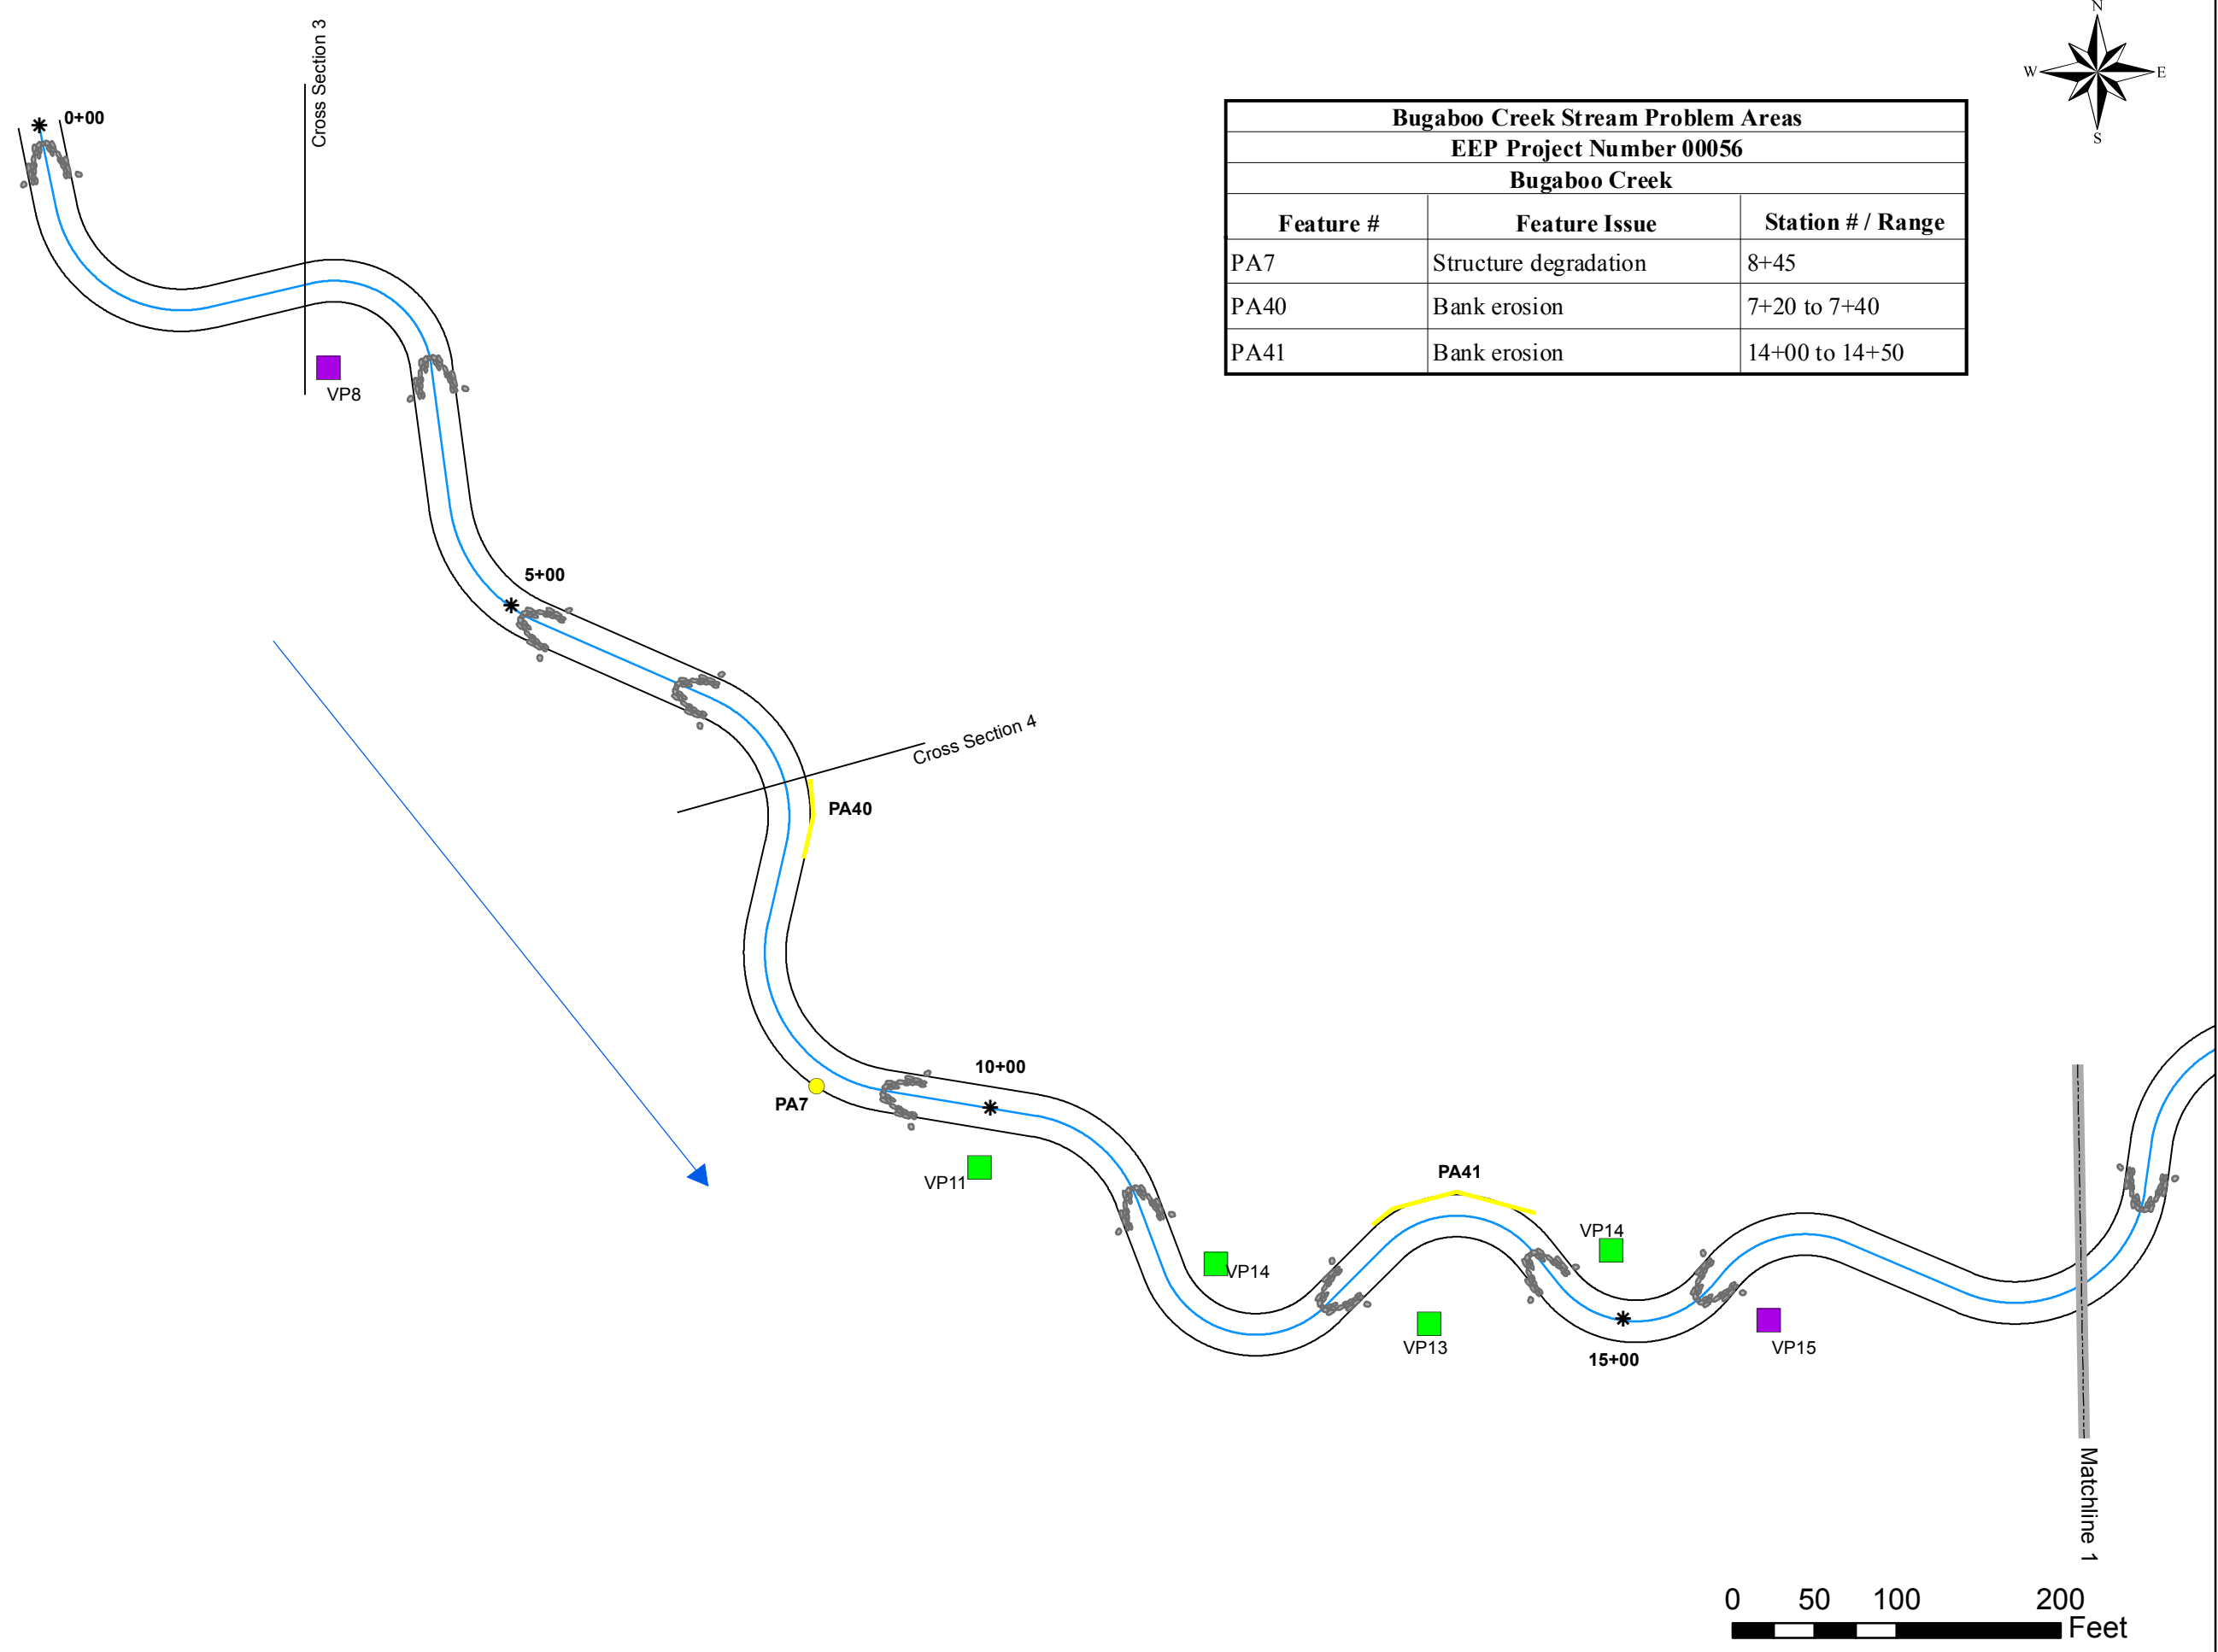
**Stream
 Current Condition
 Plan View**

Bugaboo Creek Stream Problem Areas		
EEP Project Number 00056		
Bugaboo Creek		
Feature #	Feature Issue	Station # / Range
PA7	Structure degradation	8+45
PA40	Bank erosion	7+20 to 7+40
PA41	Bank erosion	14+00 to 14+50

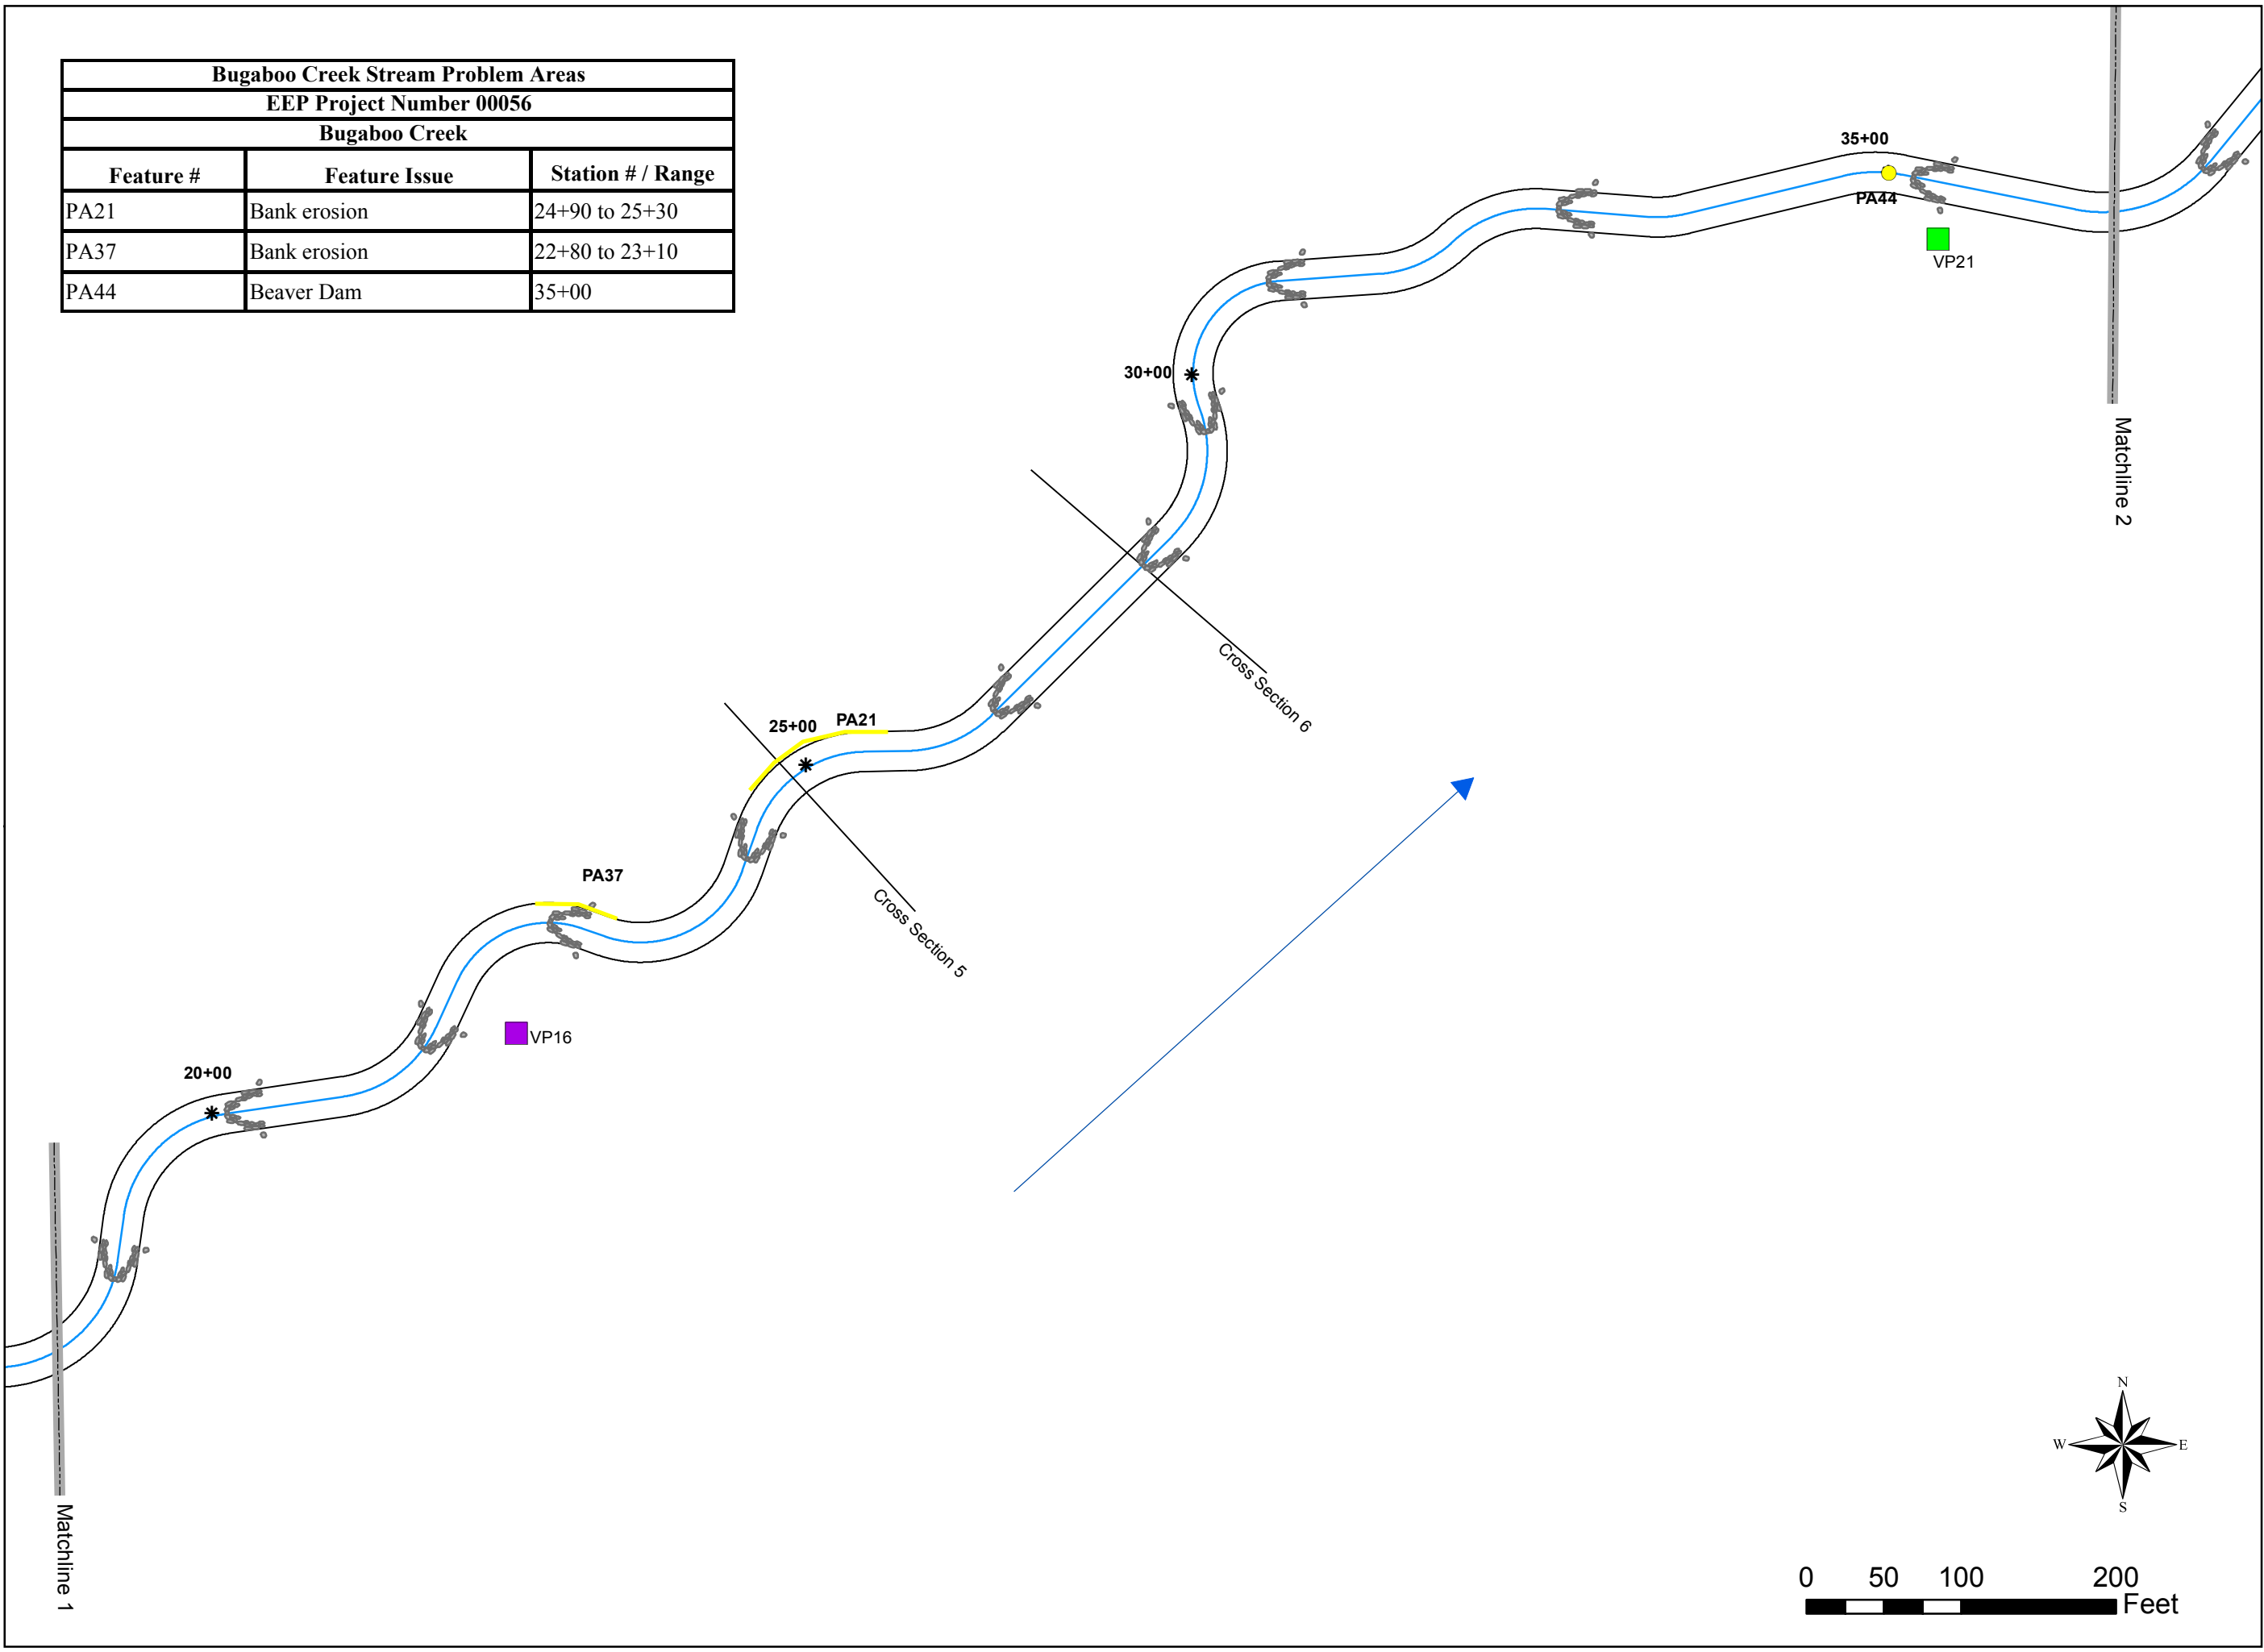
Bugaboo Creek Stream Problem Areas		
EEP Project Number 00056		
Bugaboo Creek		
Feature #	Feature Issue	Station # / Range
PA21	Bank erosion	24+90 to 25+30
PA37	Bank erosion	22+80 to 23+10
PA44	Beaver Dam	35+00

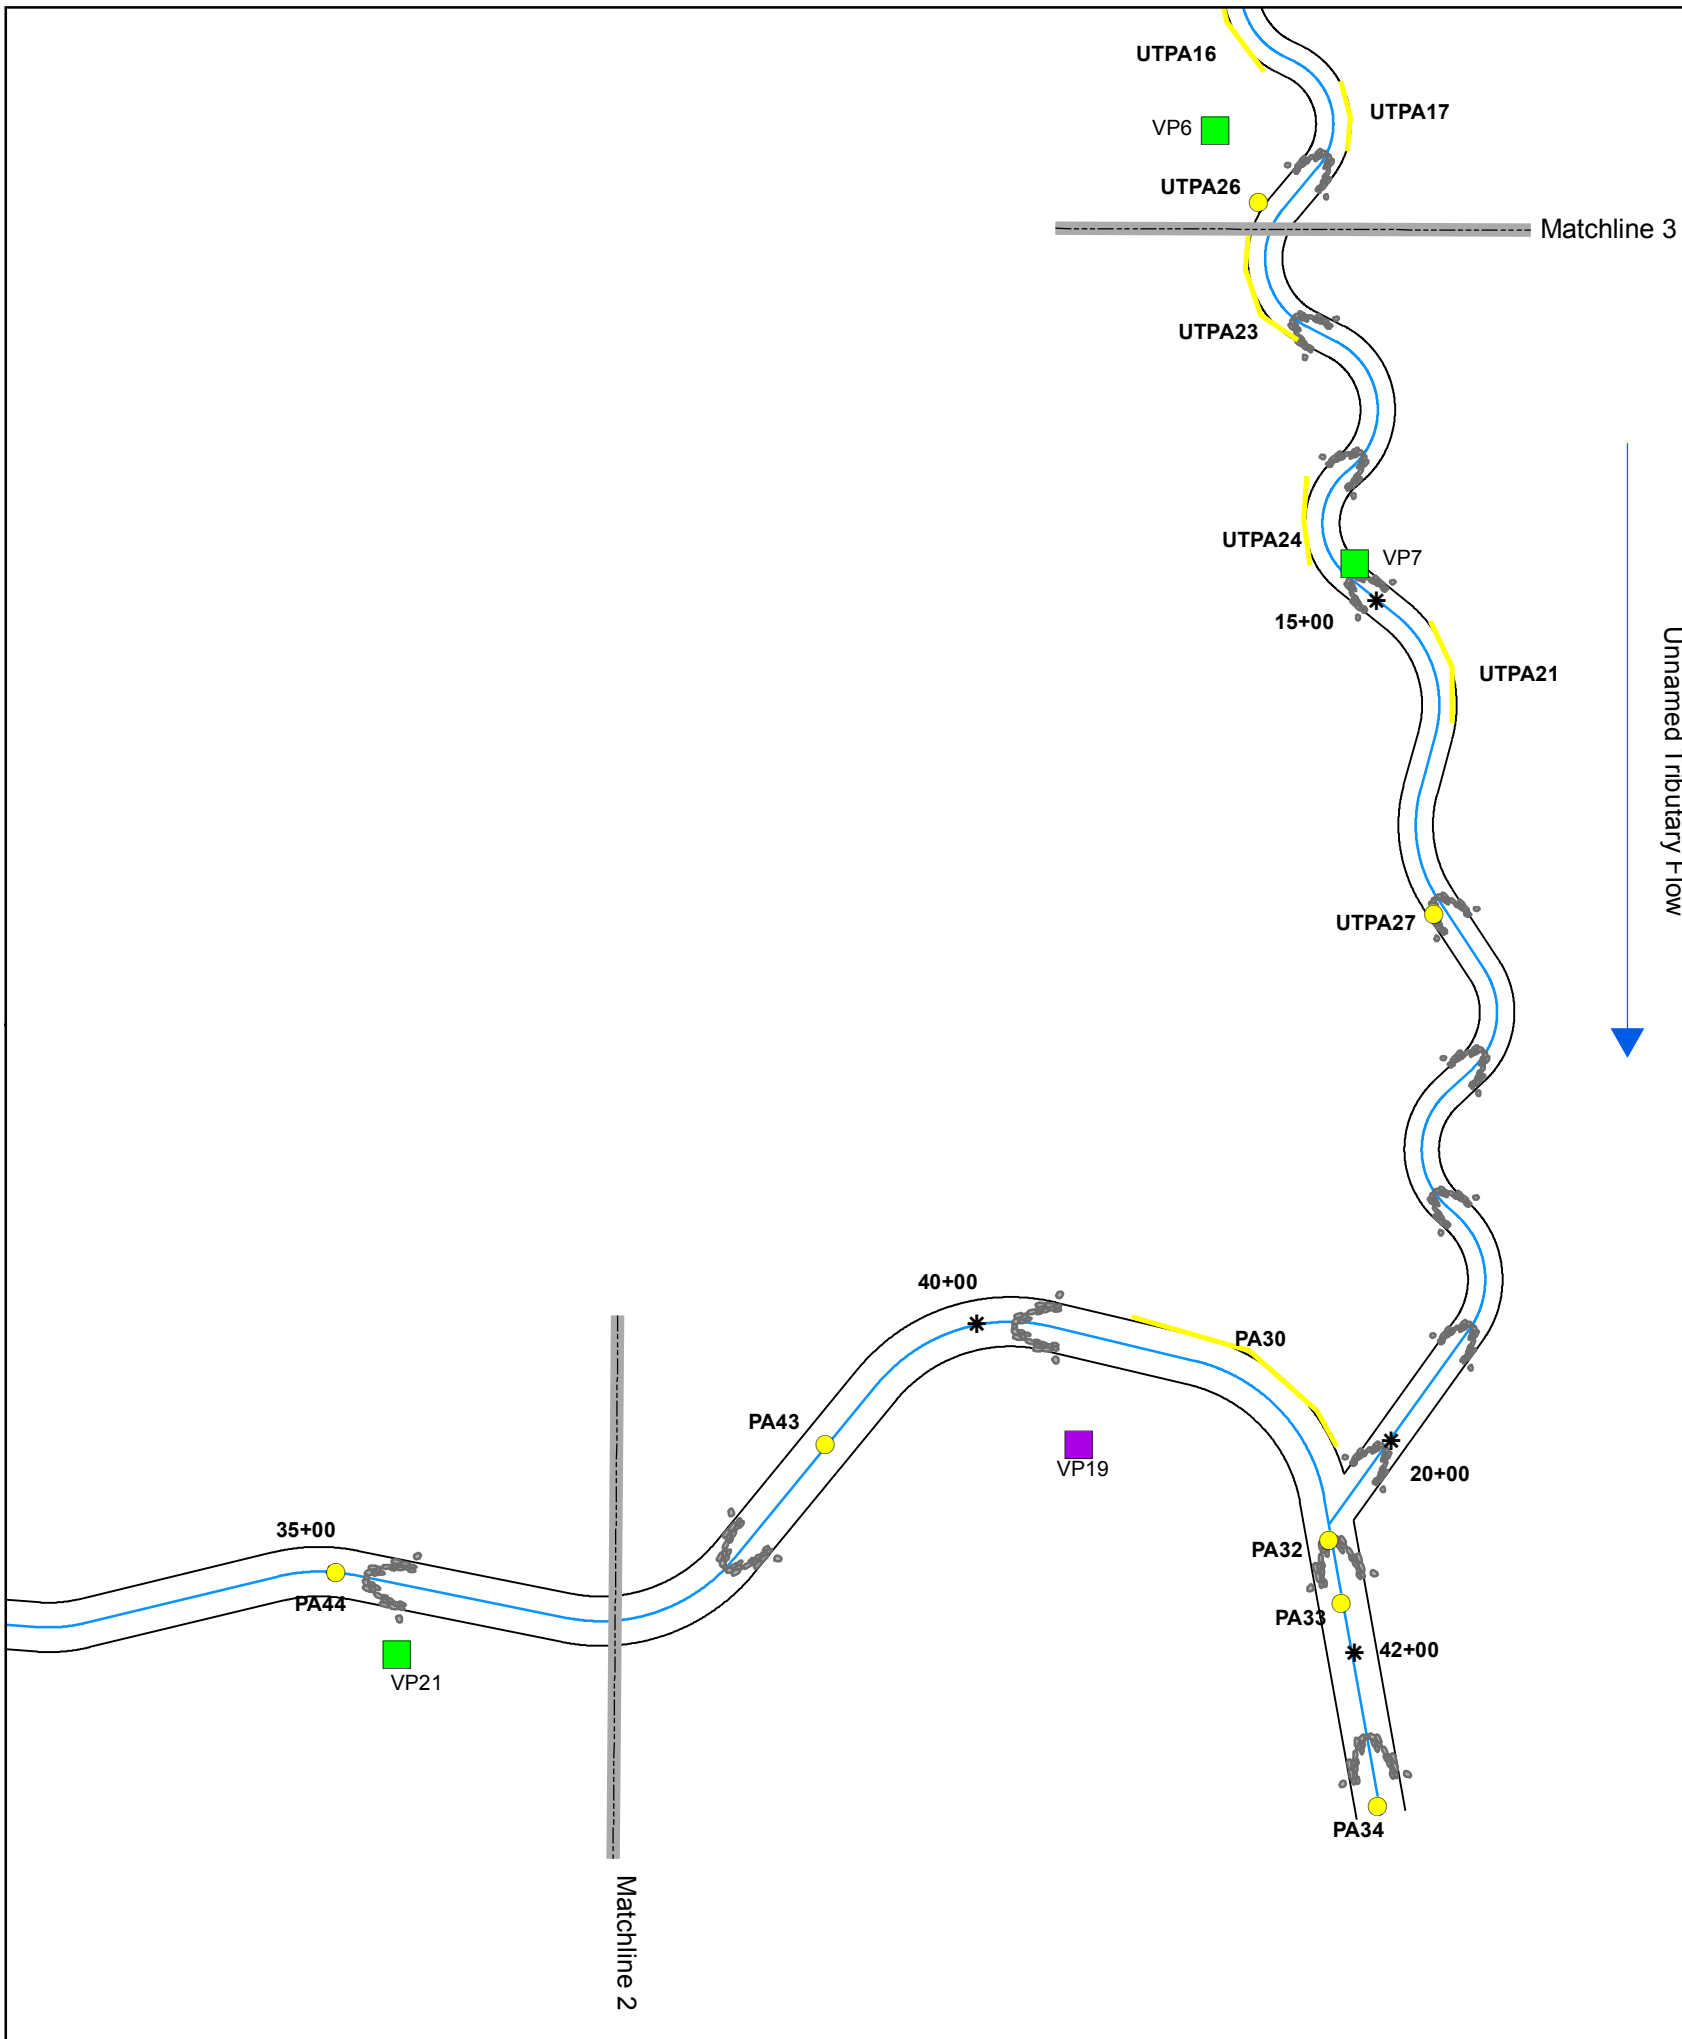
Stream
 Current Condition
 Plan View

Bugaboo Creek Stream Problem Areas		
EEP Project Number 00056		
Bugaboo Creek		
Feature #	Feature Issue	Station # / Range
PA30	Bank erosion	40+80 to 41+50
PA32	Bank erosion	41+30
PA33	Structure degradation	41+60
PA34	Structure degradation	42+76
PA43	Beaver Dam	38+00
Unnamed Tributary		
UTPA21	Bank erosion	15+05 to 15+15
UTPA23	Bank erosion	13+00 to 13+30
UTPA24	Bank erosion	14+85 to 14+95
UTPA27	Bank erosion	17+20

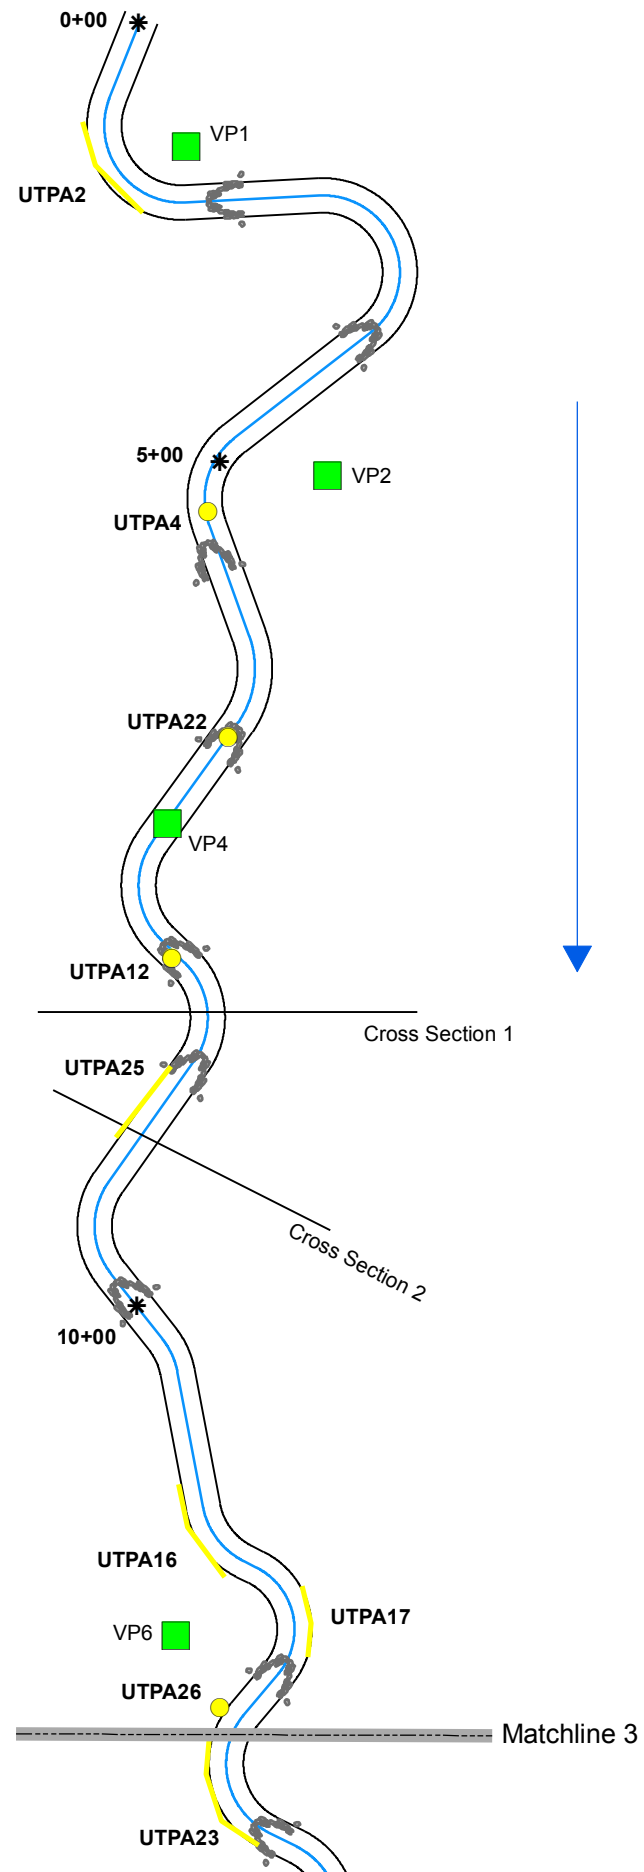
**Stream
 Current Condition
 Plan View**

Bugaboo Creek Stream Problem Areas		
EEP Project Number 00056		
Unnamed Tributary		
Feature #	Feature Issue	Station # / Range
UTPA2	Bank erosion	1+60 to 2+00
UTPA4	Bank erosion	5+35
UTPA12	Bank erosion	8+00
UTPA16	Bank erosion	11+60 to 11+75
UTPA17	Bank erosion	12+40 to 12+50
UTPA22	Structure degradation	6+80
UTPA25	Bank erosion	8+50 to 9+00
UTPA26	Root Wad Failure	12+90

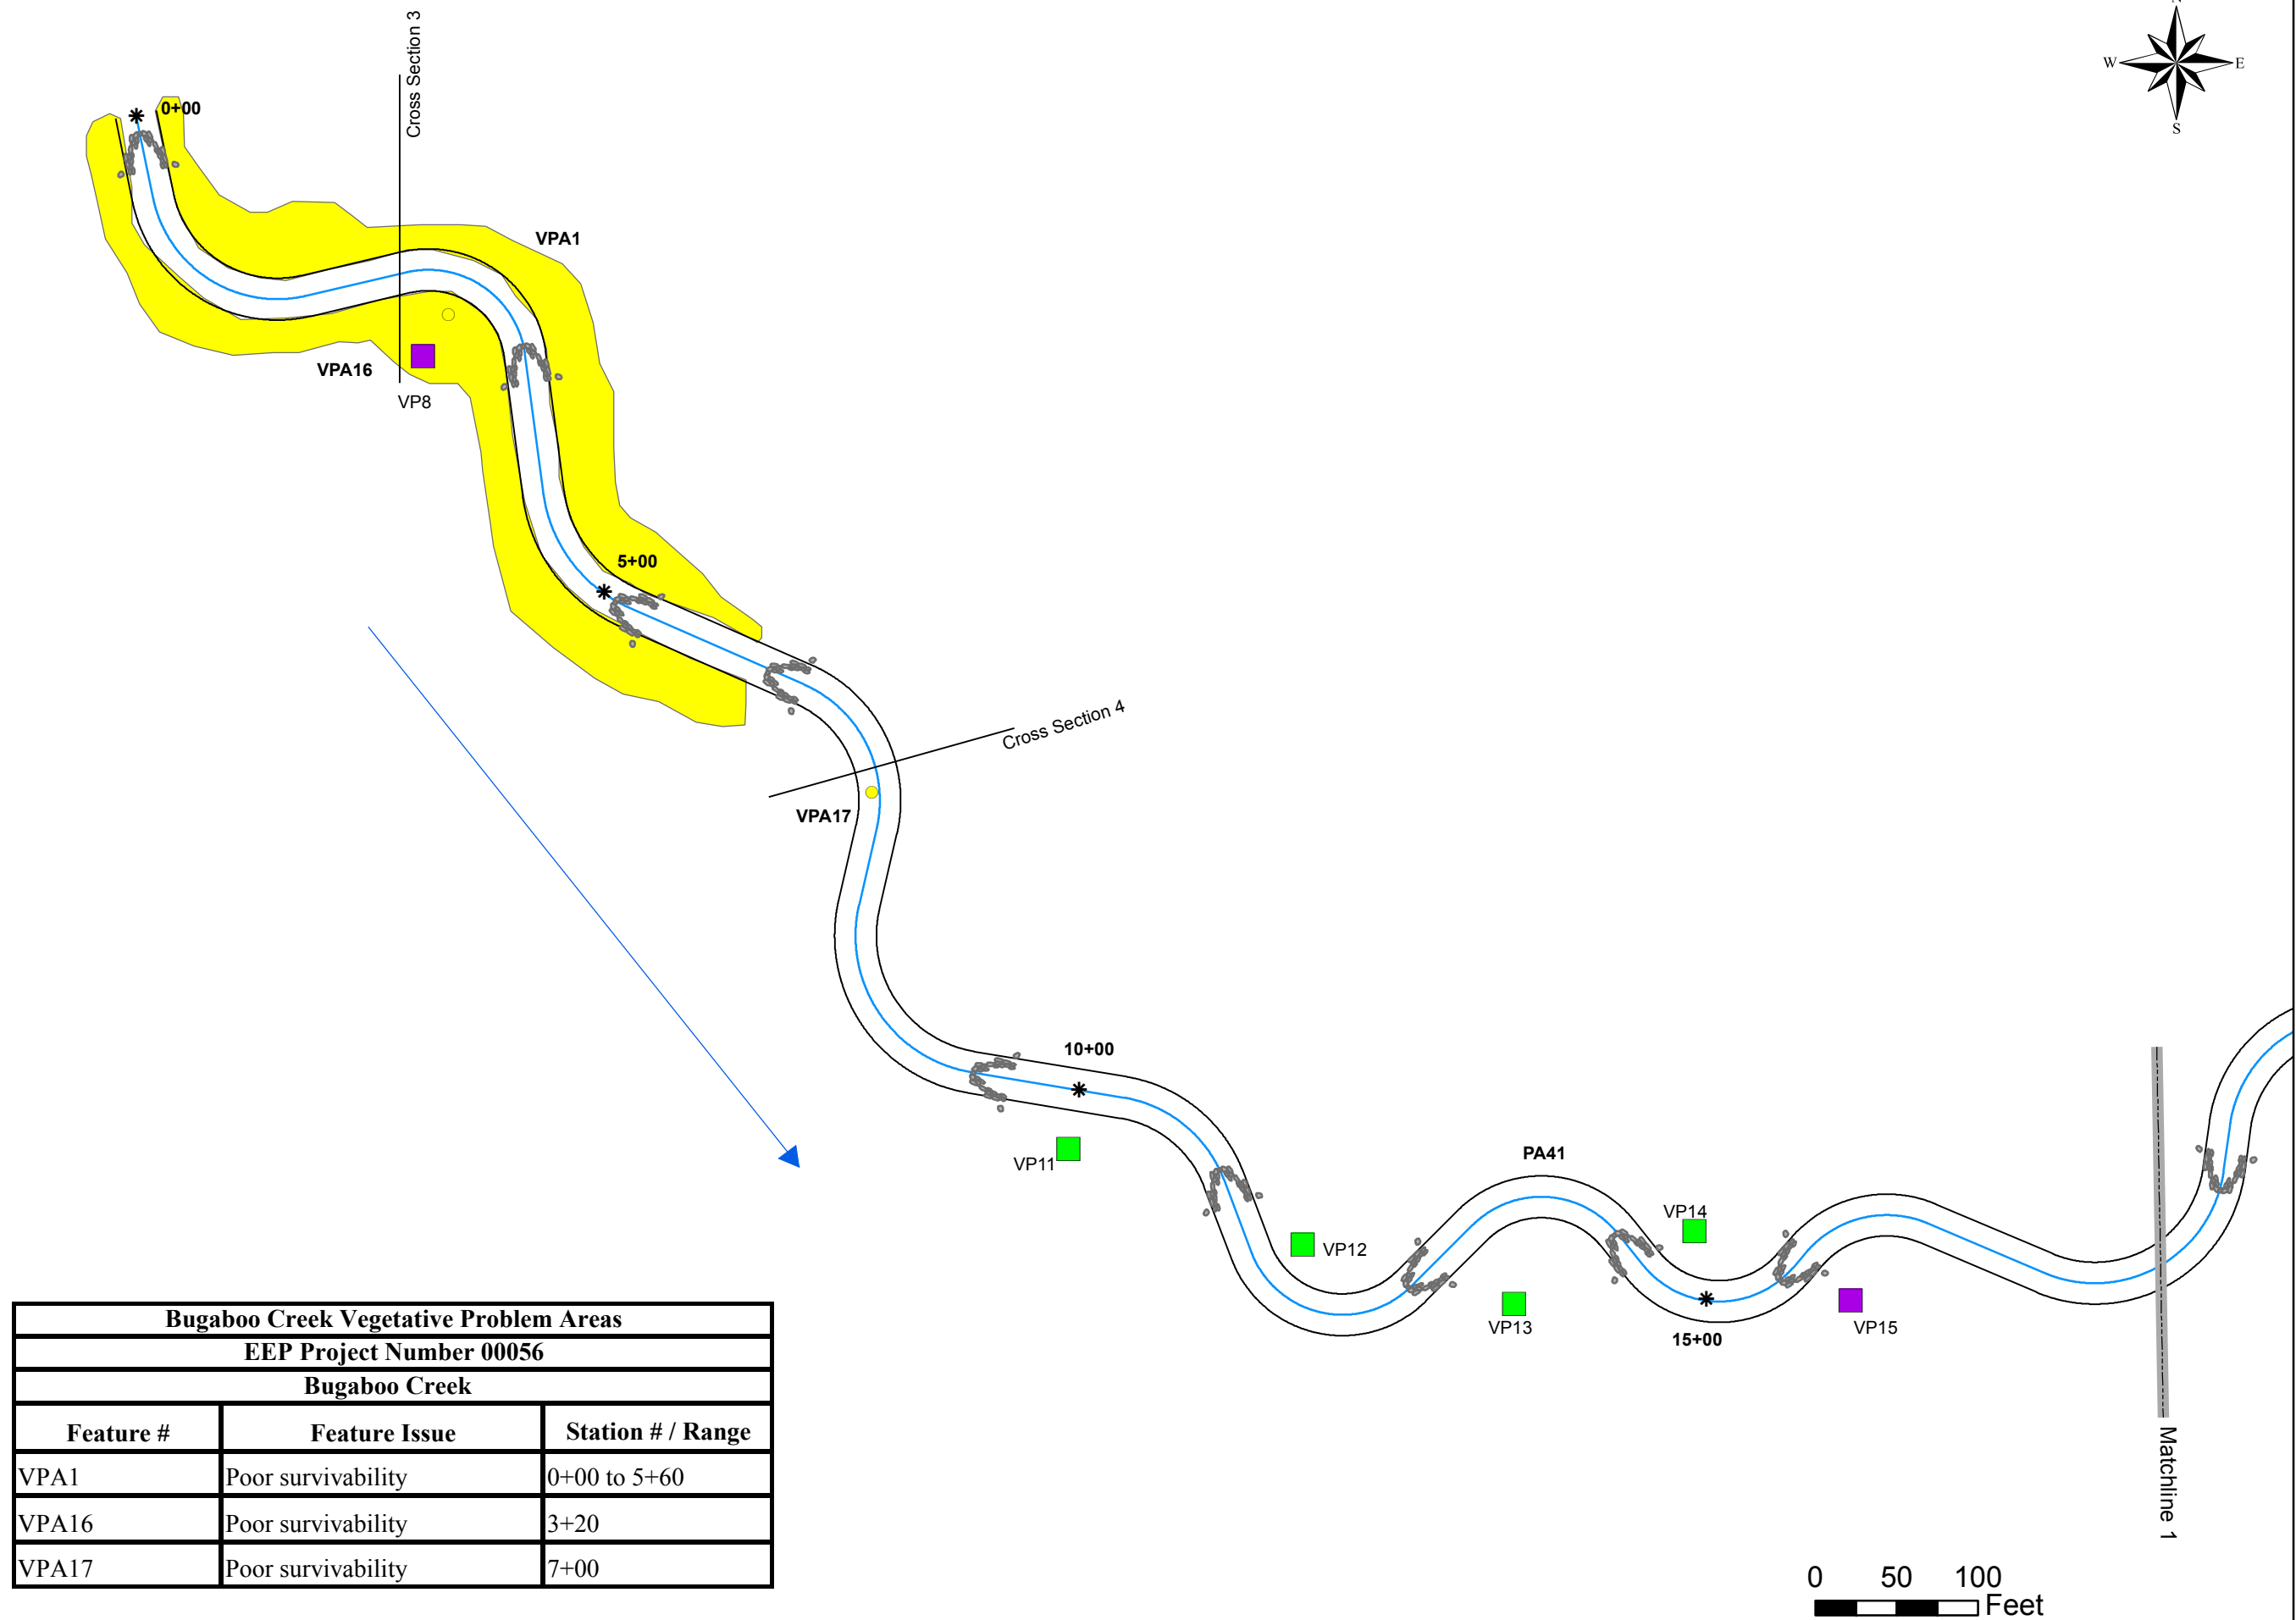
Bugaboo Creek Vegetative Problem Areas		
EEP Project Number 00056		
Bugaboo Creek		
Feature #	Feature Issue	Station # / Range
VPA1	Poor survivability	0+00 to 5+60
VPA16	Poor survivability	3+20
VPA17	Poor survivability	7+00

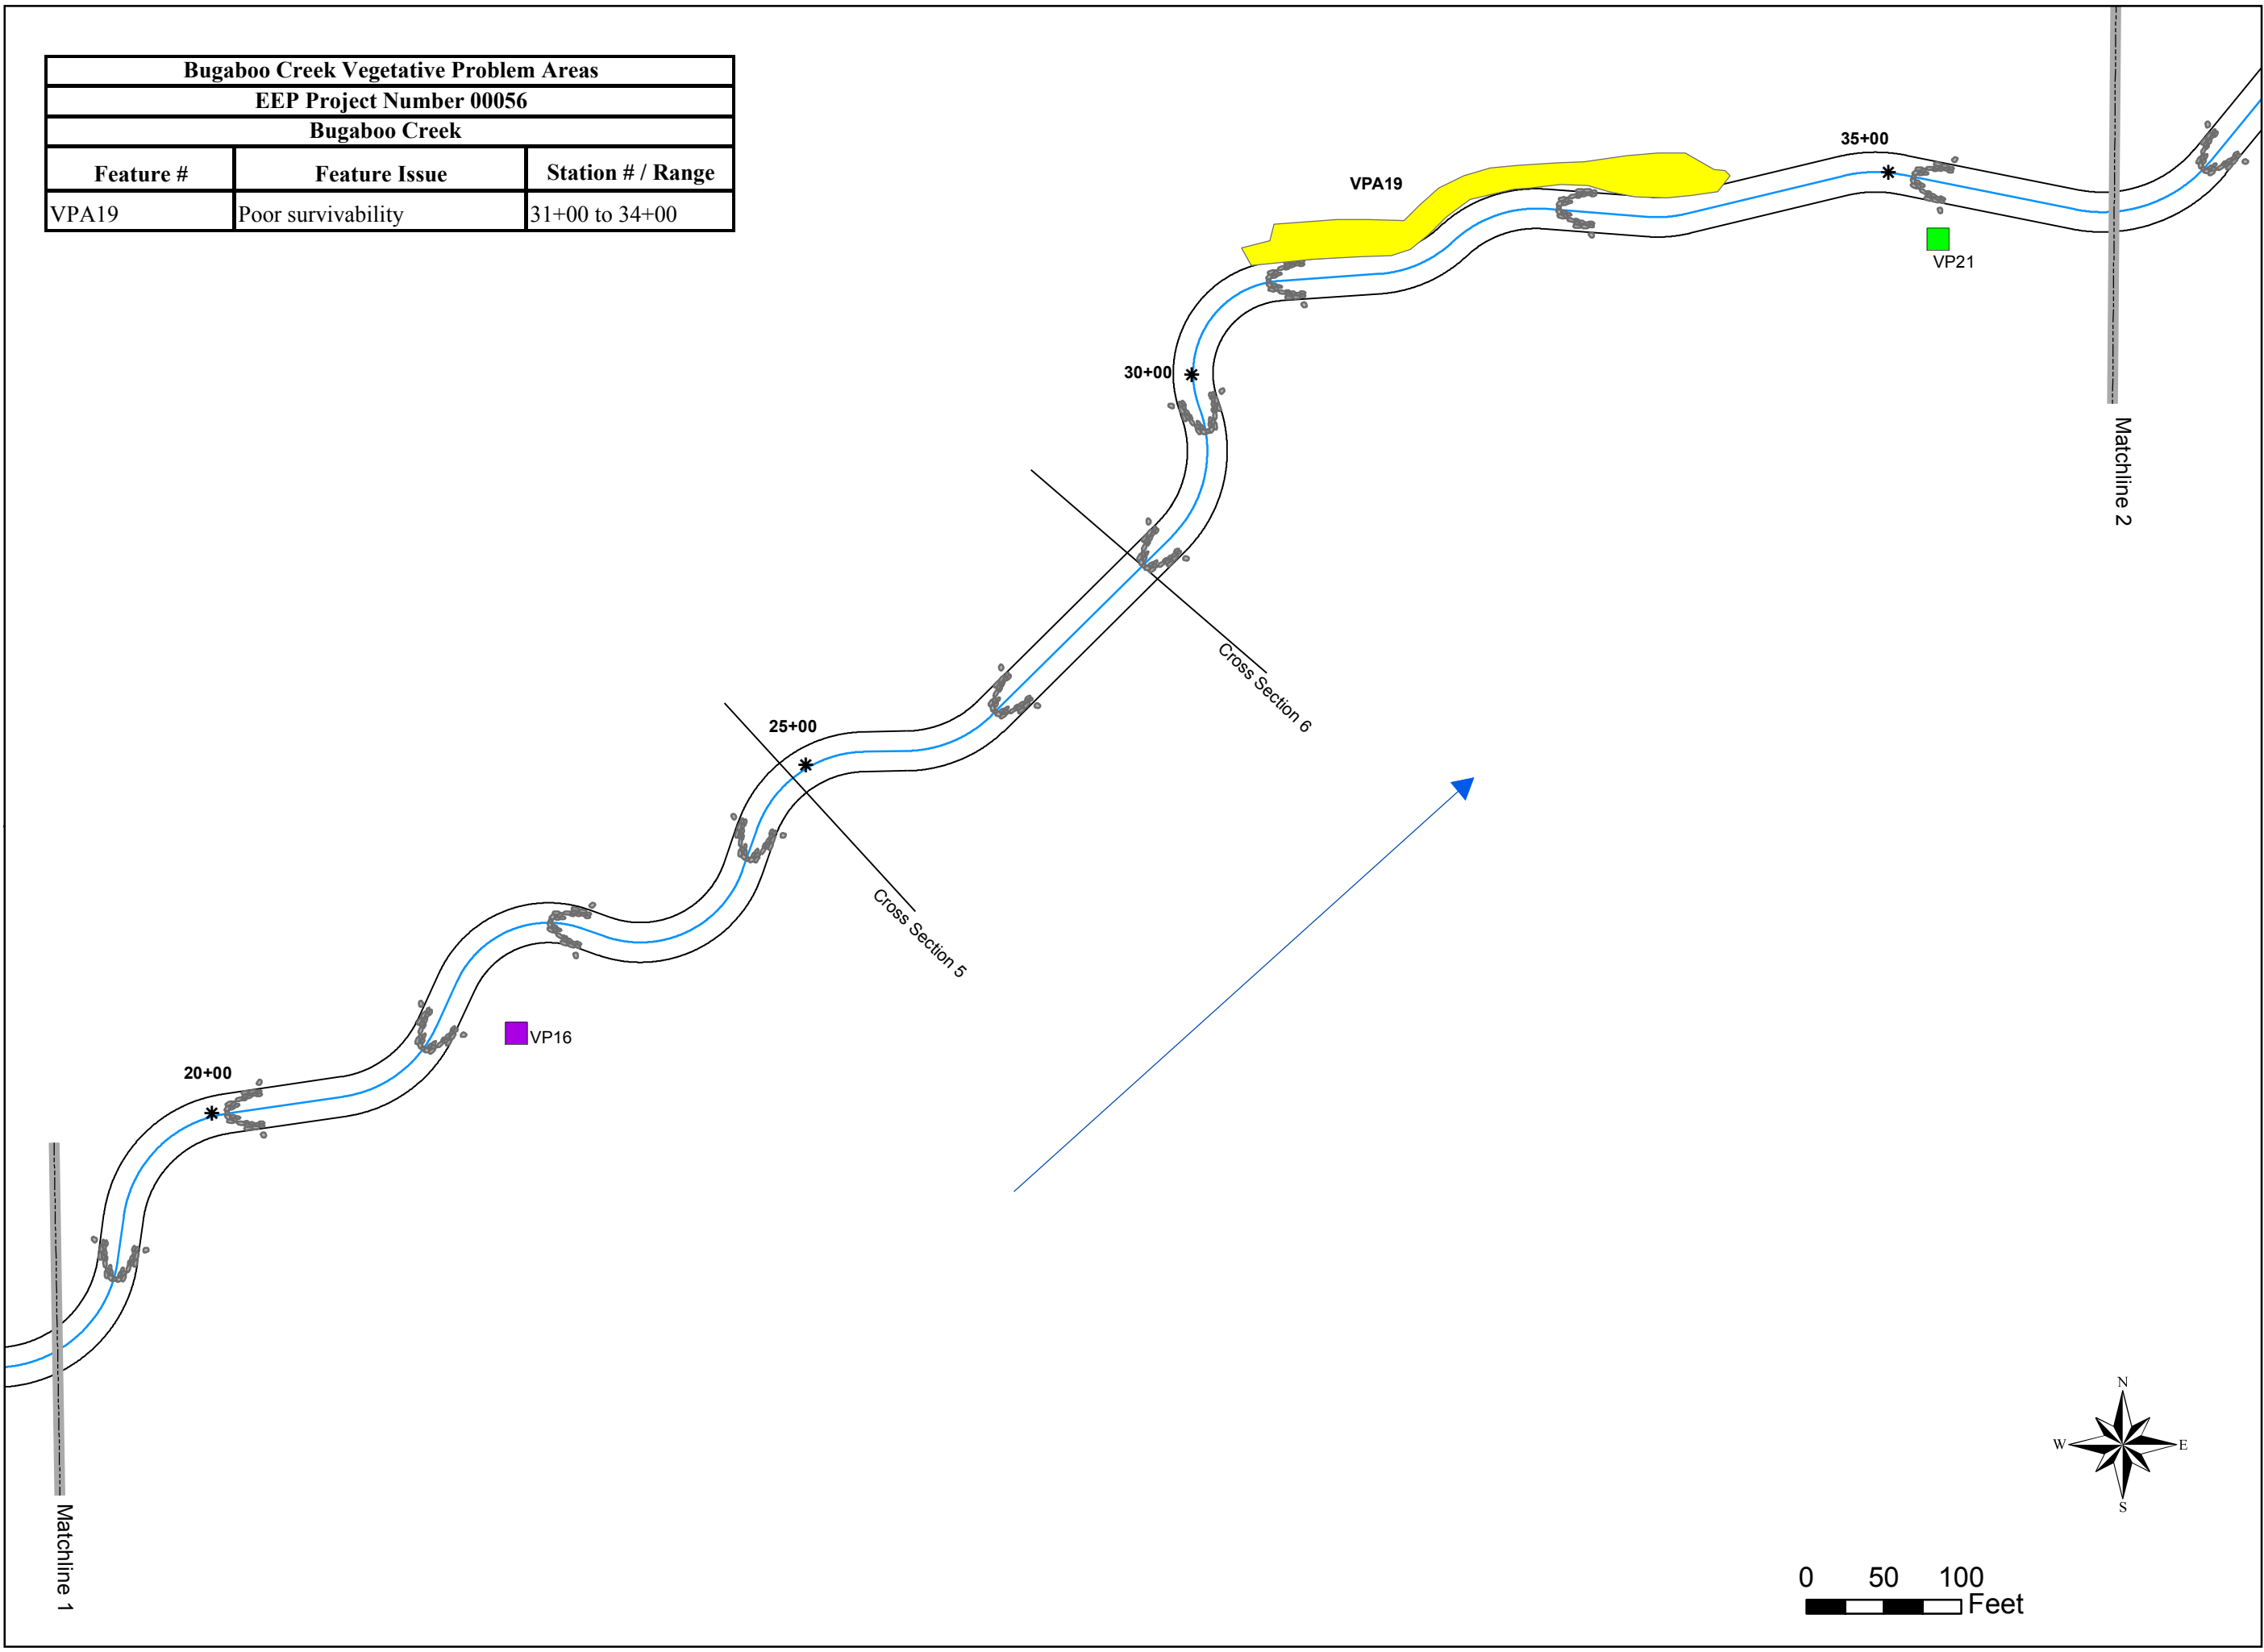
**Vegetation
 Current Condition
 Plan View**

Bugaboo Creek Vegetative Problem Areas		
EEP Project Number 00056		
Bugaboo Creek		
Feature #	Feature Issue	Station # / Range
VPA19	Poor survivability	31+00 to 34+00
