**Bugaboo Creek Stream Restoration
2009 Final Monitoring Report
Monitoring Year Five**

Ecosystem Enhancement Program Project Number 00056

Submitted: April 23, 2010

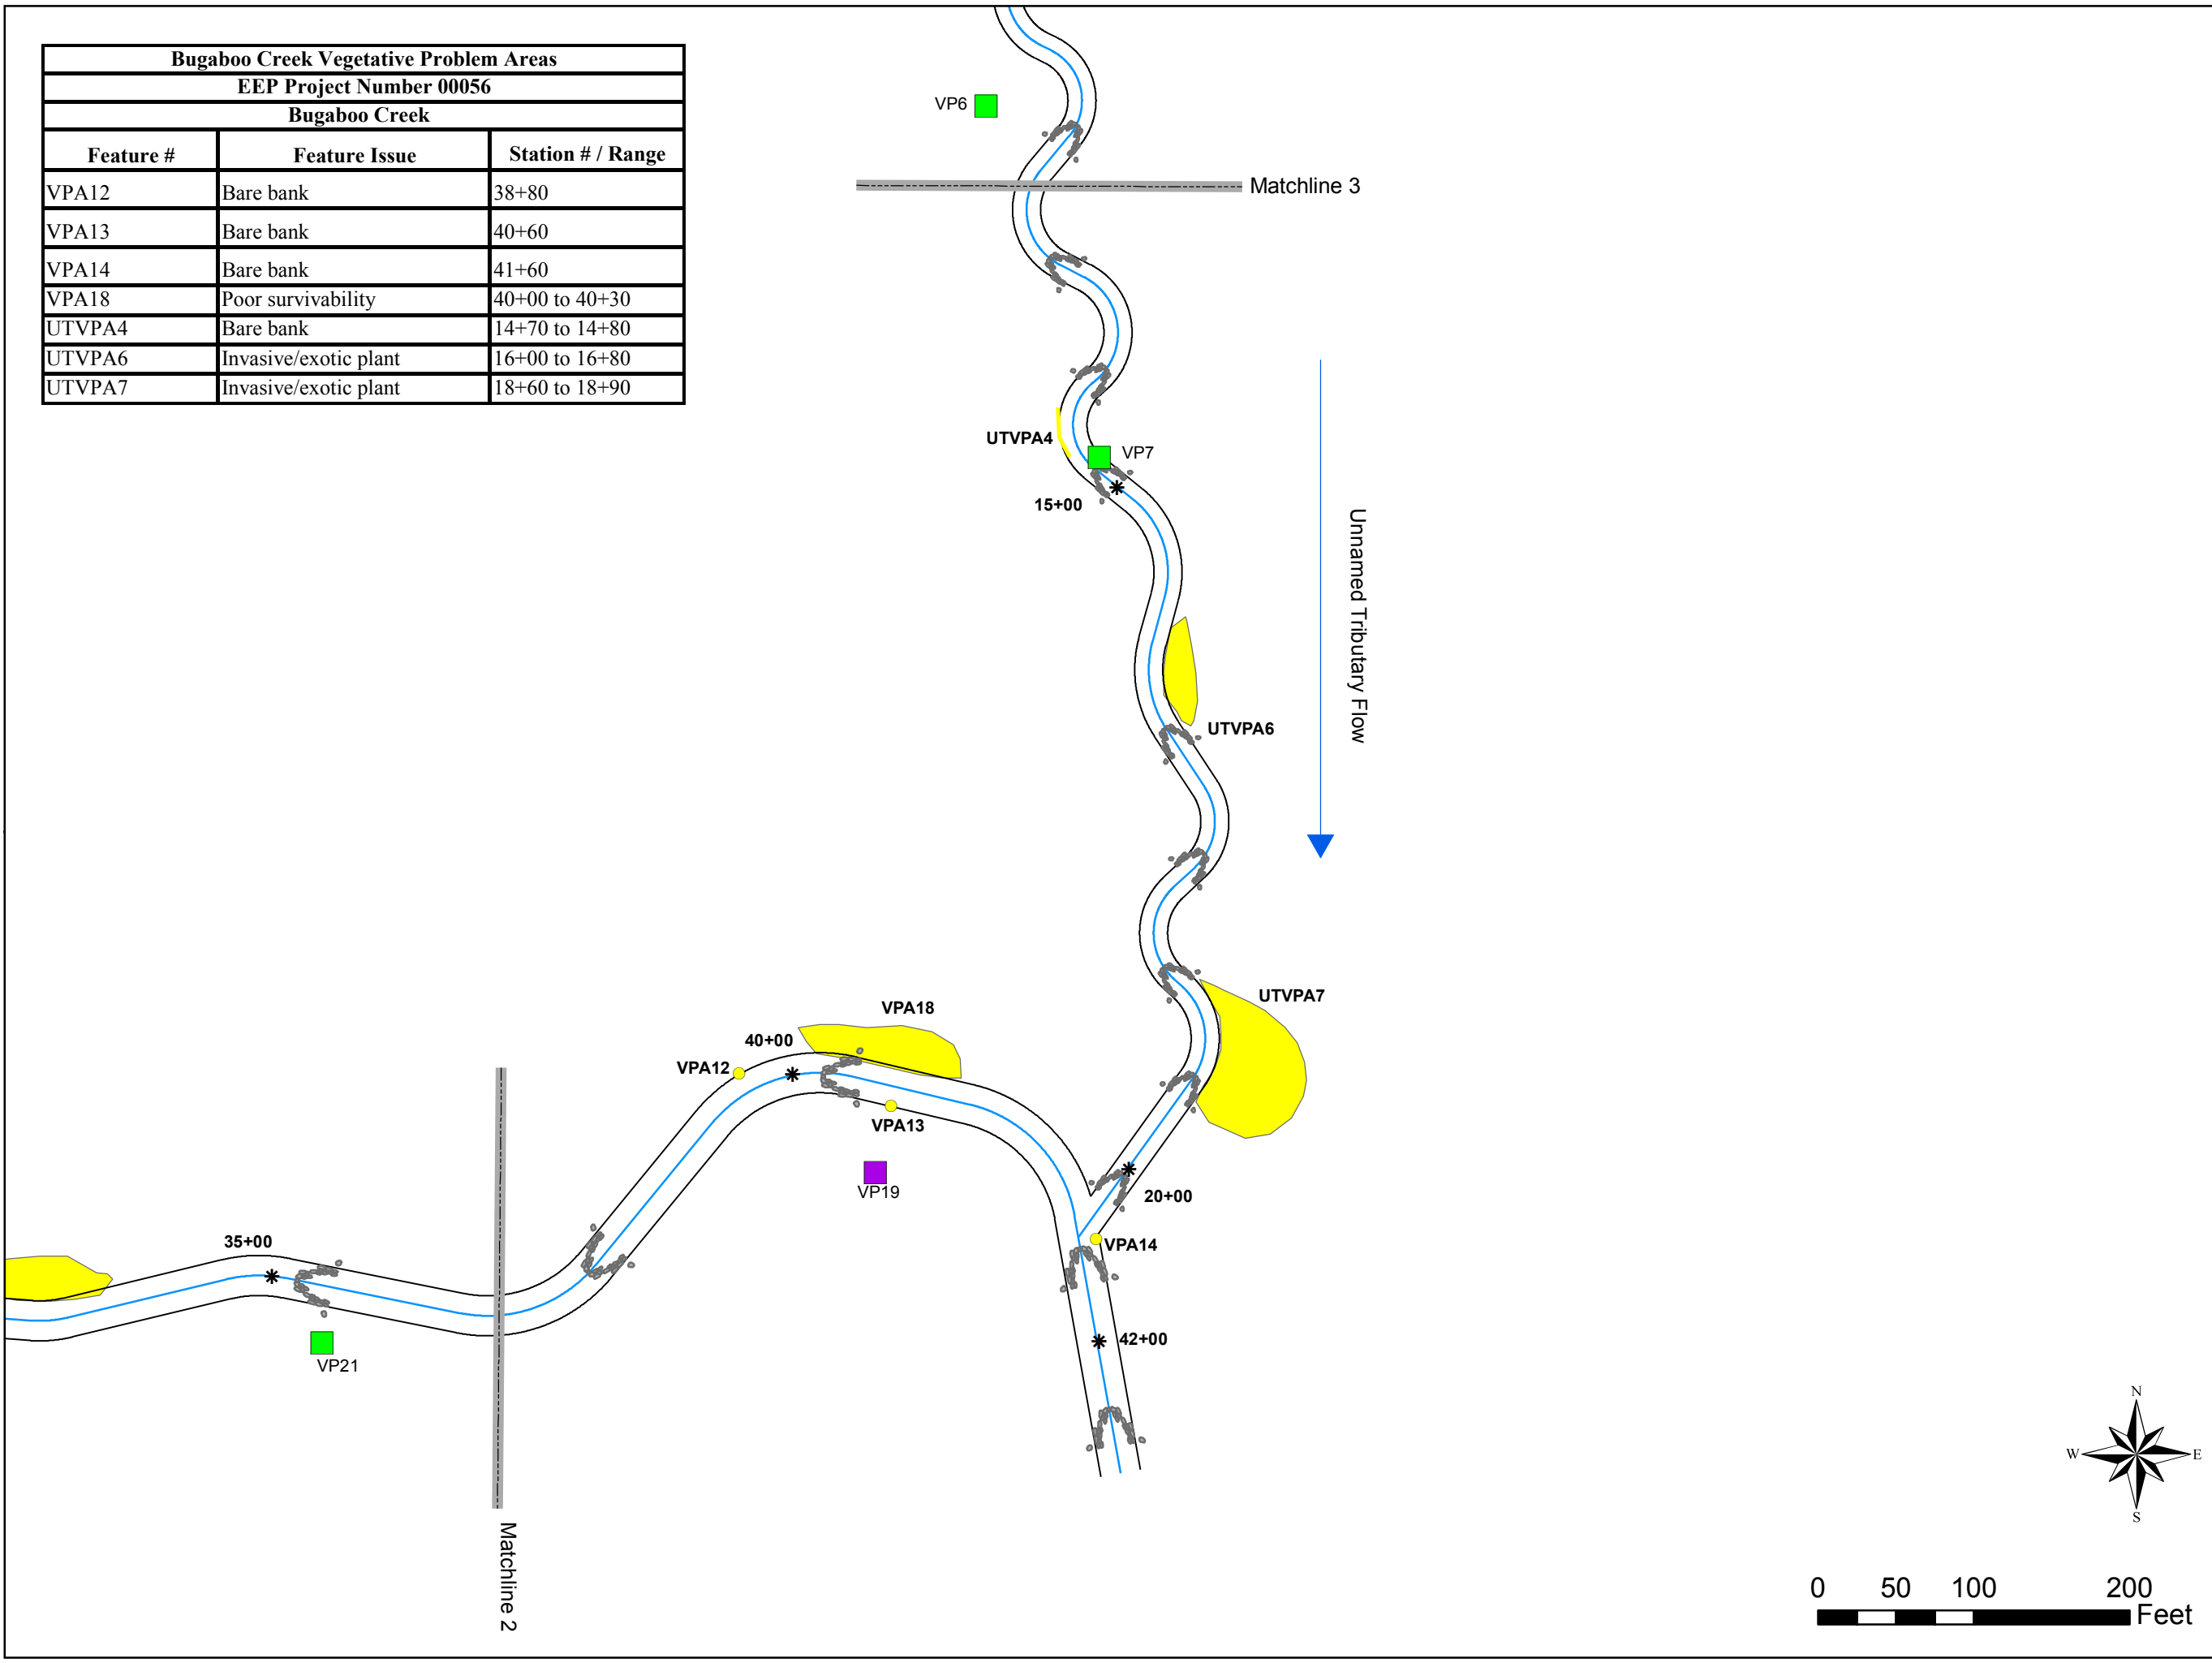
Vegetation
 Current Condition
 Plan View

Bugaboo Creek Vegetative Problem Areas		
EEP Project Number 00056		
Bugaboo Creek		
Feature #	Feature Issue	Station # / Range
VPA12	Bare bank	38+80
VPA13	Bare bank	40+60
VPA14	Bare bank	41+60
VPA18	Poor survivability	40+00 to 40+30
UTVPA4	Bare bank	14+70 to 14+80
UTVPA6	Invasive/exotic plant	16+00 to 16+80
UTVPA7	Invasive/exotic plant	18+60 to 18+90

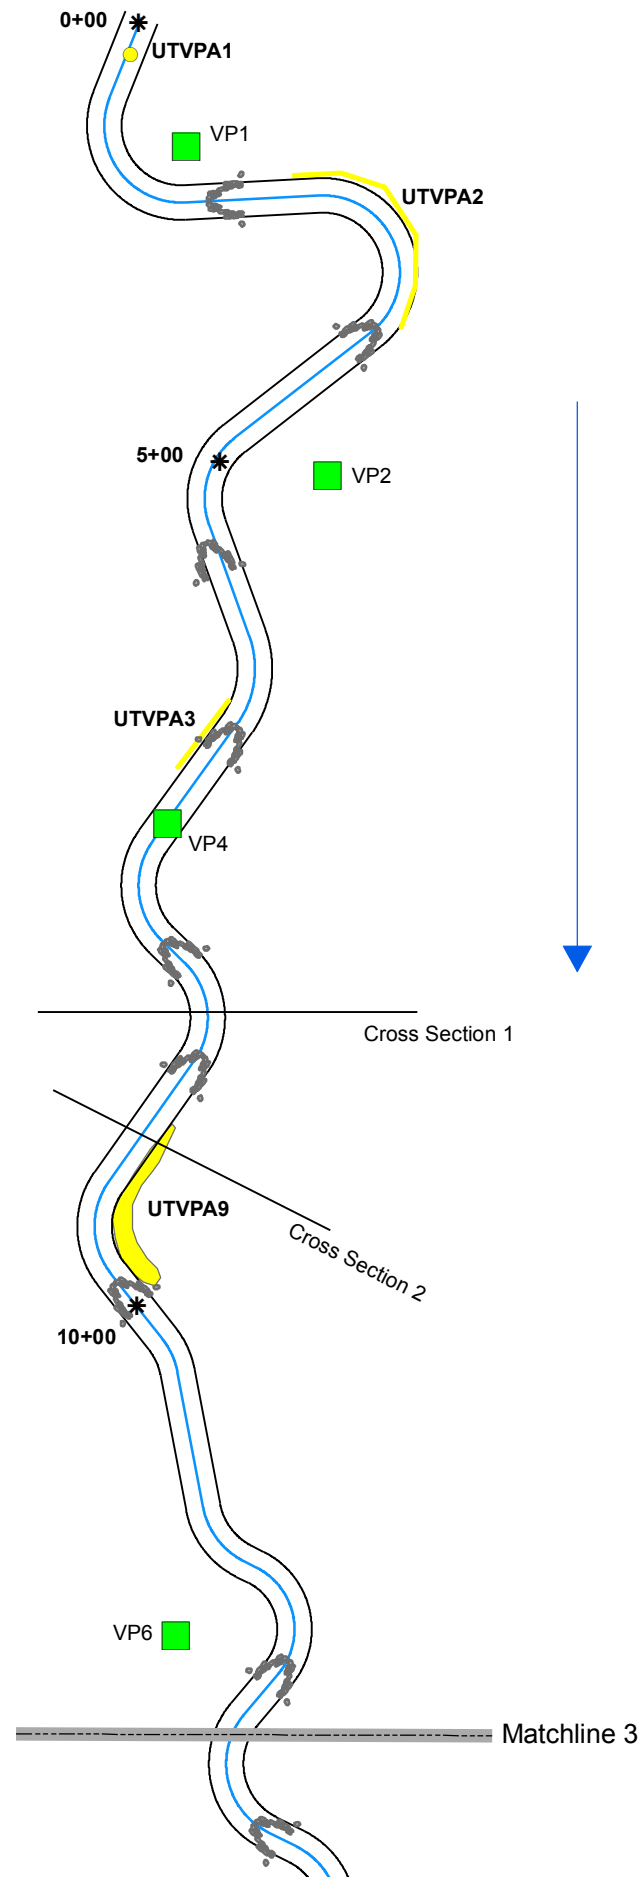
Vegetation
 Current Condition
 Plan View

Bugaboo Creek Vegetative Problem Areas		
EEP Project Number 00056		
Bugaboo Creek		
Feature #	Feature Issue	Station # / Range
UTVPA1	Bare bank	0+15
UTVPA2	Bare bank	1+90 to 3+10
UTVPA3	Bare bank	7+20 to 7+40
UTVPA9	Invasive/exotic plant	8+90 to 9+40

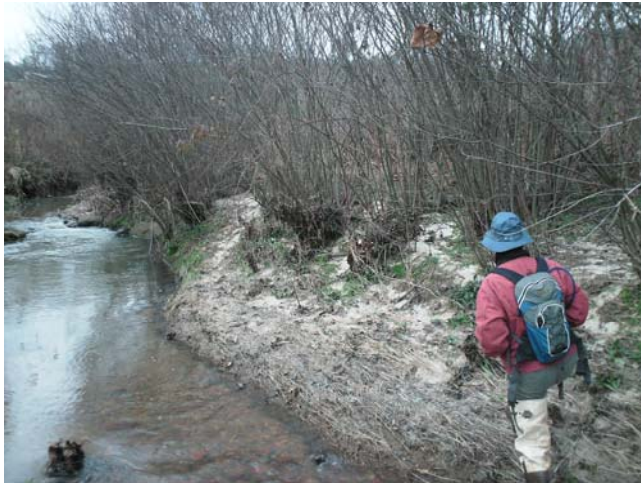
12/2009 Wrack lines at and above bankfull

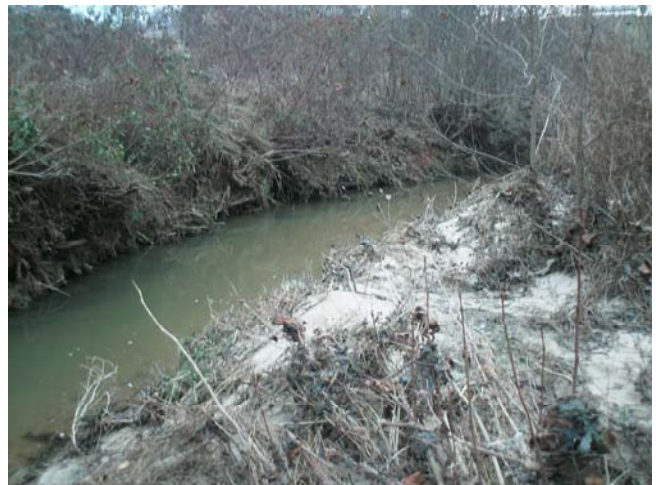
12/2009 Wrack lines at and above bankfull

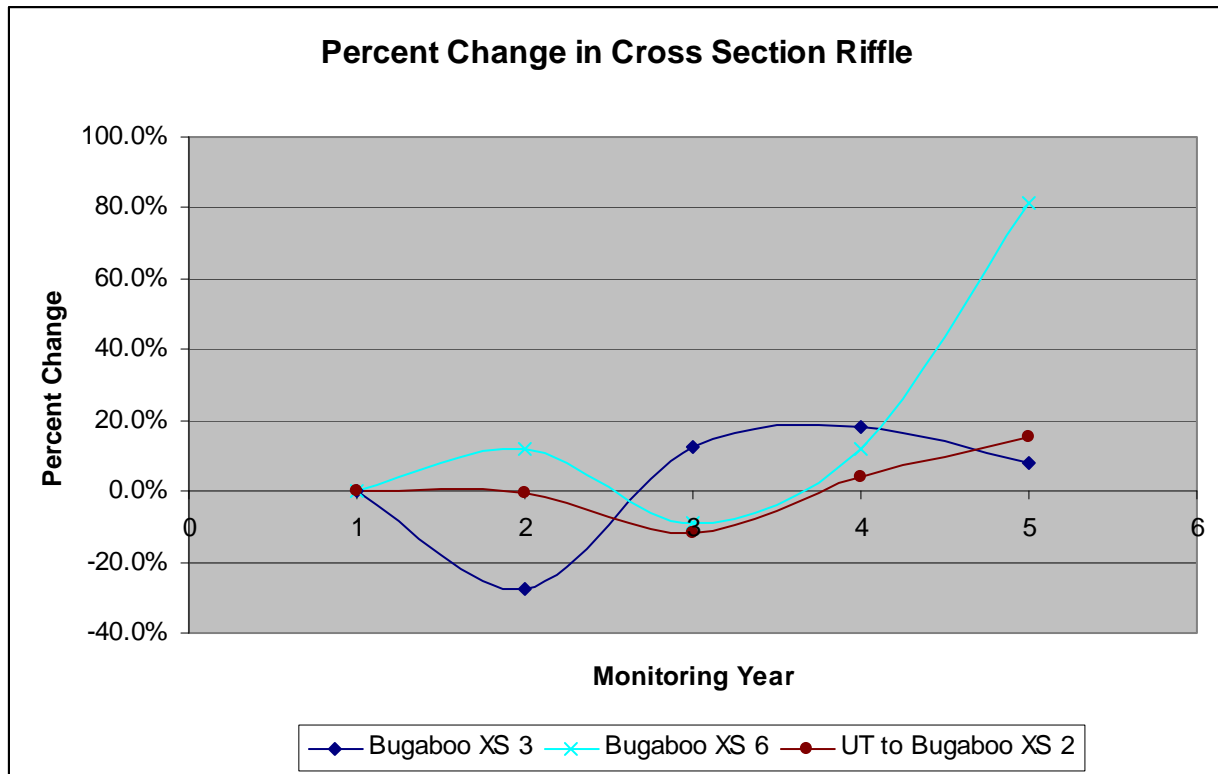
Figure 5: Percent Change in Cross Section Riffle

Figure 5 summaries the percent changes in each riffle cross section monitored. The peaks and valleys beginning to reduce in size by monitoring year (remaining closer to zero) reveals a stabilizing trend as shown in two of the riffle cross sections on-site.

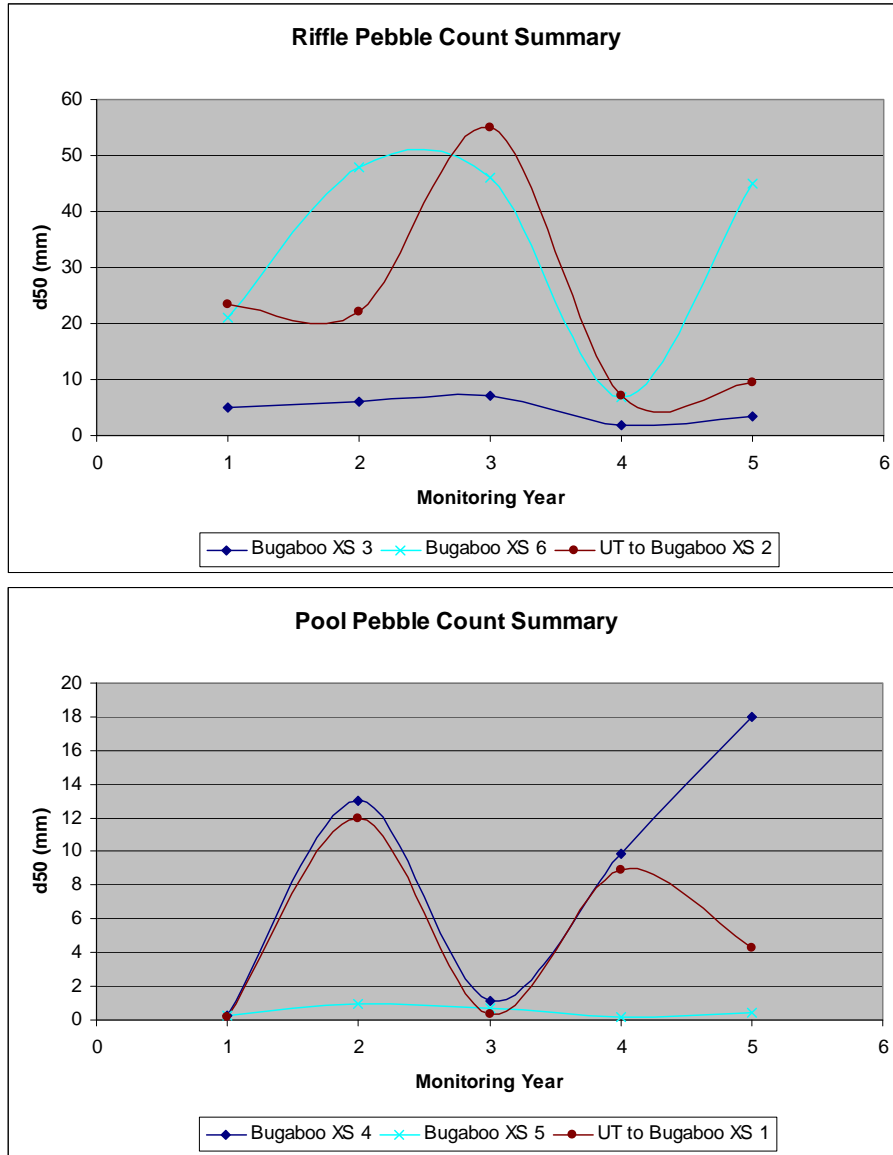
Figure 6: Pebble Count Summaries

In a riffle cross section, a stable system is indicated by a d50 maintaining or increasing. Maintaining a d50 indicates the riffles are not filling with sediment and pools are not moving into the reach. In a pool cross section, the bed material in a stable system typically remains small. Bugaboo’s pebble counts show changes throughout the monitoring years due to the presence and absence of beaver dams. The dams cause water to slow upstream of them, thus fine sediments cover the bed material. As the dams are eradicated, the stream has the ability to transport the sediment load again and the natural bed materials begin to show back up in the pebble counts.
