MONITORING YEAR 2 ANNUAL REPORT

BUG HEADWATERS MITIGATION SITE

Wilkes County, NC
Yadkin River Basin
HUC 03040101

DMS Project No. 100084
DMS RFP No. 16-007406 / Date of Issue: December 17,
2017
NCDEQ Contract No. 7617
USACE Action ID No. 2018-01788
DWR Project No. 2018-1273

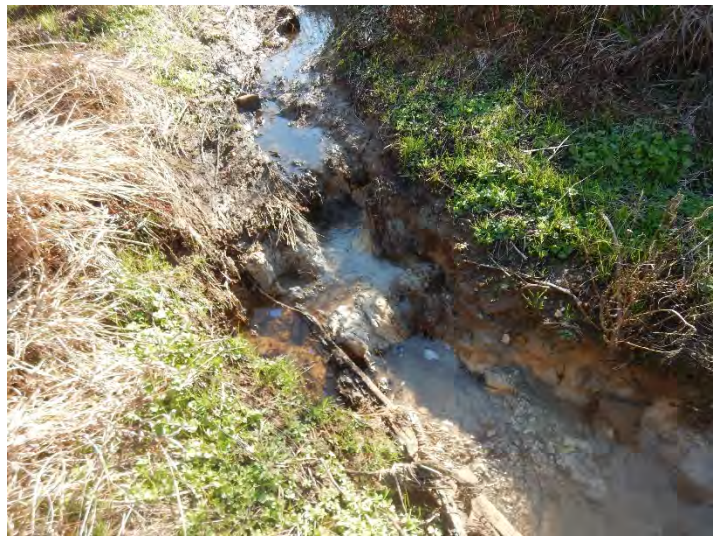
There is 28 linear feet of incision that happened over the course of the year along the Enhancement II section of UT2A Reach 1. This is only 2% of the stream channels along UT2A and 0.3% of the stream channels across the Site. This particular area was left untouched during construction but will most likely be mechanically repaired while equipment is on Site. Refer to Figure 1a and Appendix A for a photo log.

Before – Localized Incision (11/17/2022)

along Big Bugaboo Reach 4. Since equipment will already be on Site, Wildlands will repair 28 linear feet of incision along an Enhancement II section of UT2A Reach 1. Bankfull events were documented on all stream reaches and greater than 30 days of consecutive flow was recorded on all intermittent reaches, fulfilling MY2 success requirements. Overall, the Site is meeting its goals of preventing excess nutrients and sediment from entering the Yadkin River tributaries and is on track to meet final success criteria.

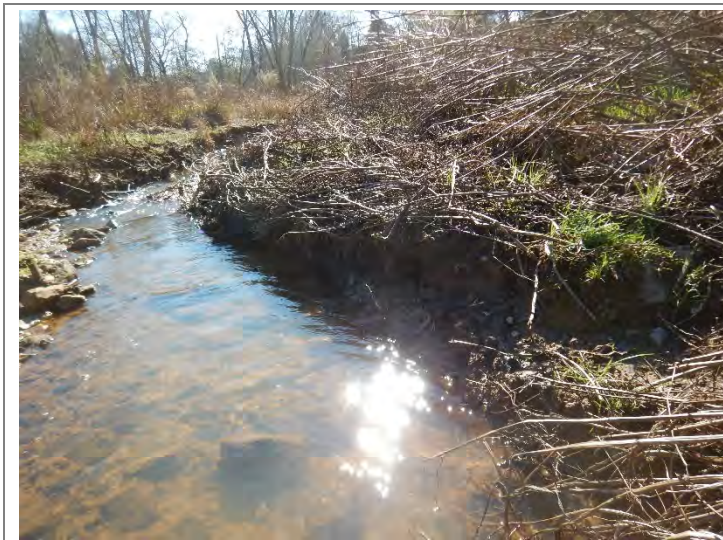
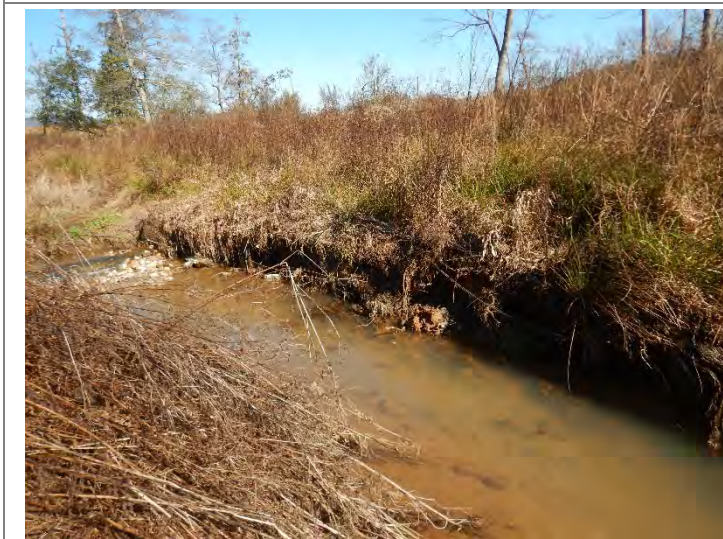
Stream Area of Concern Photographs
Big Bugaboo Creek Reach 4
Station 138+52 – 140+28

Out of the nearly 8,000 linear feet of stream bank along Big Bugaboo Creek, a small, isolated section of 176 linear feet is experiencing toe erosion along the Enhancement I section of Big Bugaboo Reach 4. Cross-section 9 survey gives a snapshot of the toe erosion along Big Bugaboo Creek Reach 4. This is only 2.2% of the stream banks along Big Bugaboo Creek and 1.0% of stream banks across the Site. The cause of the bank erosion is a combination of minimal vegetation due to collateral damage from the *Murdannia keisak* treatment, frequent high velocity flow events over the course of the year, and one log sill eroding around the side. Rainfall was above average for the second half of the year, which along with a lack of vegetative stream banks after *Murdannia keisak* treatment, contributed to erosion. Mechanical equipment will most likely need to be used to repair this Enhancement I section of stream during MY3. Refer to Figure 1c and Appendix A for a photo log.

Before – Localized Toe Erosion (11/17/2022)

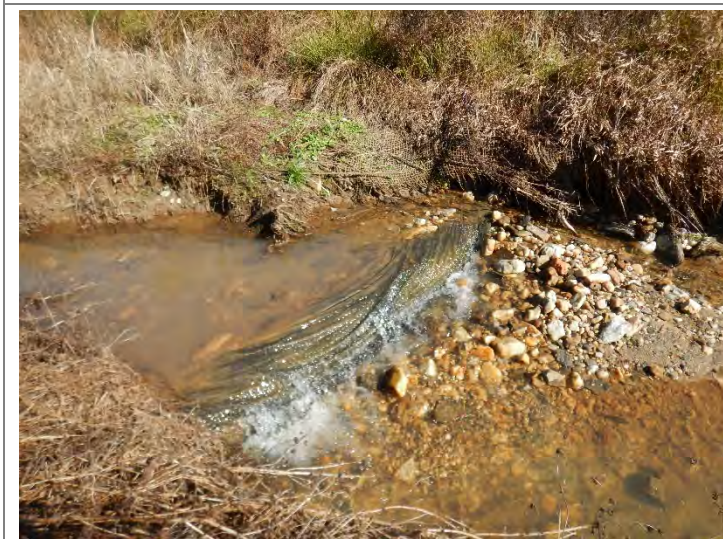
Before – Eroded Log Sill at STA 139+59 (11/17/2022)
