# MY1 (2022) FINAL MONITORING REPORT

## Bull Chute Stream and Riparian Wetland Mitigation Site

Randolph County, NC  
Yadkin River Basin  
Cataloging Unit 03040103

DMS Project ID No. 100137  
Full Delivery Contract No. 7878-01  
RFP #16-007878 (Issued: 5/6/2019)  
USACE Action ID No. SAW-2020-00049  
DWR Project No. 20200021

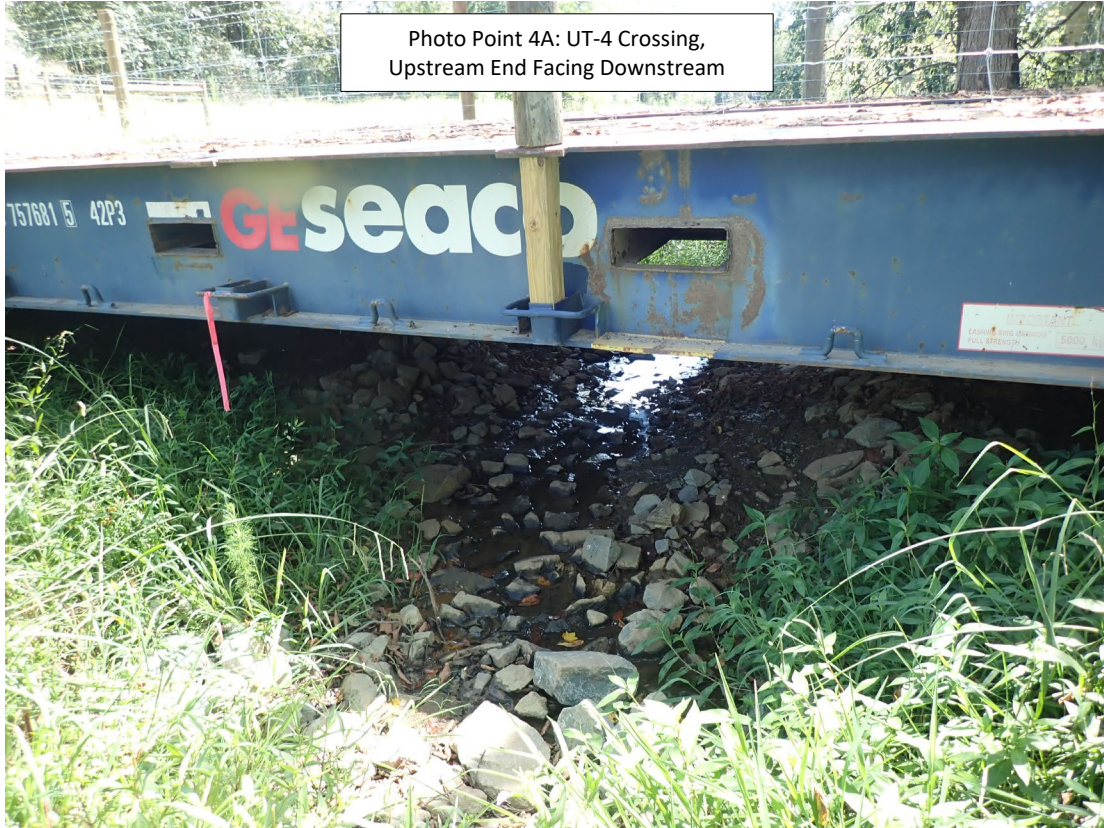
Photo Point 4A: UT-4 Crossing,  
Upstream End Facing Downstream

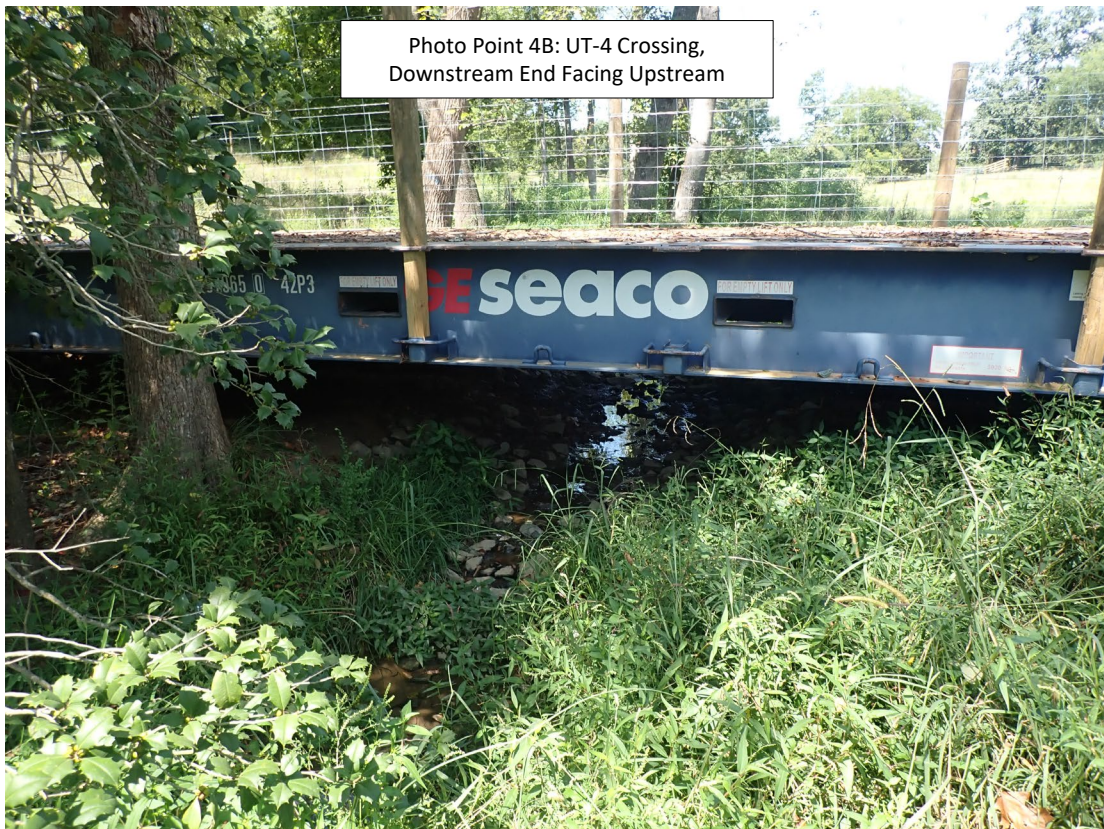
Photo Point 4B: UT-4 Crossing,  
Downstream End Facing Upstream

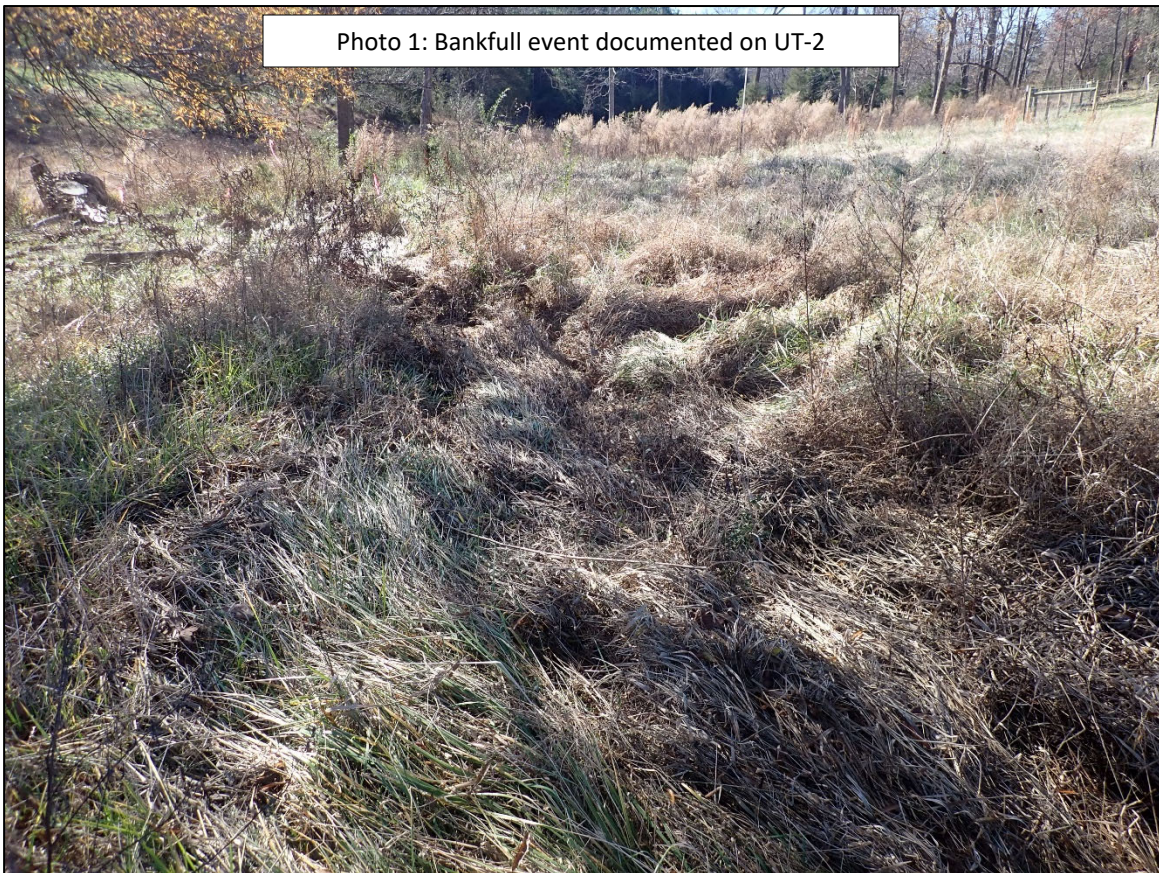
Photo 1: Bankfull event documented on UT-2

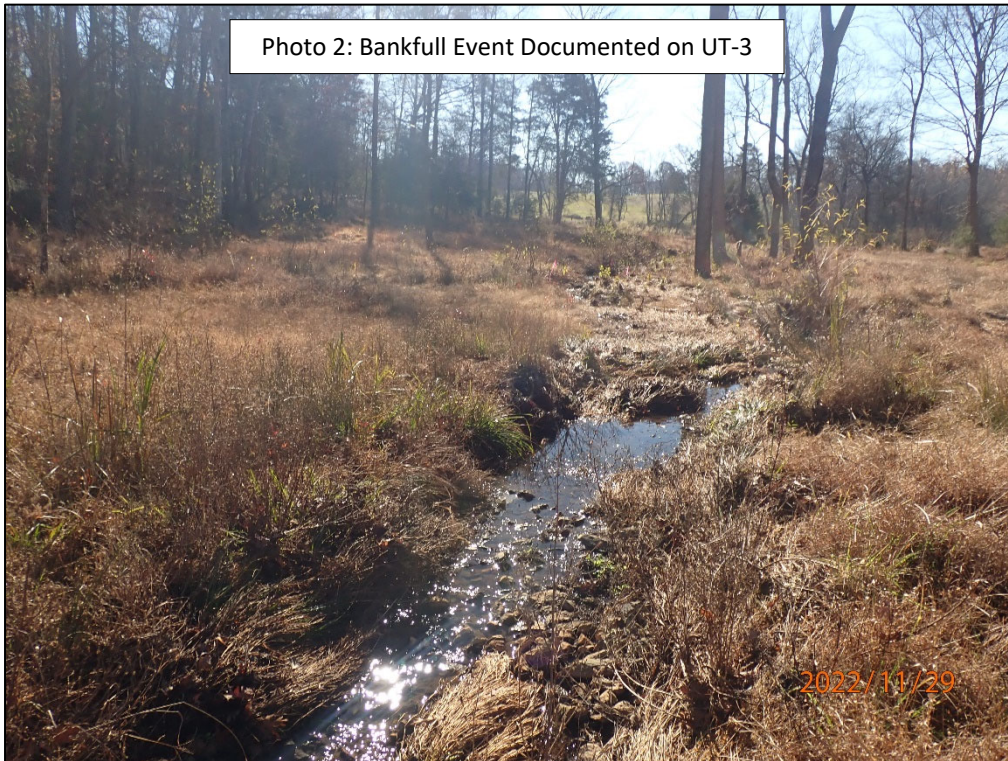
Photo 2: Bankfull Event Documented on UT-3

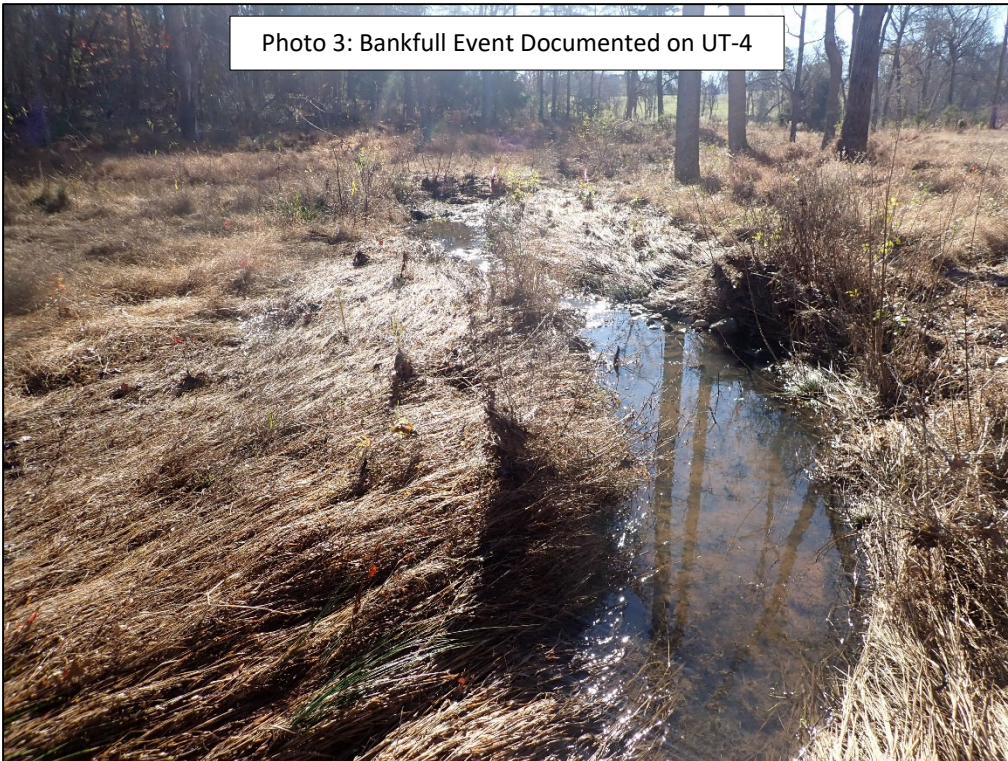
Photo 3: Bankfull Event Documented on UT-4

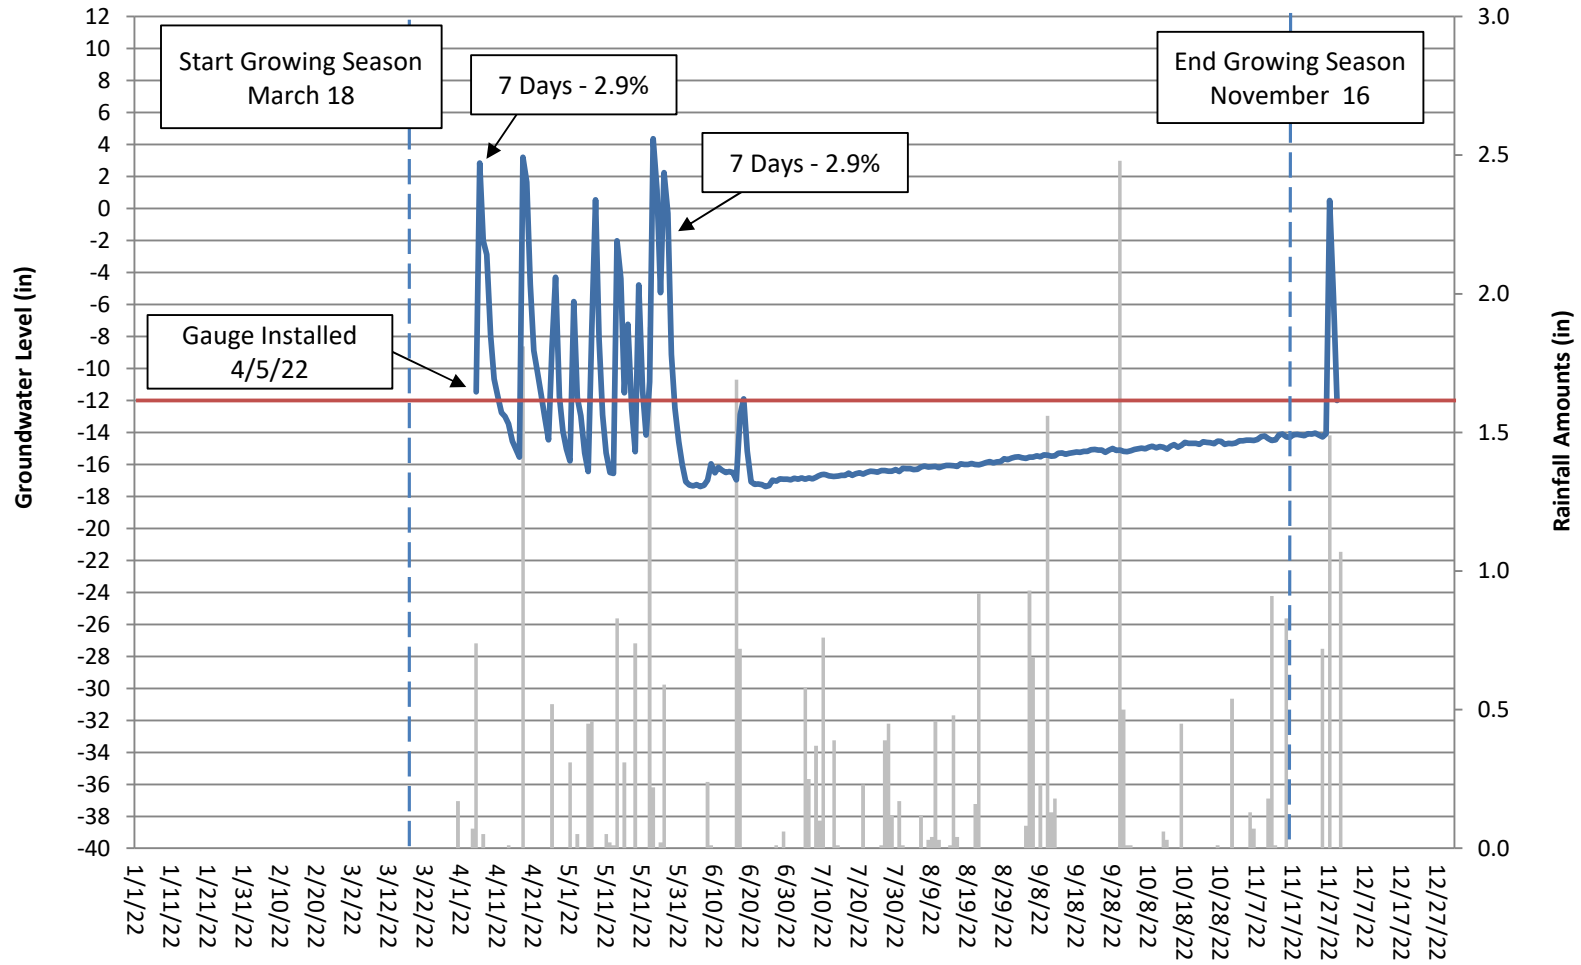
# Bull Chute Groundwater Gauge 4 Year 1 (2022 Data)

- Groundwater Gauge 4 Graph: Suggest revising Graph 4, the label of '7 days' is confusing in that it indicates a time frame greater than 7 days by calling out two 7-day periods. Please revise for clarity.  
[The gauge 4 graph was edited to show two separate callout boxes with two separate arrows. This should clarify that two separate 7-day periods occurred.](#)
