MY2 (2023) FINAL MONITORING REPORT

Bull Chute Stream and Riparian Wetland Mitigation Site

Randolph County, NC
Yadkin River Basin
Cataloging Unit 03040103

DMS Project ID No. 100137
Full Delivery Contract No. 7878-01
RFP #16-007878 (Issued: 5/6/2019)
USACE Action ID No. SAW-2020-00049
DWR Project No. 20200021

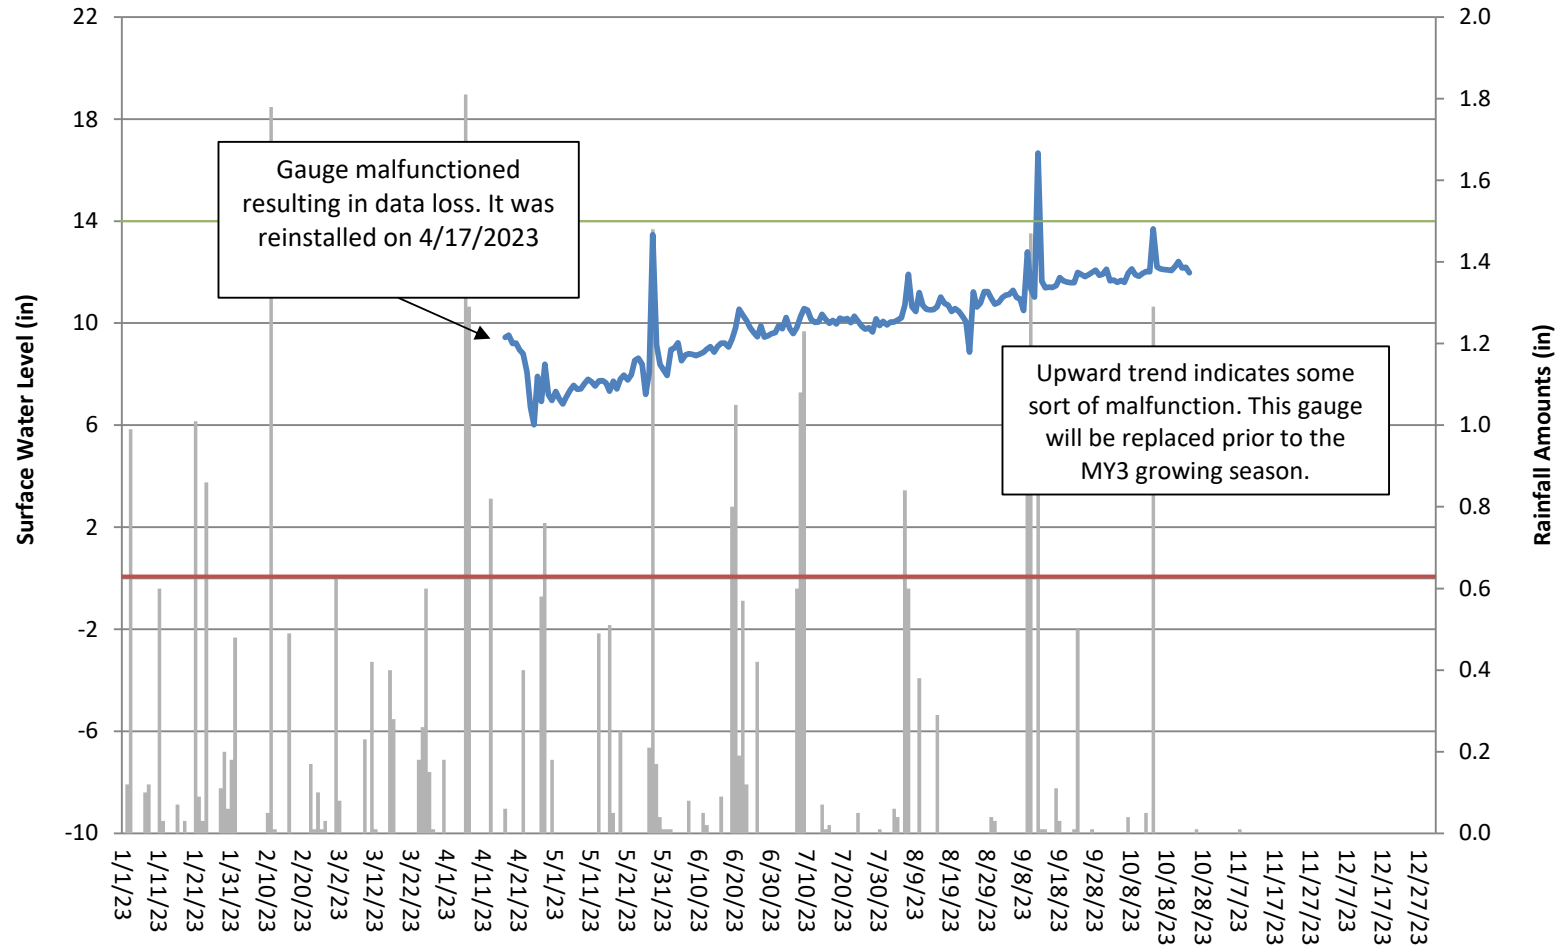
Bull Chute UT4 Crest Gauge Year 2 (2023 Data)

UT4 crest gauge data was initially collected for MY2 on April 17, 2023, however a shuttle failure occurred, resulting in the loss of data up to this date. The gauge remained in working order thereafter, but over the course of year 2 (2023) monitoring, the crest gauge showed a continued upward trend in water level. This looks significantly different than the overall trend of other crest gauges and seems indicative of a pressure sensor malfunction. The gauge will be replaced early in the MY3 monitoring year to ensure accurate documentation of MY3 bankfull events on this reach.

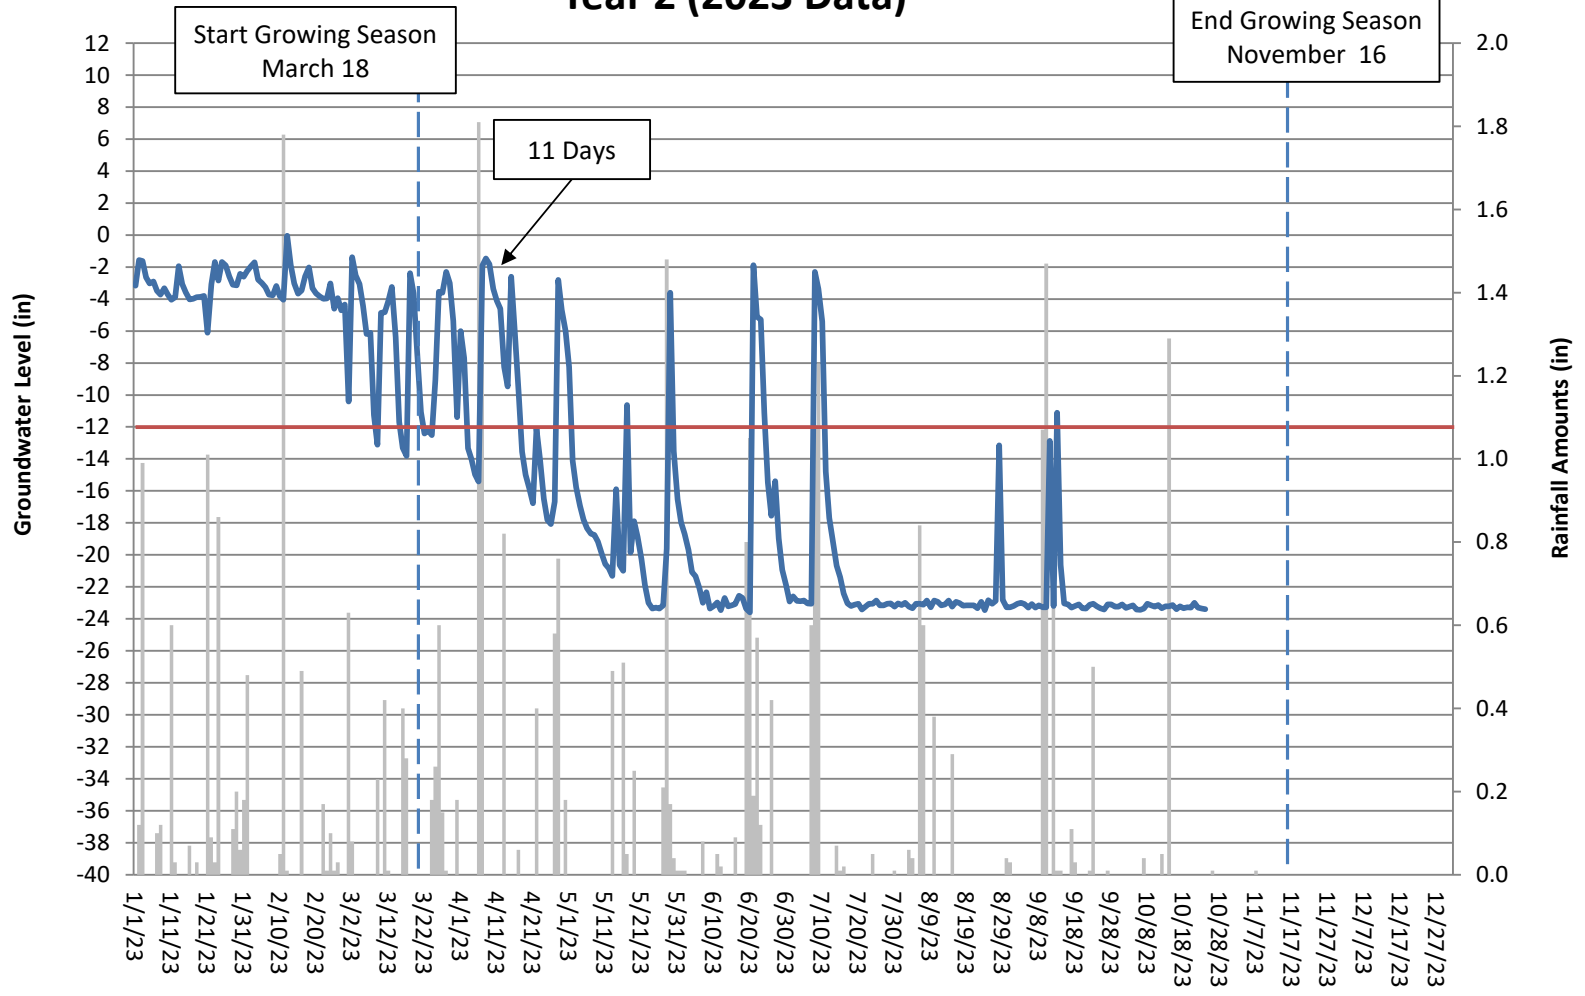
Bull Chute Groundwater Gauge 3 Year 2 (2023 Data)

- 5) 3.2 Hydrology Assessment: Recommend revising discussion regarding Gauge 3 in this section. The hydrology data submitted with the draft report shows that Gauge 3 dropped below 12" for 14 days in April. The report indicates there were only 4 days below in April. I recognize that there was a 4 day period in April (4/3-4/6) below 12"

that prevented the success criteria from being met. Revising the discussion for clarity would be helpful.

Re: The discussion of Gauge 3 has been revised to reflect the correct water levels in April.

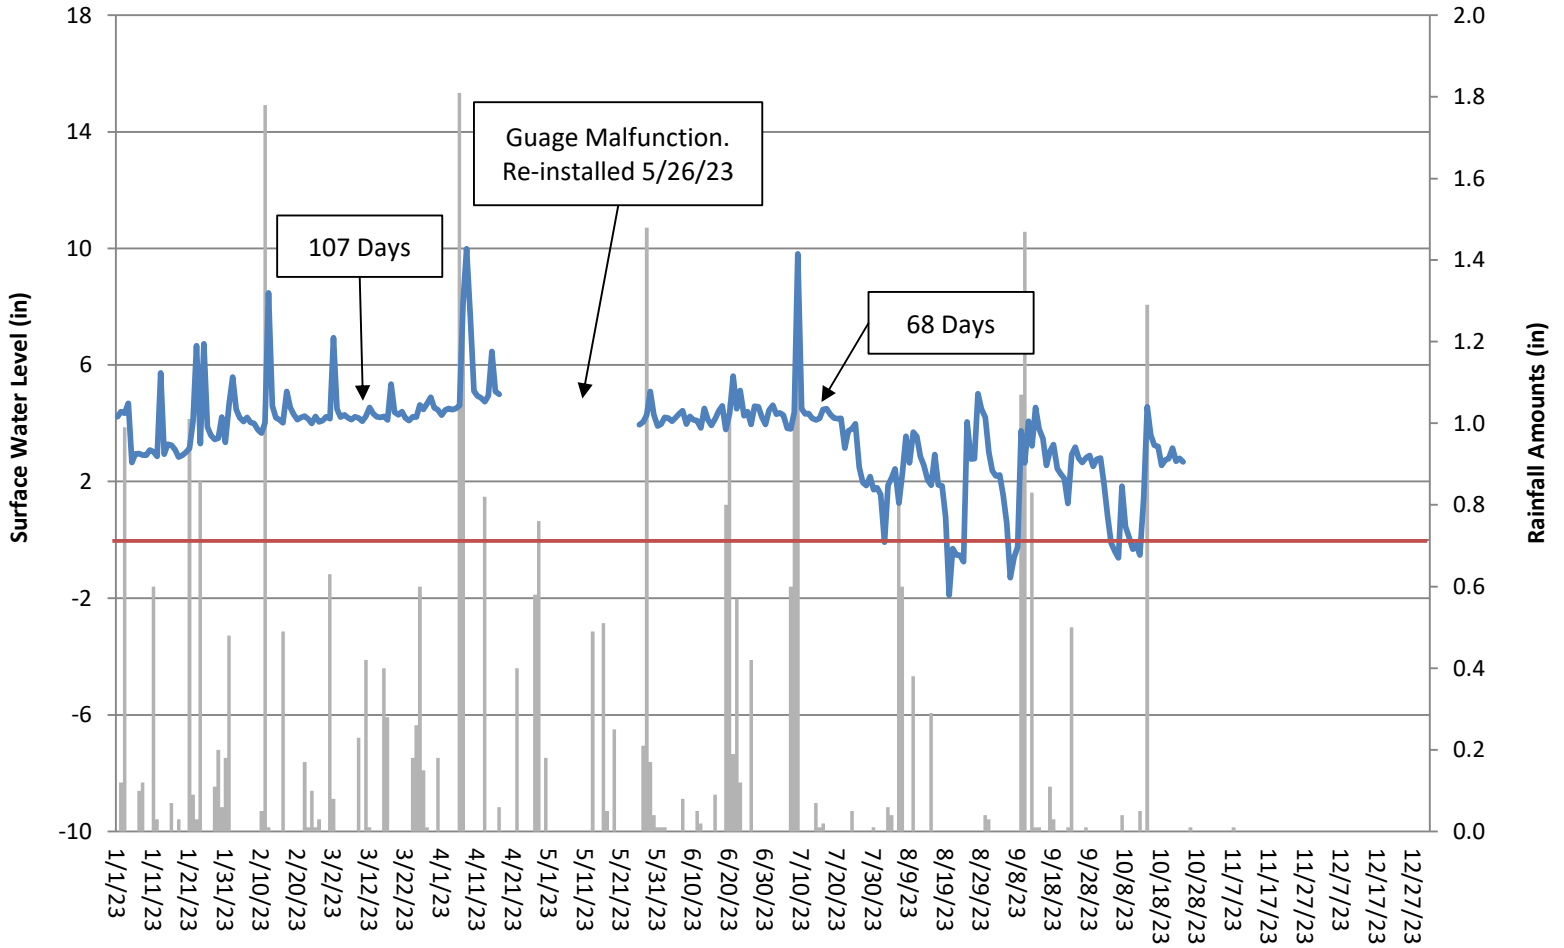
Bull Chute UT3 Flow Gauge Year 2 (2023 Data)

The flow gauge on UT3 malfunctioned starting on April 18, 2023, resulting in a loss of data. The gauge was replaced when this was discovered on May 26, 2023, and the gauge continued working the rest of the year. The flow gauge on UT4A also malfunctioned starting on January 27, 2023, in which water levels were reading sporadically and incorrectly. The gauge was relaunched when the issue was discovered on April 17, 2023, and read properly the rest of the year.
