# **MY4 FINAL MONITORING REPORT**

# **Burnetts Chapel Mitigation Site-Phase II**

DMS Project No. 100045 DMS Contract No. 7430 DMS RFP No. 16-007242 DWR Project Number 2011-0841

Data Collection Period: September 2022 Submission Date: November 2022

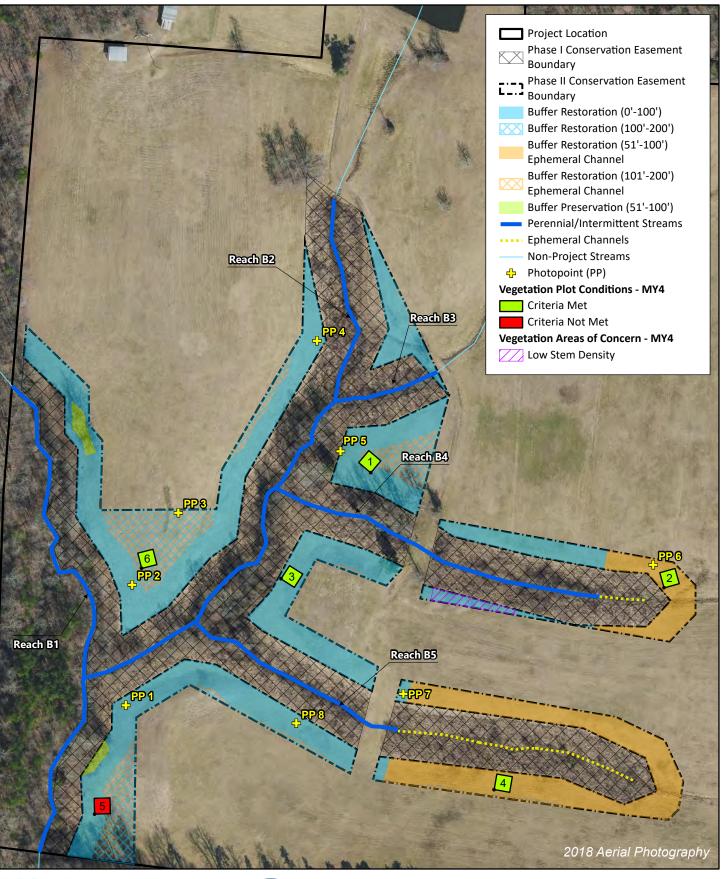
Figure 3 Current Conditions Plan View Burnetts Chapel Mitigation Site - Phase II 2022 Monitoring Report (MY4) Cape Fear River Basin (03030003)

An assessment of the vegetation condition was conducted throughout the site. Similar to last year, there were no bare or encroachment areas, and only 0.1 acres with a low visual stem density. Vegetative areas of concern continue to be minimal and are not negatively affecting the overall vegetative success of the Site. These areas are outlined below, presented in Table 6, and are depicted in Figure 3 of Appendix B.

There is an area of low stem density along Reach B4 that consists of less than 0.1 acres; however, the area's herbaceous cover is dense and thriving. It is likely that this area's stem density will increase throughout the monitoring period by way of resprouts and the continued introduction of volunteer species; therefore, no additional planting is needed at this time. Wildlands will continue to monitor this area for the emergence of woody species.

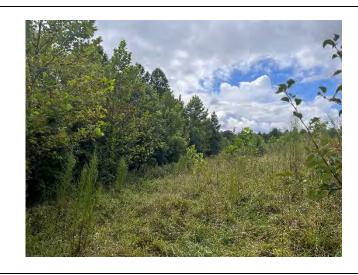
Photo Point 4 – Looking downstream B2 (09/08/2022)

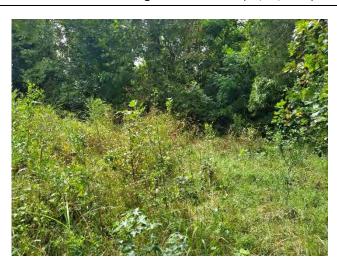
Photo Point 5 – Looking downstream to B2-B4 confluence (09/08/2022)

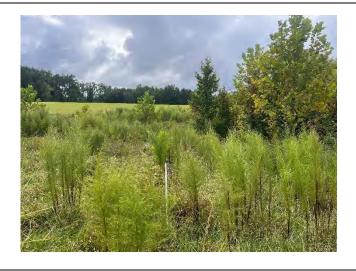
Photo Point 6 – Looking upstream across top of B4 (09/08/2022)

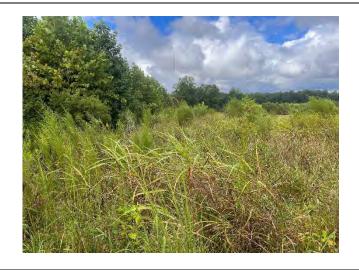
Photo Point 6 – Looking downstream B4 (09/08/2022)

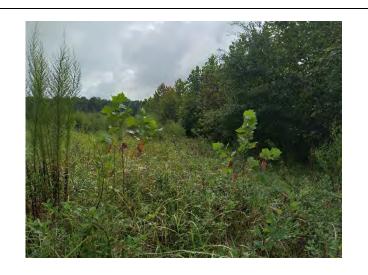
Photo Point 7 – Looking upstream B5 (09/08/2022)

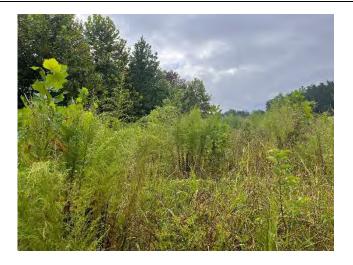
Photo Point 8 – Looking upstream B5 (09/08/2022)

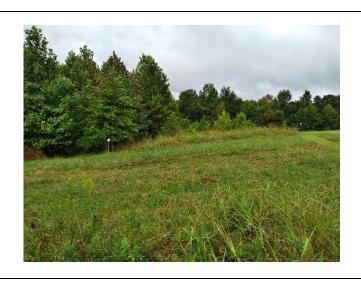
Photo Point 7 – Looking downstream B5 (09/08/2022)

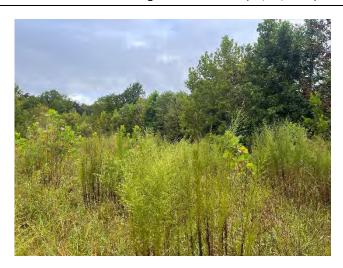
Photo Point 8 – Looking downstream B5 (09/08/2022)
