MONITORING YEAR 1 ANNUAL REPORT

BYRDS CREEK MITIGATION SITE

Person County, NC
DENR Contract 003987
NCEEP Project Number 95020

Data Collection Period: March 2014-September 2014
Draft Submission Date: December 1, 2014
Final Submission Date: December 10, 2014

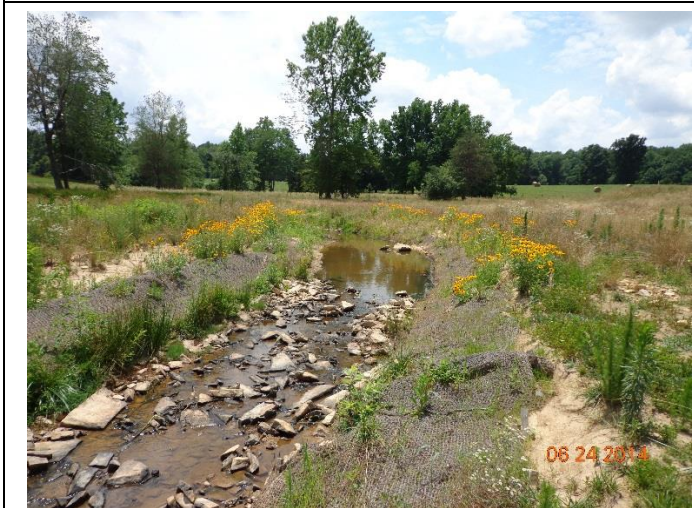
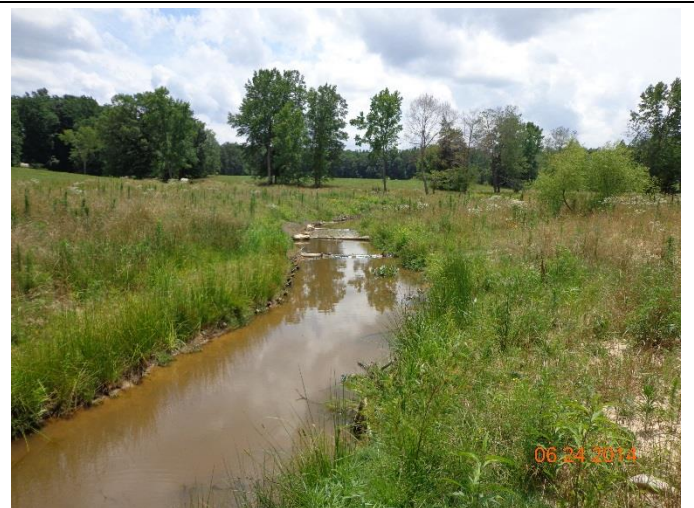
Representative Photos of Matting Repairs and Seeding

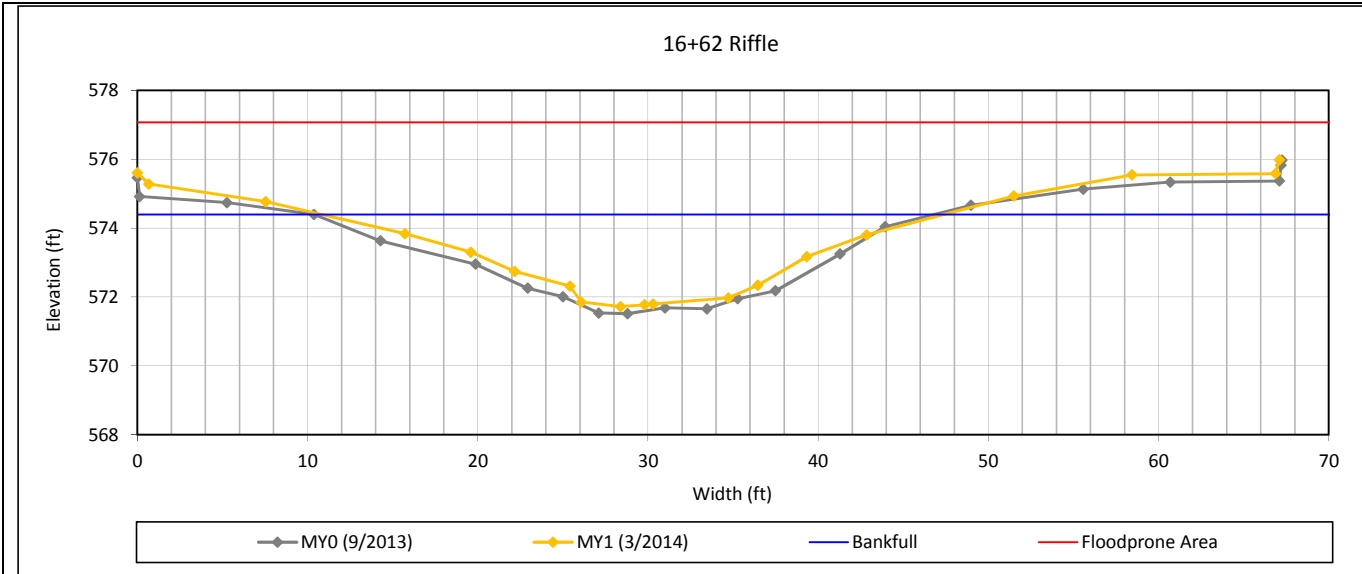
Cross Section 1-BC2

51.1	x-section area (ft.sq.)
36.6	width (ft)
1.4	mean depth (ft)
2.7	max depth (ft)
37.1	wetted parimeter (ft)
1.4	hyd radi (ft)
26.2	width-depth ratio
150.0	W flood prone area (ft)
4.1	entrenchment ratio
1.0	low bank height ratio

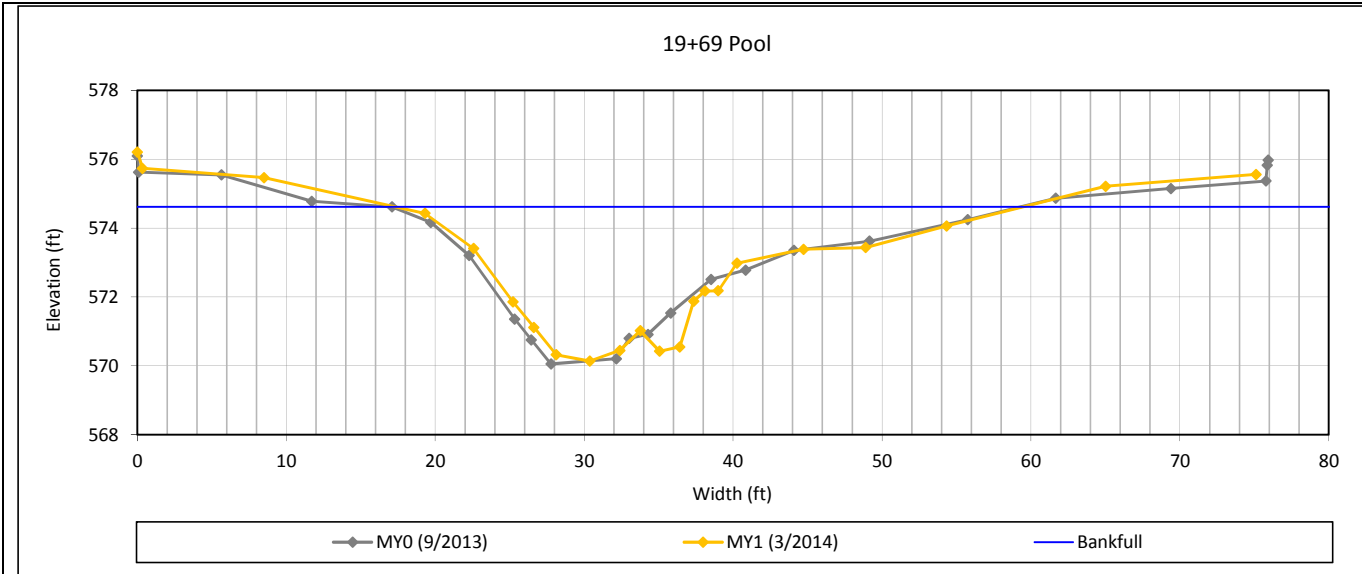
Cross Section 2-BC2

79.9	x-section area (ft.sq.)
42.1	width (ft)
1.9	mean depth (ft)
4.5	max depth (ft)
44.4	wetted perimeter (ft)
1.8	hyd radi (ft)
22.2	width-depth ratio

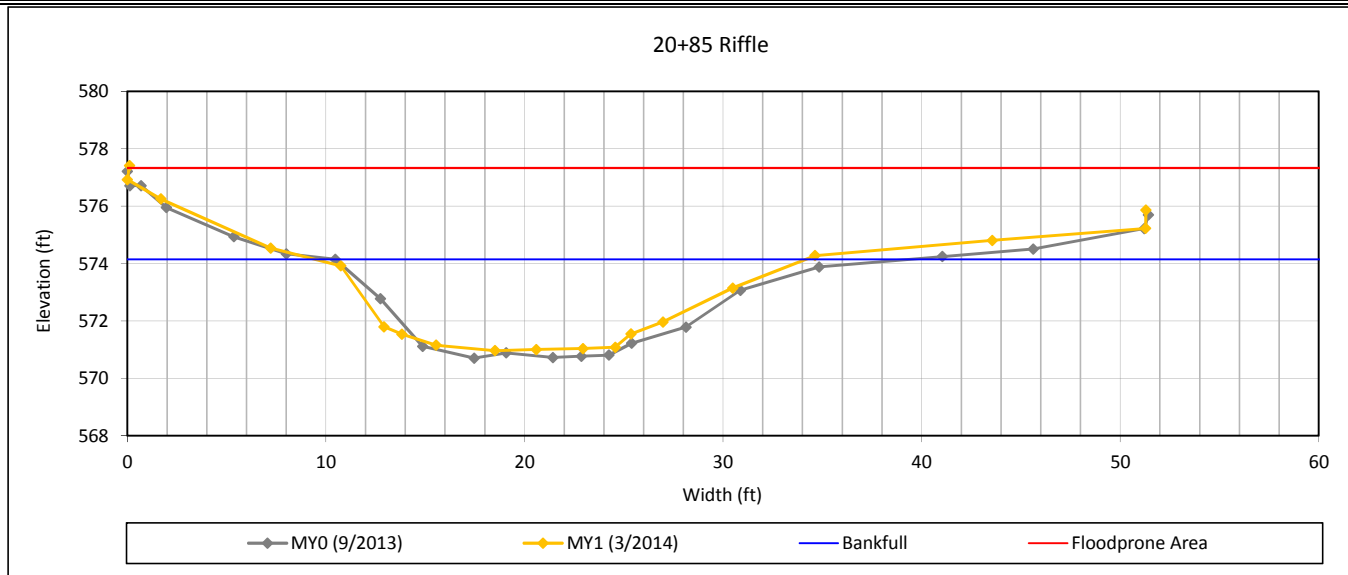
Cross Section 3-BC2

51.6	x-section area (ft.sq.)
24.7	width (ft)
2.1	mean depth (ft)
3.2	max depth (ft)
26.2	wetted parimeter (ft)
2.0	hyd radi (ft)
11.8	width-depth ratio
150.0	W flood prone area (ft)
6.1	entrenchment ratio
1.0	low bank height ratio

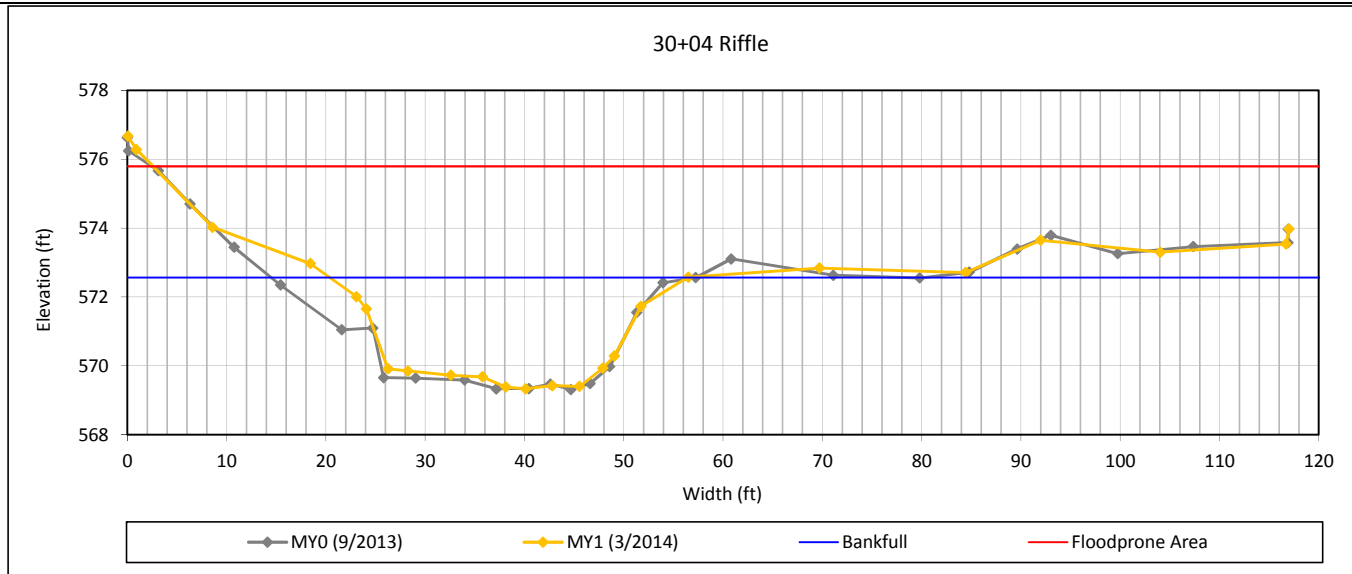
Cross Section 4-BC2

- 78.3 x-section area (ft.sq.)
- 36.0 width (ft)
- 2.2 mean depth (ft)
- 3.2 max depth (ft)
- 37.3 wetted parimeter (ft)
- 2.1 hyd radi (ft)
- 16.6 width-depth ratio
- 150.0 W flood prone area (ft)
- 4.2 entrenchment ratio
- 1.0 low bank height ratio

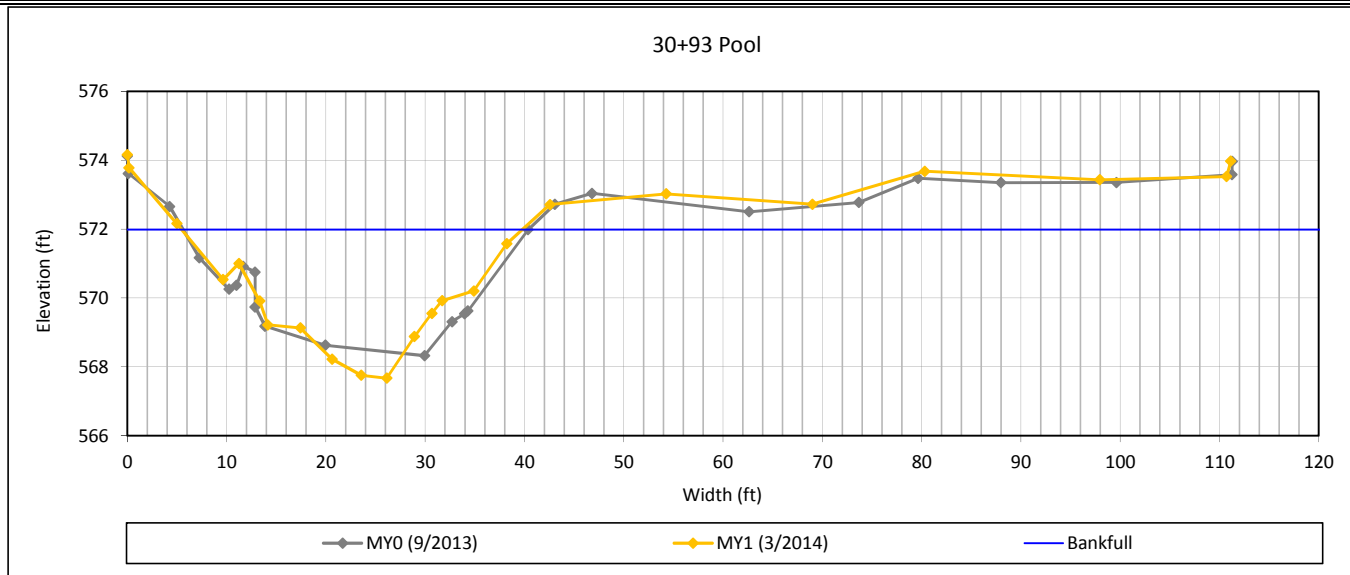
Cross Section 5-BC2

- 80.2 x-section area (ft.sq.)
- 34.3 width (ft)
- 2.3 mean depth (ft)
- 4.3 max depth (ft)
- 36.1 wetted perimeter (ft)
- 2.2 hyd radi (ft)
- 14.7 width-depth ratio

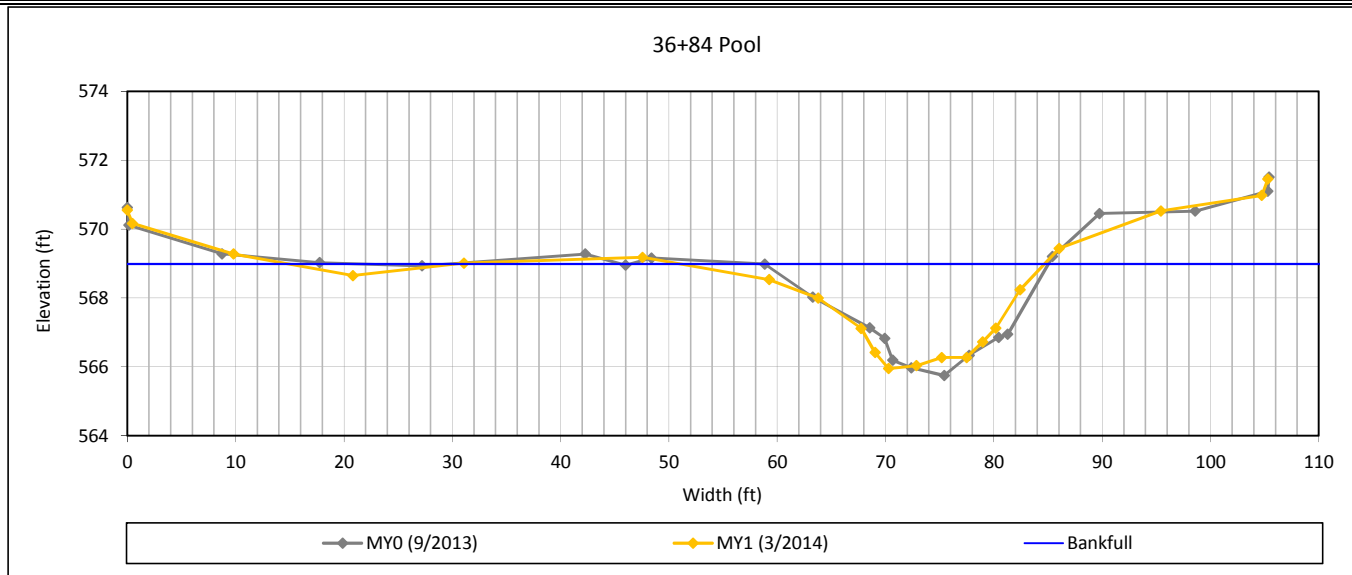
Cross Section 6-BC3

45.8	x-section area (ft.sq.)
25.4	width (ft)
1.8	mean depth (ft)
3.0	max depth (ft)
26.3	wetted perimeter (ft)
1.7	hyd radi (ft)
14.1	width-depth ratio

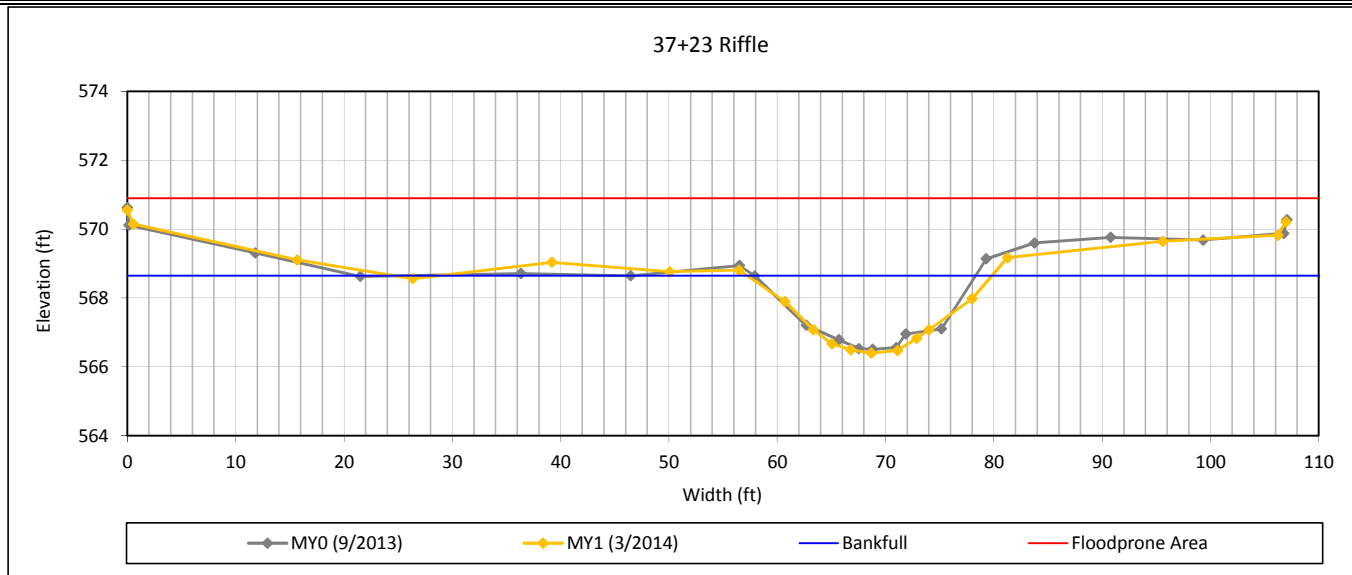
Cross Section 7-BC3

31.0	x-section area (ft.sq.)
22.6	width (ft)
1.4	mean depth (ft)
2.2	max depth (ft)
23.2	wetted perimeter (ft)
1.3	hyd radi (ft)
16.5	width-depth ratio
---	W flood prone area (ft)
---	entrenchment ratio
1.0	low bank height ratio

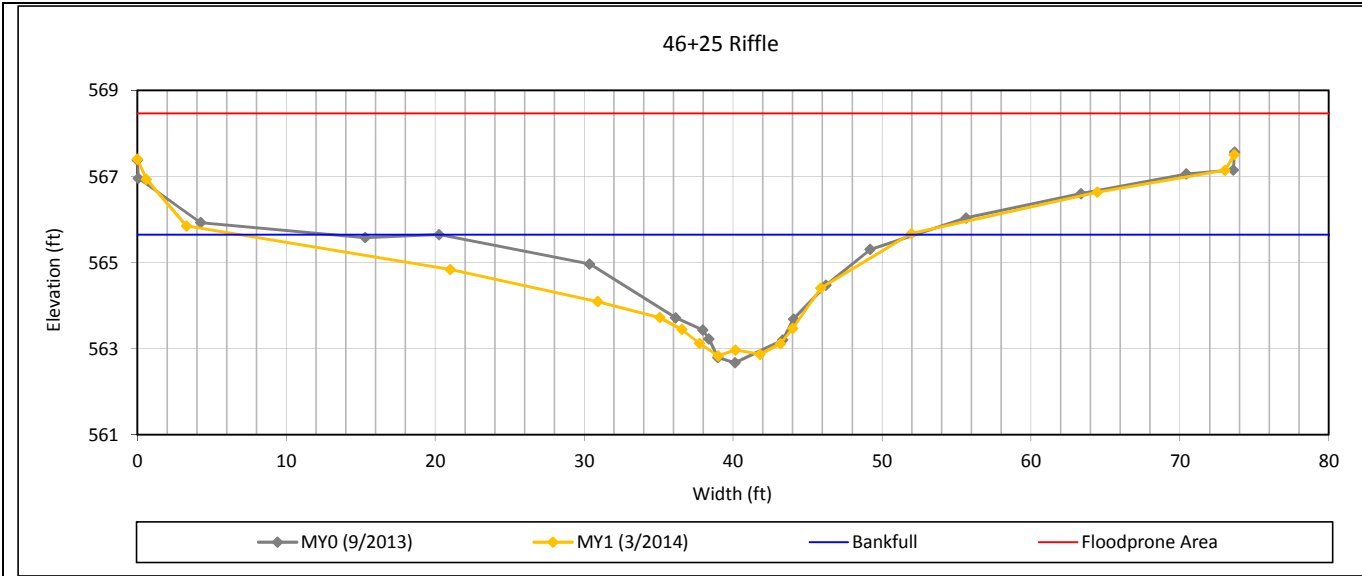
Cross Section 8-BC3

54.1	x-section area (ft.sq.)
45.0	width (ft)
1.2	mean depth (ft)
2.8	max depth (ft)
45.6	wetted parimeter (ft)
1.2	hyd radi (ft)
37.5	width-depth ratio
150.0	W flood prone area (ft)
3.3	entrenchment ratio
1.0	low bank height ratio

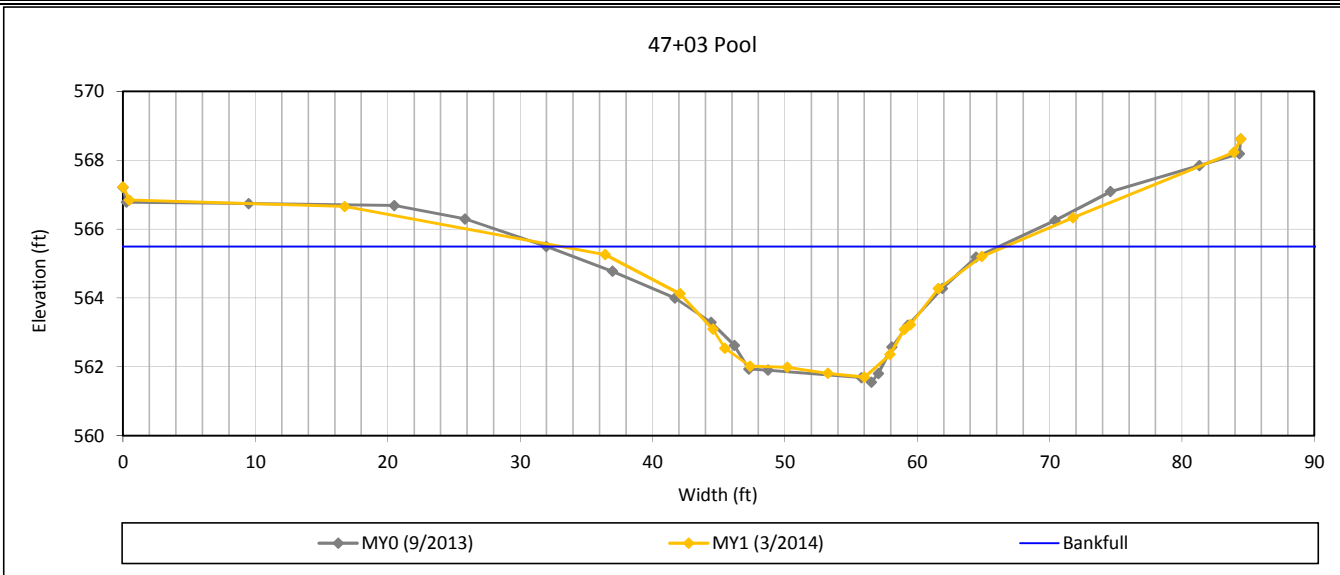
Cross Section 9-BC3

66.5	x-section area (ft.sq.)
33.6	width (ft)
2.0	mean depth (ft)
3.8	max depth (ft)
34.9	wetted perimeter (ft)
1.9	hyd radi (ft)
17.0	width-depth ratio

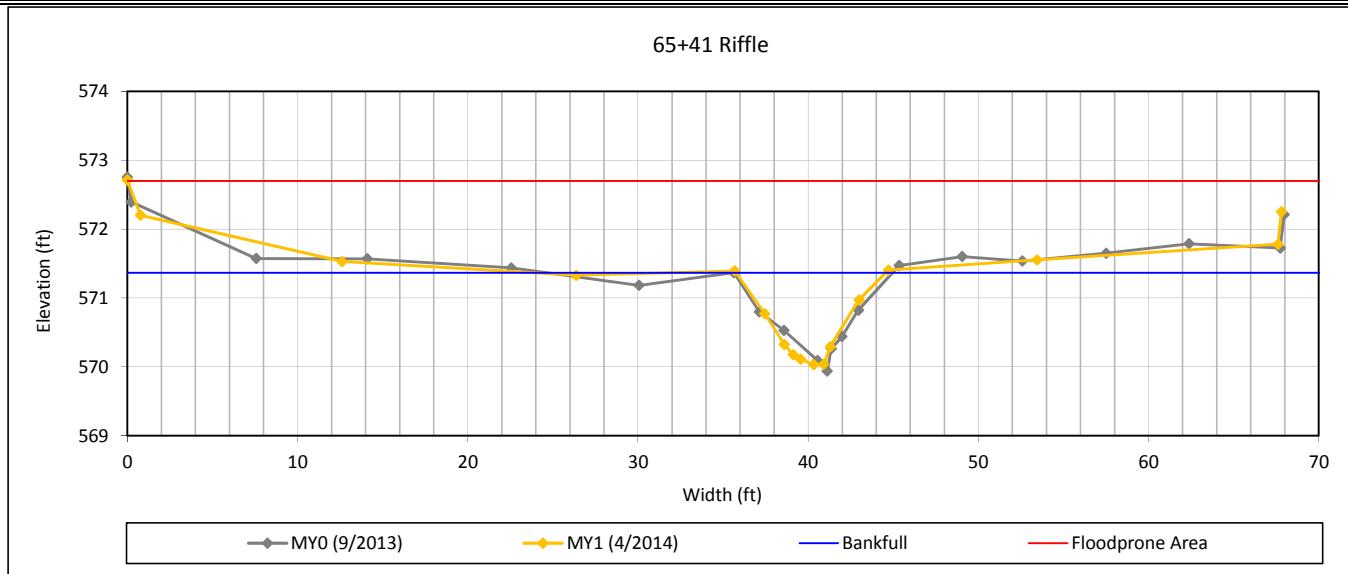
Cross Section 10-SB1

6.4	x-section area (ft.sq.)
8.8	width (ft)
0.7	mean depth (ft)
1.3	max depth (ft)
9.3	wetted perimeter (ft)
0.7	hyd radi (ft)
12.2	width-depth ratio
100.0	W flood prone area (ft)
11.4	entrenchment ratio
1.0	low bank height ratio

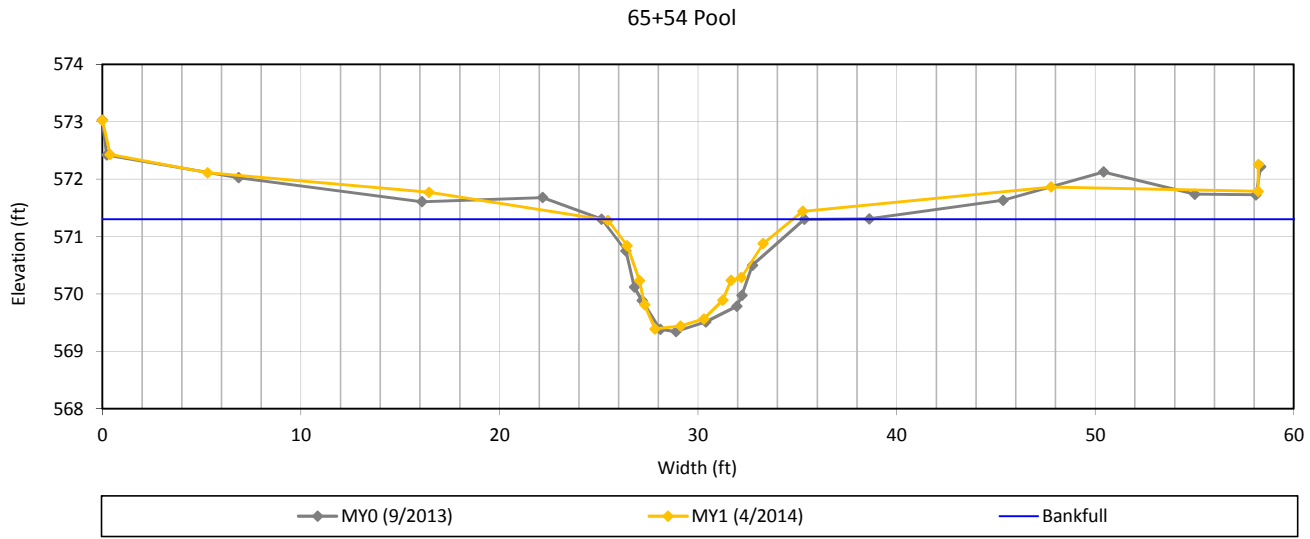
Cross Section 11-SB1

10.1	x-section area (ft.sq.)
9.7	width (ft)
1.0	mean depth (ft)
1.9	max depth (ft)
10.8	wetted parimeter (ft)
0.9	hyd radi (ft)
9.2	width-depth ratio

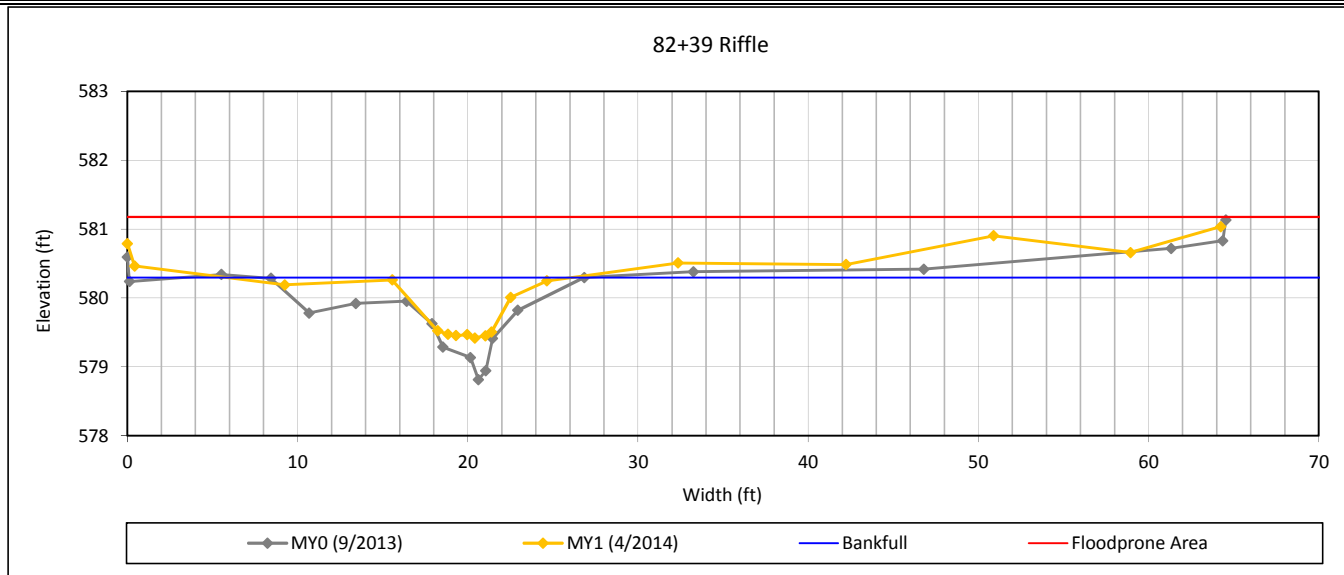
Cross Section 12 - SE1

5.2	x-section area (ft.sq.)
16.8	width (ft)
0.3	mean depth (ft)
0.9	max depth (ft)
17.1	wetted perimeter (ft)
0.3	hyd radi (ft)
54.9	width-depth ratio
75.0	W flood prone area (ft)
4.5	entrenchment ratio
1.0	low bank height ratio

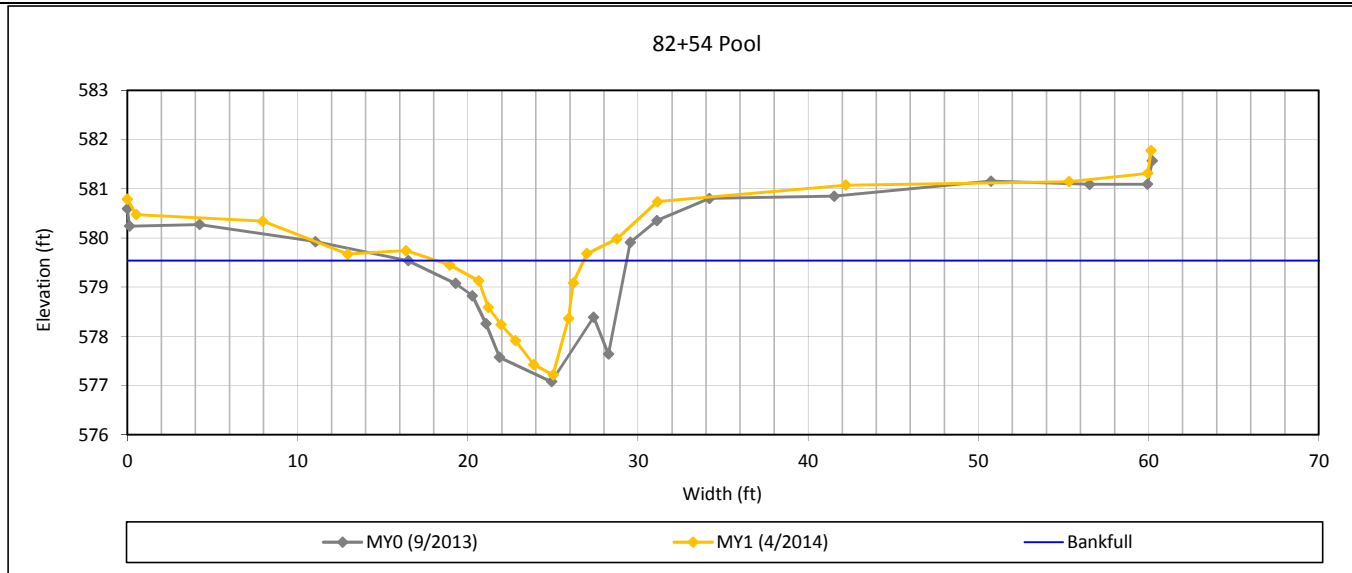
Cross Section 13 - SE1

- 9.4 x-section area (ft.sq.)
- 8.6 width (ft)
- 1.1 mean depth (ft)
- 2.3 max depth (ft)
- 10.4 wetted perimeter (ft)
- 0.9 hyd radi (ft)
- 7.9 width-depth ratio

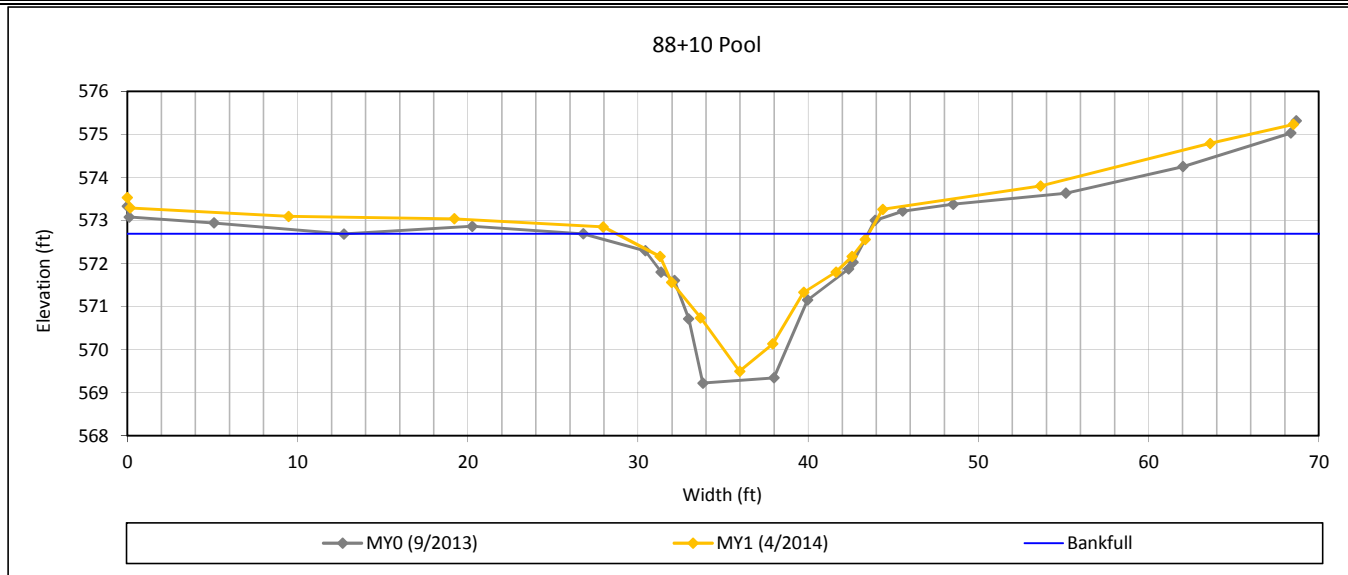
Cross Section 14 - SE2

22.0	x-section area (ft.sq.)
14.8	width (ft)
1.5	mean depth (ft)
3.2	max depth (ft)
16.3	wetted parimeter (ft)
1.3	hyd radi (ft)
10.0	width-depth ratio

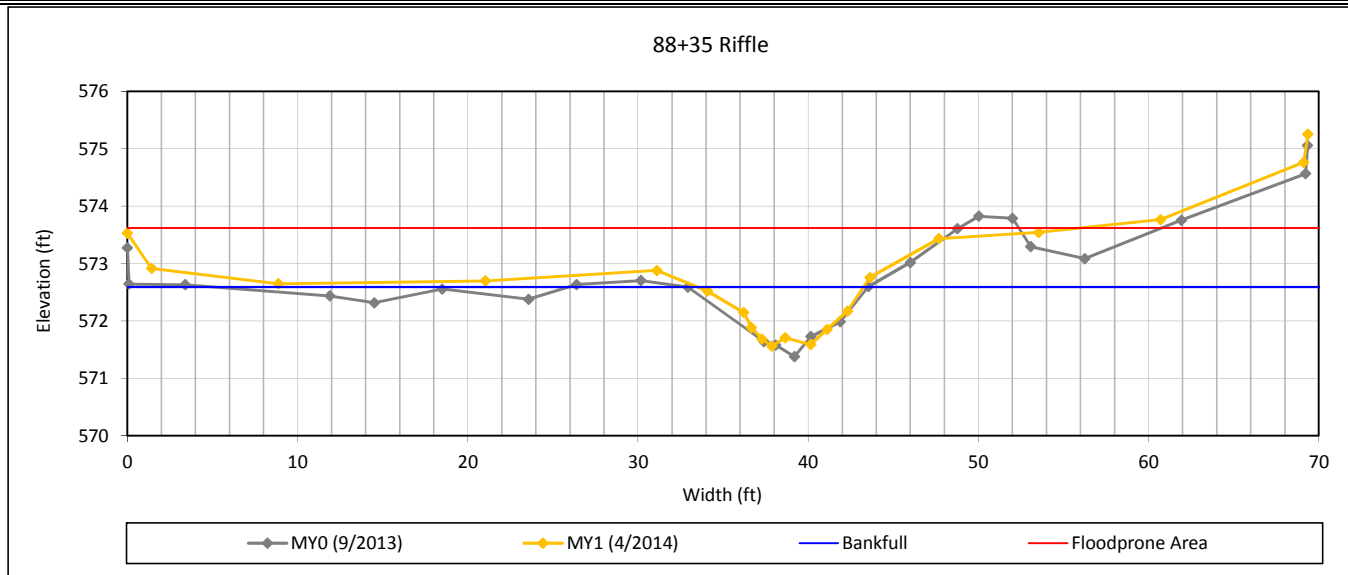
Cross Section 15 - SE2

5.8	x-section area (ft.sq.)
9.7	width (ft)
0.6	mean depth (ft)
1.0	max depth (ft)
10.1	wetted perimeter (ft)
0.6	hyd radi (ft)
16.4	width-depth ratio
100.0	W flood prone area (ft)
10.3	entrenchment ratio
1.0	low bank height ratio
