MONITORING YEAR 2 ANNUAL REPORT

BYRDS CREEK MITIGATION SITE

Person County, NC
NCDEQ Contract 003987
NCDMS Project Number 95020

Data Collection Period: March 2015-October 2015
Draft Submission Date: November 12, 2015
Final Submission Date: November 30, 2015

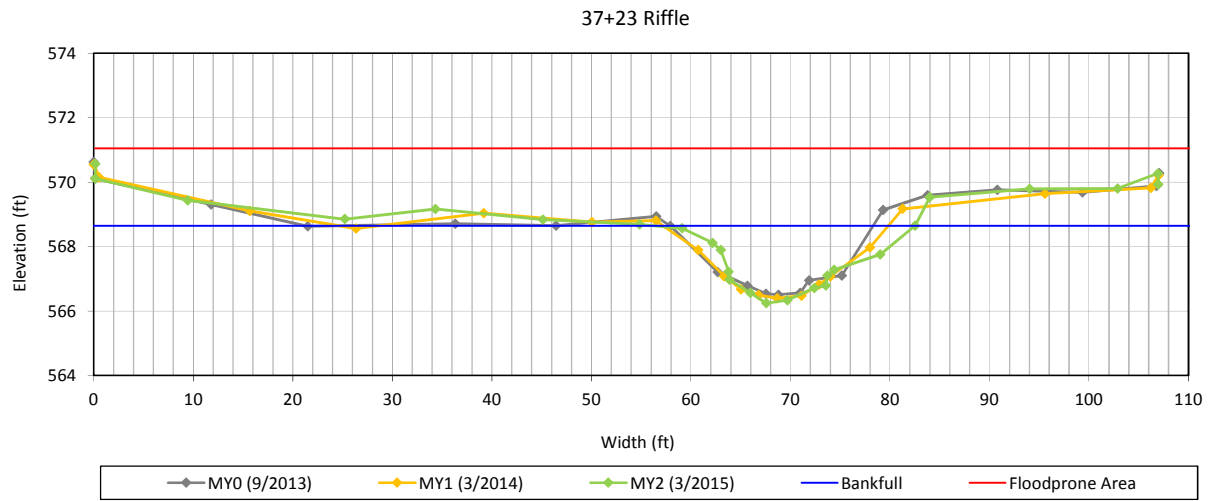
Cross Section 7- Byrds Creek Reach 3

Bank scour was observed along portions of Byrds Creek Reach 3 below the culvert crossing at the end of MY-1 and the beginning of MY-2. However, these areas have stabilized as vegetation has grown. Cross sections seven and eight show some of this bank scour that has occurred on Byrds Creek Reach 3. Cross section seven has had some scour on the right bank between MY-1 and MY-2. Cross section eight has shown similar scour on the left bank between MY-0 and MY-1. This scour on cross section eight looks to have stabilized between MY-1 and MY-2. The cross-sectional areas and bankfull widths have increased on cross sections seven and eight, but still fall within the appropriate Rosgen stream type parameters. These areas will be monitored for any active scour during MY-3.
