# MONITORING YEAR 3 ANNUAL REPORT

## BYRDS CREEK MITIGATION SITE

Person County, NC  
NCDEQ Contract 003987  
DMS Project Number 95020

Data Collection Period: March 2016-August 2016  
Draft Submission Date: September 26, 2016  
Final Submission Date: October 19, 2016

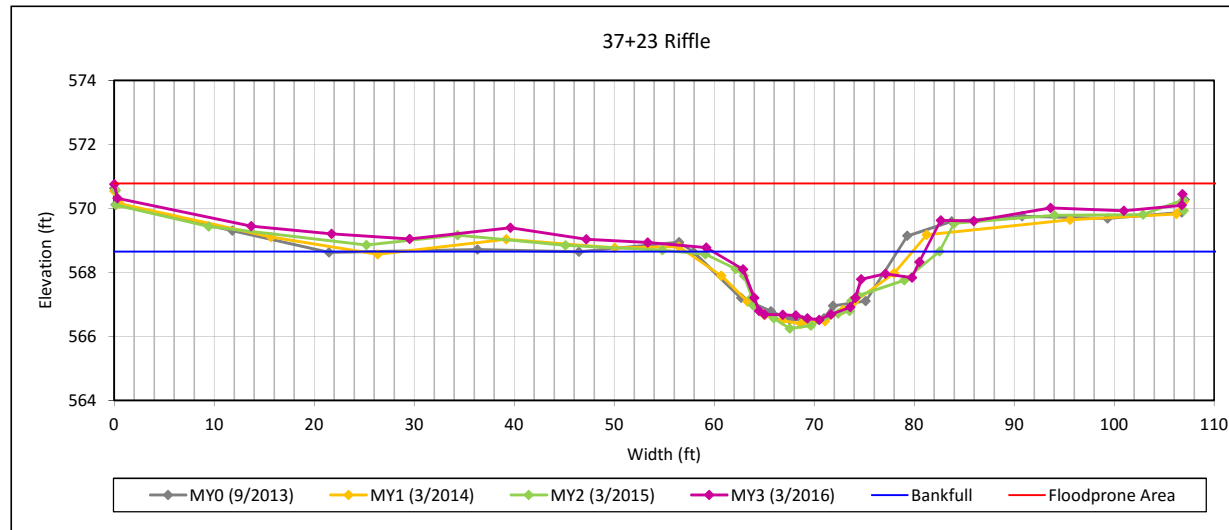
#### Cross Section 7- Byrds Creek Reach 3

Bank scour was observed along portions of Byrds Creek Reach 3 below the culvert crossing at the end of MY-1 and MY-2. These areas were repaired at the beginning of MY-3 following the cross-sectional survey. Cross sections seven and eight show some minor bank scour that has occurred on Byrds Creek Reach 3. Scour in the cross sections has stabilized between MY-2 and MY-3. The cross-sectional areas and bankfull widths on cross sections seven and eight still fall within the appropriate Rosgen stream type parameters. These areas will be monitored for any active scour during subsequent monitoring years.

During March of MY-3, existing areas of localized instability were repaired along Byrds Creek between stations 35+00 and 48+00. Banks were reconstructed with geolifts and live whips to minimize the effects of bank stress during high flow events. Additionally, permanent seed, live stakes and herbaceous plugs

were installed following the repair activities. These areas appear to be stable with strong support from vegetation. Wildlands will continue to monitor these areas and take corrective action as needed.
