**CANDIFF CREEK RESTORATION PROJECT**  
**ANNUAL MONITORING REPORT FOR 2012 (YEAR 1)**

**EEP Project Number: 92767**

**January 2013**  
**FINAL**

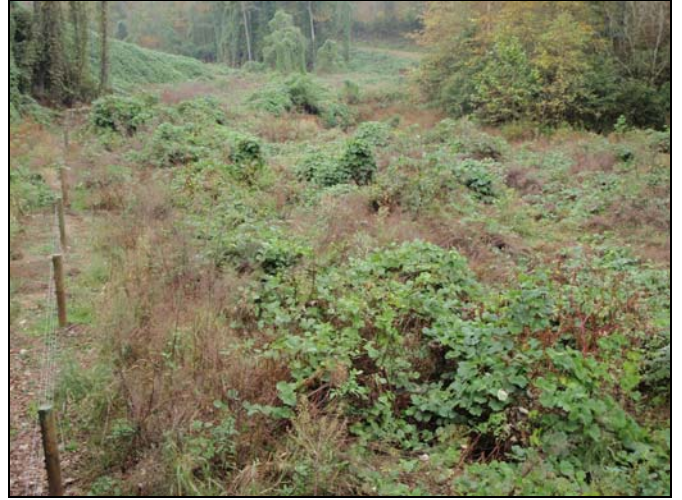
During Year 1 monitoring, kudzu (*Pueraria montana*) was observed on the Site in the vicinity of vegetation Plot 13. This concentration of kudzu is located on the upstream portion of Reach M1, downstream of River-Siloam road. This area of kudzu was previously treated during construction. This area of kudzu is scheduled to be treated again during the appropriate time(s) in 2013.

Kudzu growth in M1 and vegetation plot 13 vicinity

During Year 1 vegetation monitoring, kudzu was observed on the Site in the vicinity of vegetation Plot 13. This concentration of kudzu is located on the upstream portion of Reach M1, downstream of River-Siloam road. This area of kudzu was previously treated during construction. This area is scheduled to be treated again in 2013 during appropriate treatment window(s).

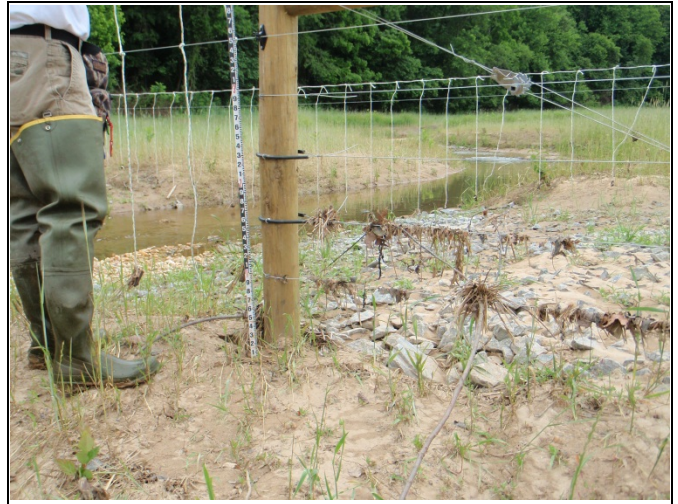
According to the on-site crest gauge, the Site experienced at least one bankfull flow event during the Year 1 monitoring period. The largest on-site bankfull flow event documented by the M3 crest gauge during Year 1 monitoring, occurred sometime in April-May 2012. It was estimated that flows at the M3 crest gauge during this time period were approximately 1.60 feet above bankfull stage. Inspection of conditions during a spring site visit revealed visual evidence of out-of-bank flows.

Bankfull evidence from April 2012 storms, photos taken May 23, 2012. Approximately 1.60 feet.

Bankfull evidence from April 2012 storms

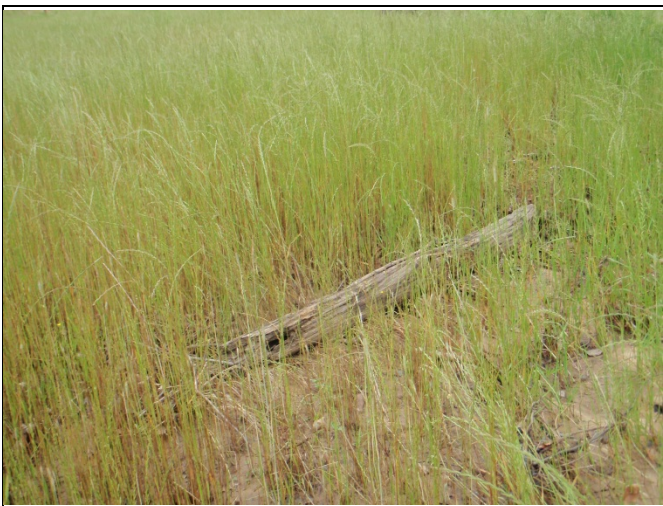
Bankfull evidence from April 2012 storms

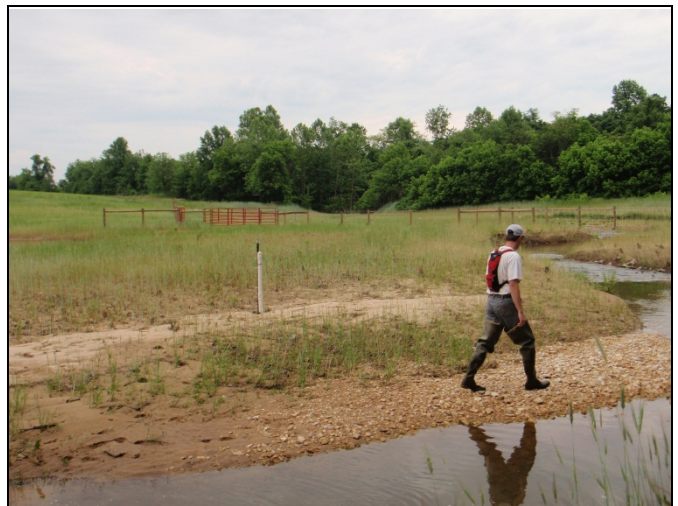
Bankfull evidence from April 2012 storms

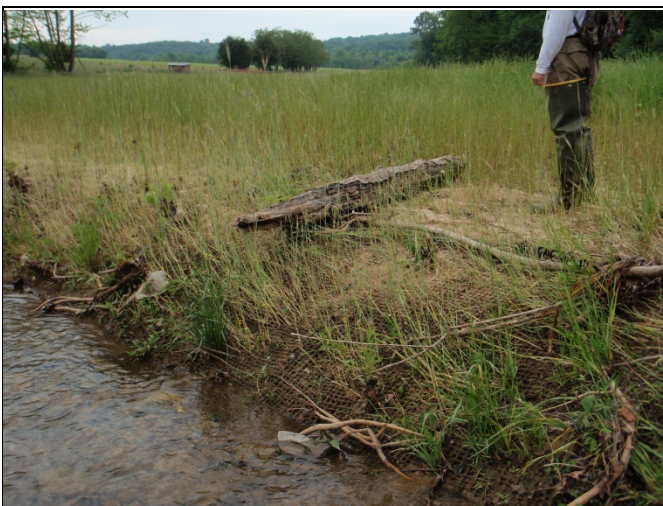
Bankfull evidence from April 2012 storms

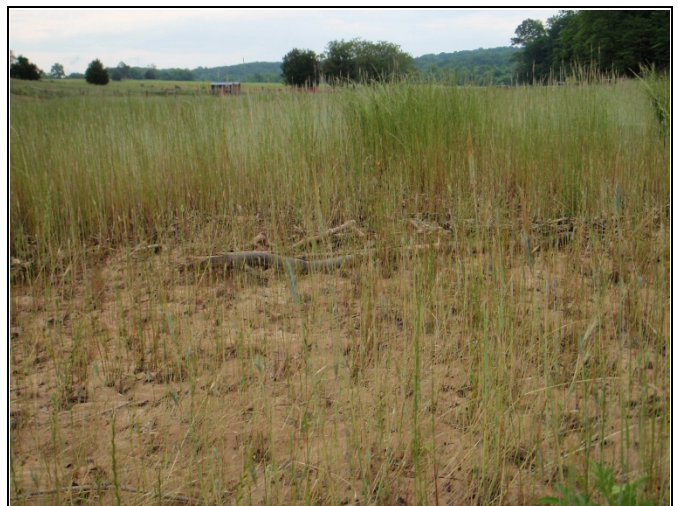
Bankfull evidence from April 2012 storms
