CANDIFF CREEK RESTORATION PROJECT
ANNUAL MONITORING REPORT FOR 2013 (YEAR 2)

EEP Project Number: 92767

February 2014
FINAL

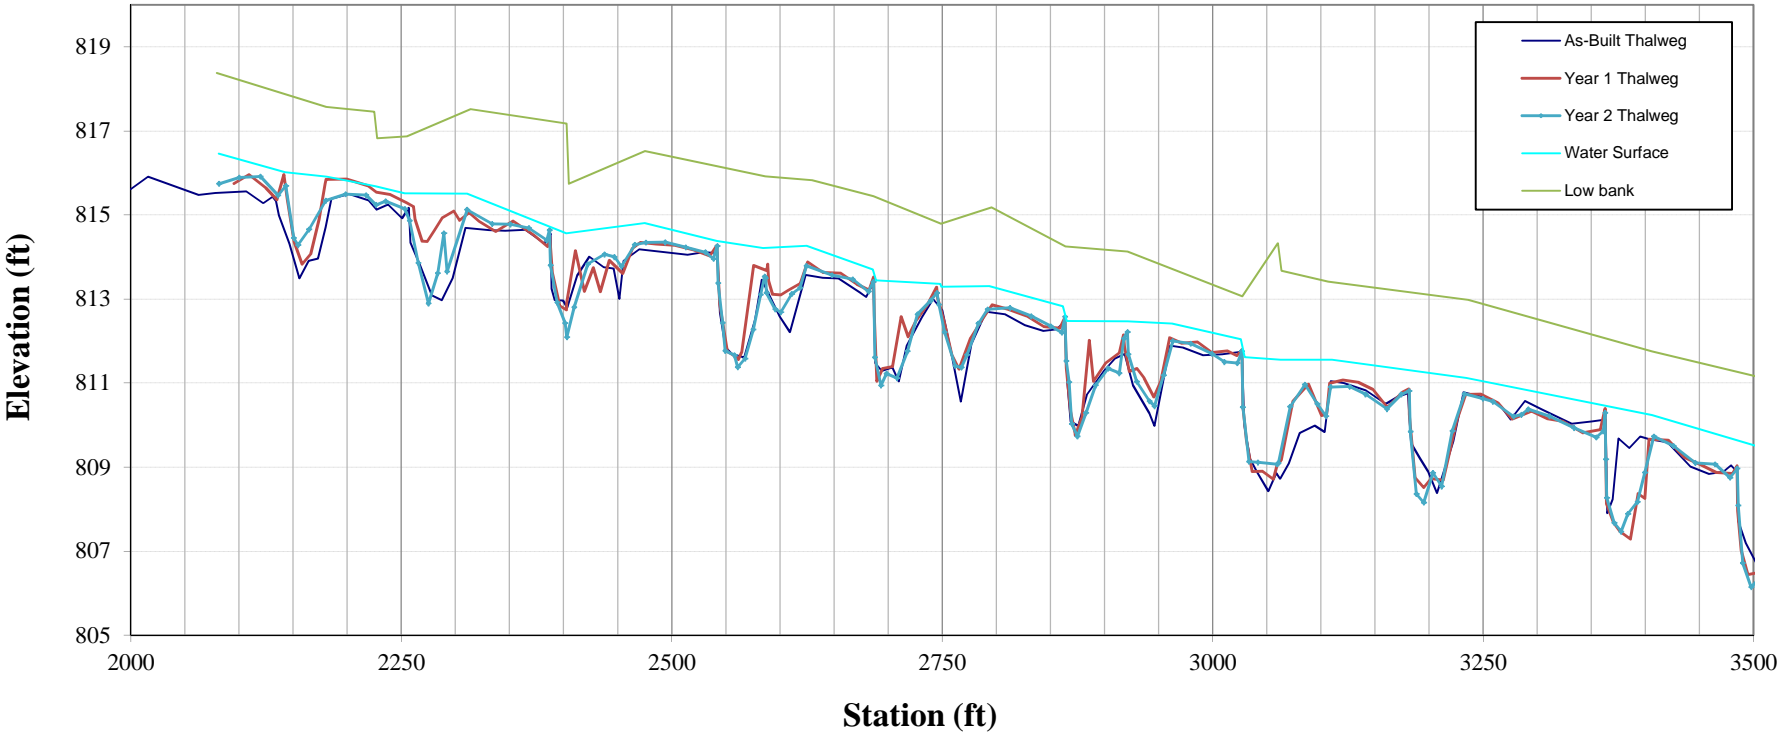
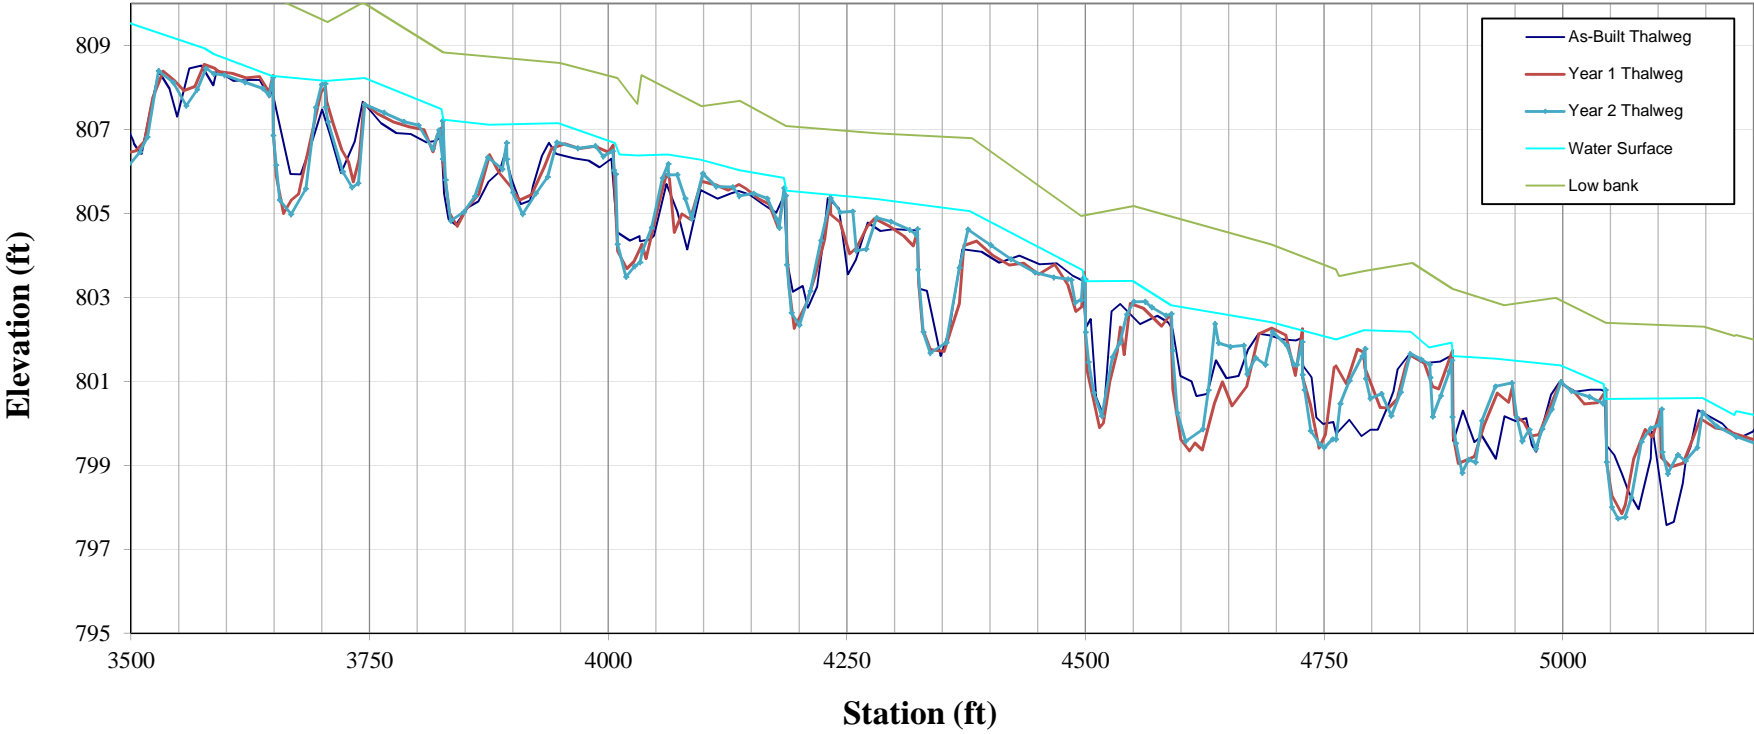
**Chart M3 - Year 2- Station 20+00 to 35+00
(Data collected October 2013)**

Year 2 monitoring data for the M3 longitudinal profile indicate that the riffles in this reach have essentially maintained the same bed elevations since as-built conditions. It was observed in Year 1 and in Year 2 that some pools in M3 have continued to increase in depth since as-built conditions. It is noted that increased pool depths were observed mostly in the middle of portion of M3. The deeper pools noted in M3 are benefiting the overall functionality of the Site by providing increased channel stability while promoting greater habitat diversity. Overall, the longitudinal profile for M3 demonstrates that the in-stream structures within the reach are stable and functioning as designed.

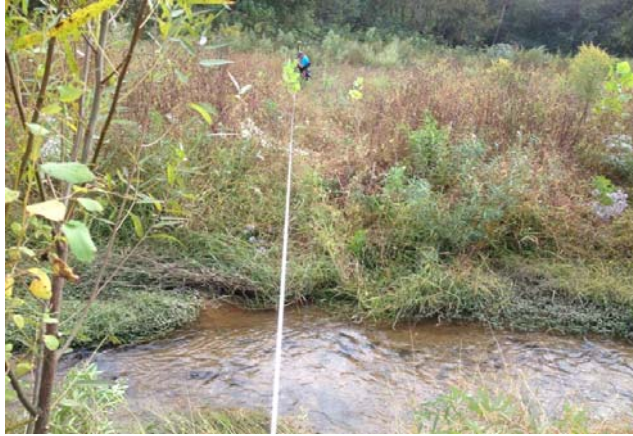
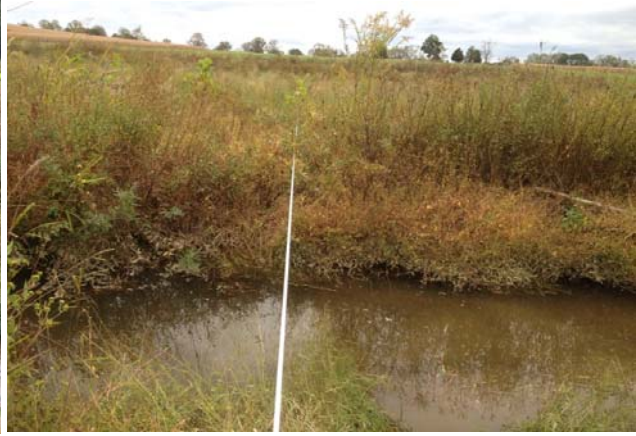
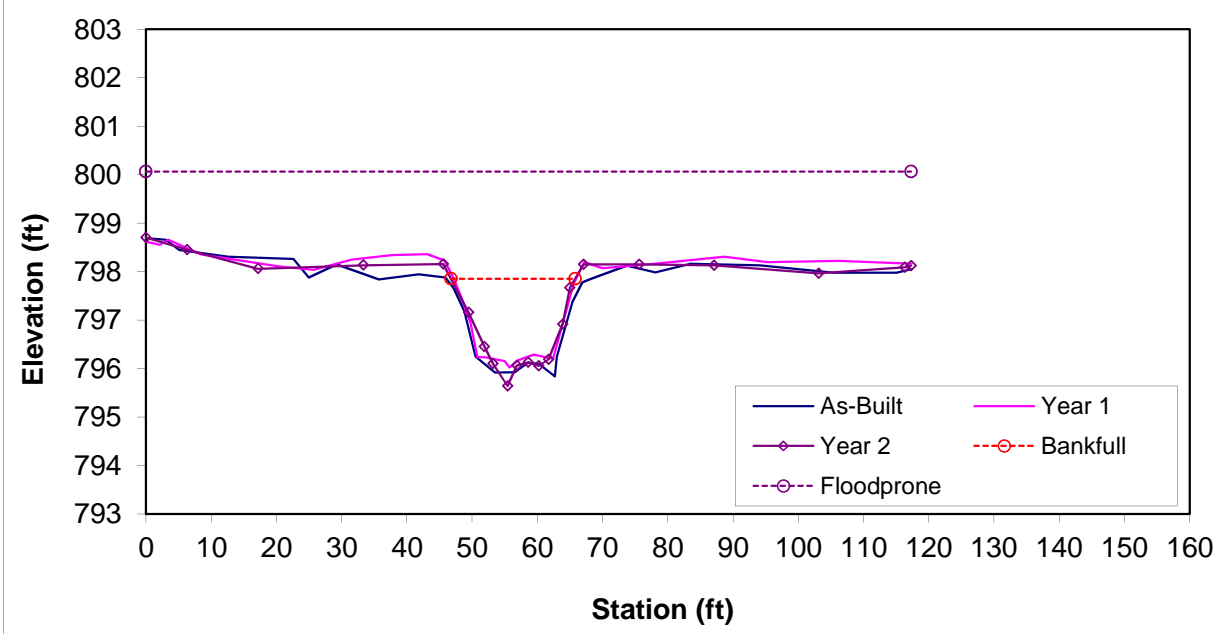
Permanent Cross-section 10
(Year 2 Data - Collected October 2013)

Cross-sections 1, 4, 6, 8 and 10 are situated across riffles that are located between pools. Based on the survey data, Cross-section 10 located on the mid-downstream portion of M3, showed relatively little change since as-built conditions. Cross-sections 1, 4, 6 and 8 are located on the upstream portion of M3 and demonstrated minor fluctuations in riffle dimensions during the first and second years of monitoring. Cross-sections 1 and 4 appear to have aggraded in channel dimension slightly since as-built conditions and Year 1. These two cross-sections were observed during Year 2 monitoring and appear to be stable. Cross-section 6 is located mid-stream on reach M3. This Cross-section has shifted slightly downward since Year 1. This shift is likely due to riffle adjustment and maturation. Cross-section 6 will be closely observed during Year 3 monitoring for any shift toward instability.
