CANDIFF CREEK RESTORATION PROJECT
ANNUAL MONITORING REPORT FOR 2014 (YEAR 3)

EEP Project Number: 92767

Prepared by: Michael Baker International

January 2015
FINAL

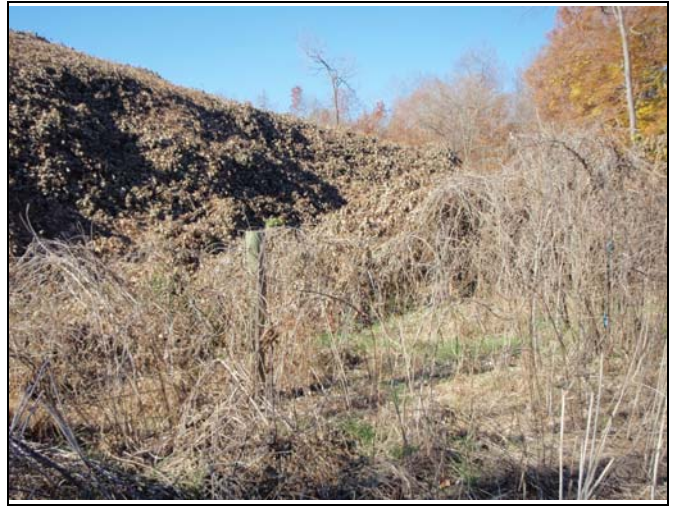
During Year 3 monitoring, kudzu (*Pueraria montana*) was present on the Site in the vicinity of vegetation plot 13. This concentration of kudzu was previously treated during construction but is now re-establishing in the same location. The kudzu is located on the upstream portion of Reach M1, downstream of River-Siloam Road. This area was treated in August and October of 2014 by use of the herbicides Glyphosate and Triclopyr. The Year 3 vegetation monitoring data for vegetation plot 13 in the treated area exhibited 243 stems per acre. Upon control of the kudzu, the area will be replanted at an appropriate density in order to meet the Year 5 success criteria of 260 stems per acre.

View of Kudzu across easement fence (vicinity of
Vegetation Plot 13)

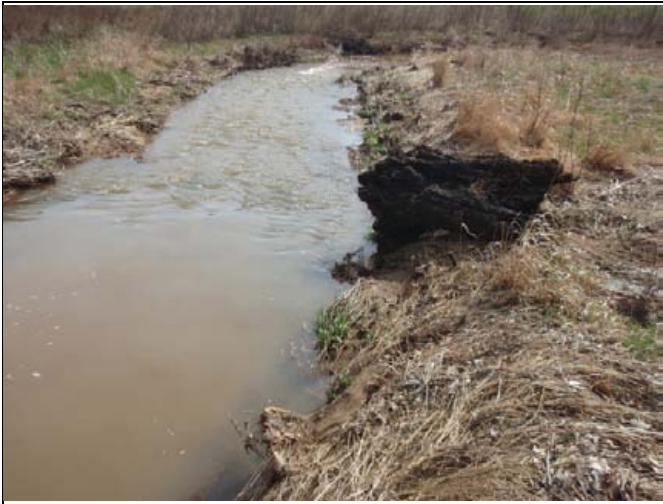
M3 crest gauge STA 55+50, April 8, 2014. Crest gauge reading of 0.82 feet.

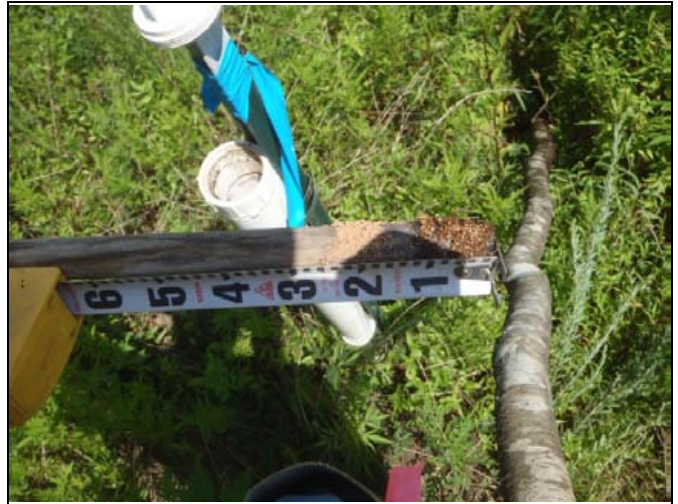
According to the on-site crest gauge, the Site experienced at least two significant bankfull flow events during Year 3 monitoring. The largest on-site bankfull flow event documented at the M3 crest gauge during Year 3 monitoring, occurred on January 11, 2014. It is estimated that the height of highest flow at the M3 crest gauge observed in January was approximately 0.82 feet above bankfull stage. Following the January event, the next recorded observation occurred approximately on April 29, 2014. The crest gauge on M3 did not document additional out of channel bankfull flows for the remainder of Year 3 monitoring. A photograph depicting a large stump that washed up along M3 in January 2014 is included in Appendix B.

Bankfull evidence observed on April 8, 2014.
Evidence likely deposited on January 11, 2014
