CANDIFF CREEK RESTORATION PROJECT
ANNUAL MONITORING REPORT FOR 2015 (YEAR 4)

NCDEQ-DMS Project Number: 92767

November 2015
FINAL

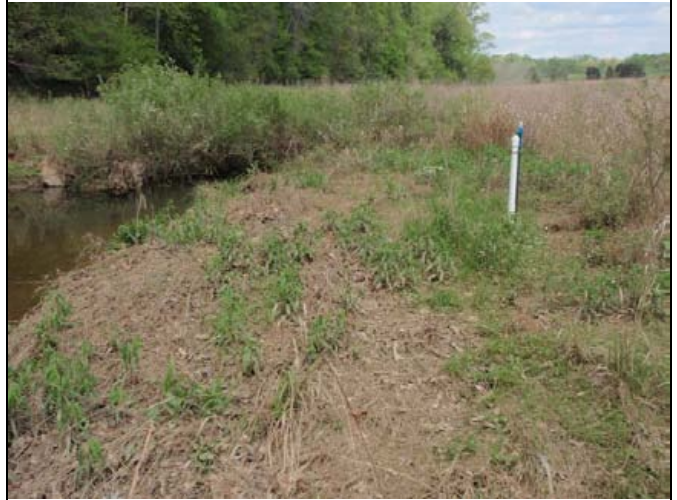
According to the on-site crest gauge, the Site experienced at least two significant bankfull flow events during Year 4 monitoring. The largest on-site bankfull flow event documented at the M3 crest gauge occurred on April 20, 2015. It is estimated that the height of highest flow at the M3 crest gauge observed in Year 4 was approximately 2.85 feet above bankfull stage. A photograph depicting a large stump that washed up along M3 on October 4, 2015 is included in Appendix B.

M3 crest gauge STA 55+50, April 30, 2015. Crest gauge reading of 2.85 feet.

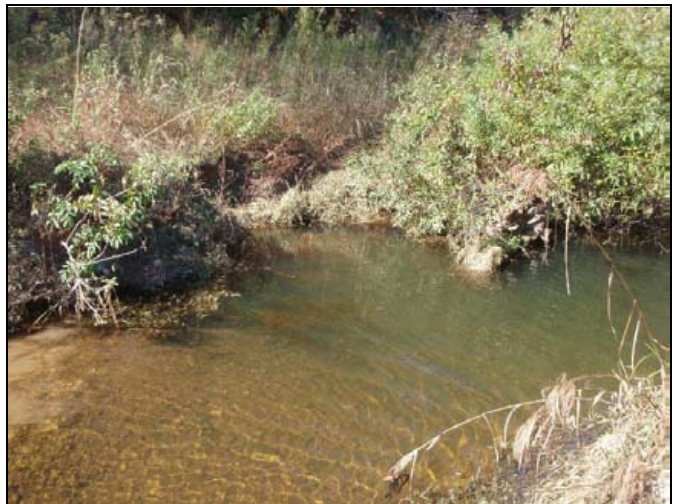
Two pools located at stations 46+50 and 55+50 have exhibited areas of erosion during Year 4 monitoring. The erosional areas observed are occurring on the outer bend below the root wads and are approximately 10 feet or less in length. These two minor problem areas make up approximately 0.2% of the total as-built stream length of 5,095 feet. Photos of these two areas are included in the Appendix. These areas are isolated and do not suggest a trend towards long-term instability.

Two pools located at stations 46+50 and 55+50 have exhibited areas of erosion during Year 4 monitoring. The erosional areas observed are occurring on the outer bend below the root wads and are approximately 10 feet or less in length. These areas are isolated and do not suggest a trend towards long-term instability.

Stream Problem Area 1 - STA 46+50. M3 bank erosion on outer portion of meander bend.

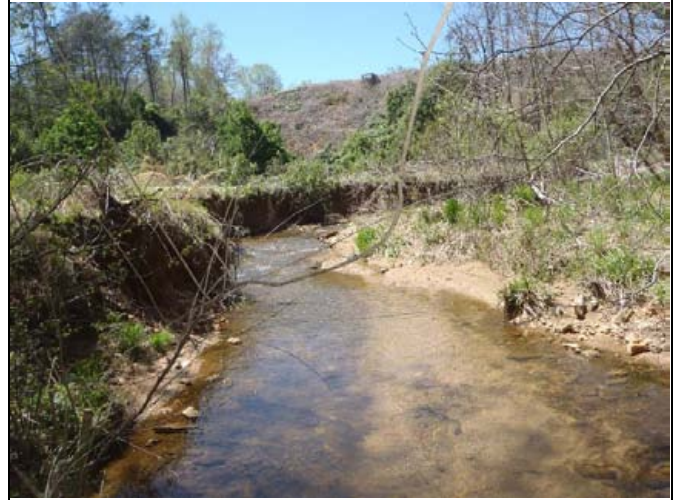
Additional stream enhancement work along M1 and UT1 was completed in September 2015. Bankfull benches were excavated and vertical stream banks were sloped to stable angles. In addition, vane structures and toe wood were installed along meander bends to protect the stream banks, provide additional habitat, and to provide long-term stream bank stabilization. No additional credit is being requested as a result of this work. During this time, the existing kudzu plants and roots were cleared within a large portion of the easement area. Per the permit conditions for the enhancement work, monitoring along M1 and UT1 will be conducted for a minimum of one additional year beyond the monitoring required in the mitigation plan. This monitoring will include visual assessments conducted twice per year and the installation and annual monitoring of two bank pin arrays installed in the outside of meander bends.

M1 before enhancement activities, April 2015.
