CANDIFF CREEK RESTORATION PROJECT
ANNUAL MONITORING REPORT FOR 2016 (YEAR 5)

NCDEQ-DMS Project Number: 92767

November 2016
FINAL

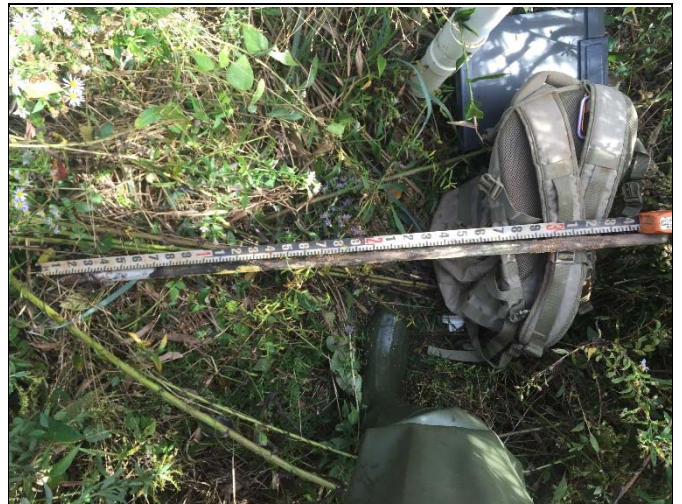
According to the on-site crest gauge, the Site experienced at least one significant bankfull flow event during Year 5 monitoring. The largest on-site bankfull flow event documented at the M3 crest gauge occurred on August 4, 2016. It is estimated that the height of highest flow at the M3 crest gauge observed in Year 5 was approximately 3.24 feet above bankfull stage. Photos of the reading and bankfull evidence are included in Appendix B.

M3 crest gauge STA 55+50, October 11, 2016.
Crest gauge reading of 3.24 feet.

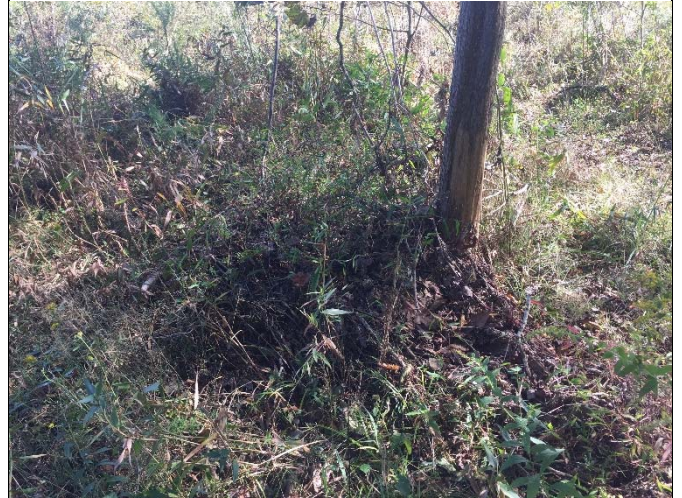
M3 crest gauge bankfull evidence. October 11, 2016.

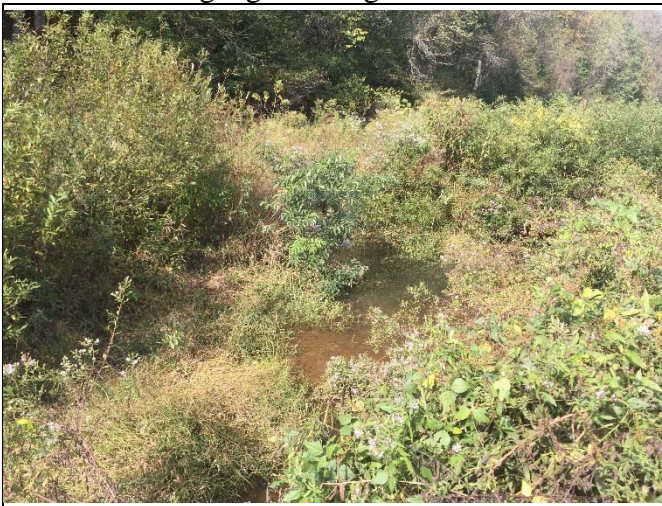
Two pools located at stations 46+50 and 55+50 exhibited areas of erosion during Year 4 monitoring. The erosional areas observed in 2015 have not expanded and are currently stable. The erosional areas are occurring on outer bends below root wads and are approximately 20 feet in length combined. These two minor problem areas make up approximately 0.28% of the total as-built stream length of 7,018 feet. The erosional areas are isolated and are not trending towards long-term instability.

Stream Problem Area 1 - STA 46+50. Bank heavily vegetated. Seems to have stabilized.

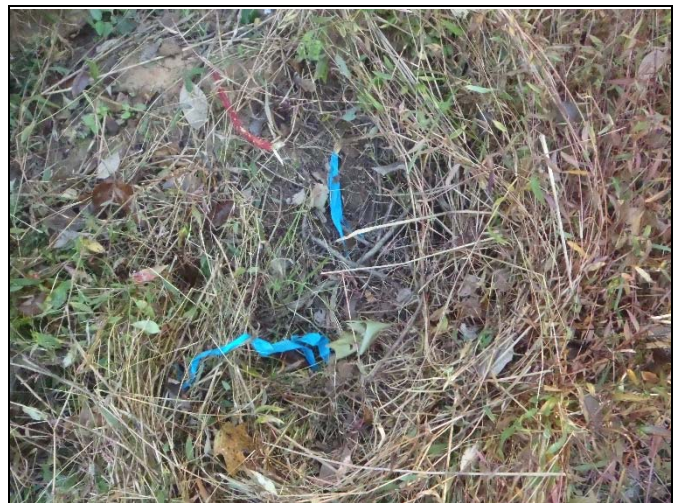
Bank pin near Station 13+40, pin NOT exposed
