**Subject: MY6 Supplemental Monitoring
Candiff Creek Restoration
Yadkin 01 River Basin
NCDEQ – DMS Project Number 92767
Contract Number 002211**

Candiff Creek Restoration – M1 and UT1, MY6 Photographs

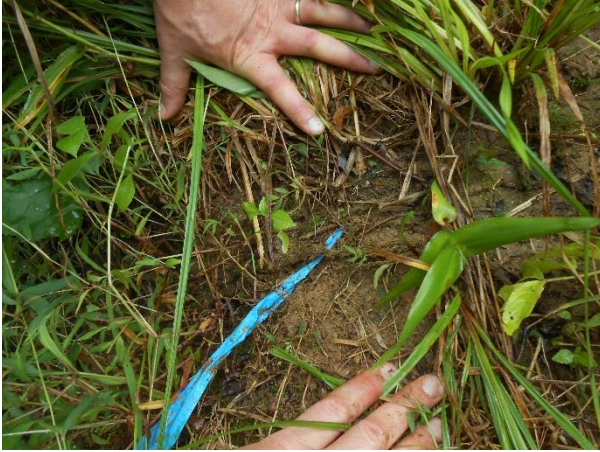
**Bottom Bank Pin – Reach M1, right bank
Between Station 11+00 and 12+00
August 14, 2017**

Monitoring of the installed bank pins indicated that banks along Reach M1 are stable and not exhibiting active erosion. Representative photographs of both reaches support this, and show that vegetation on the site is well established and helping to stabilize the stream banks. Photographs of both bank pin arrays are provided in the attached photo log. A small section of terrace slope is exhibiting some minor erosion but is not systemic and will not be a detriment to the project.

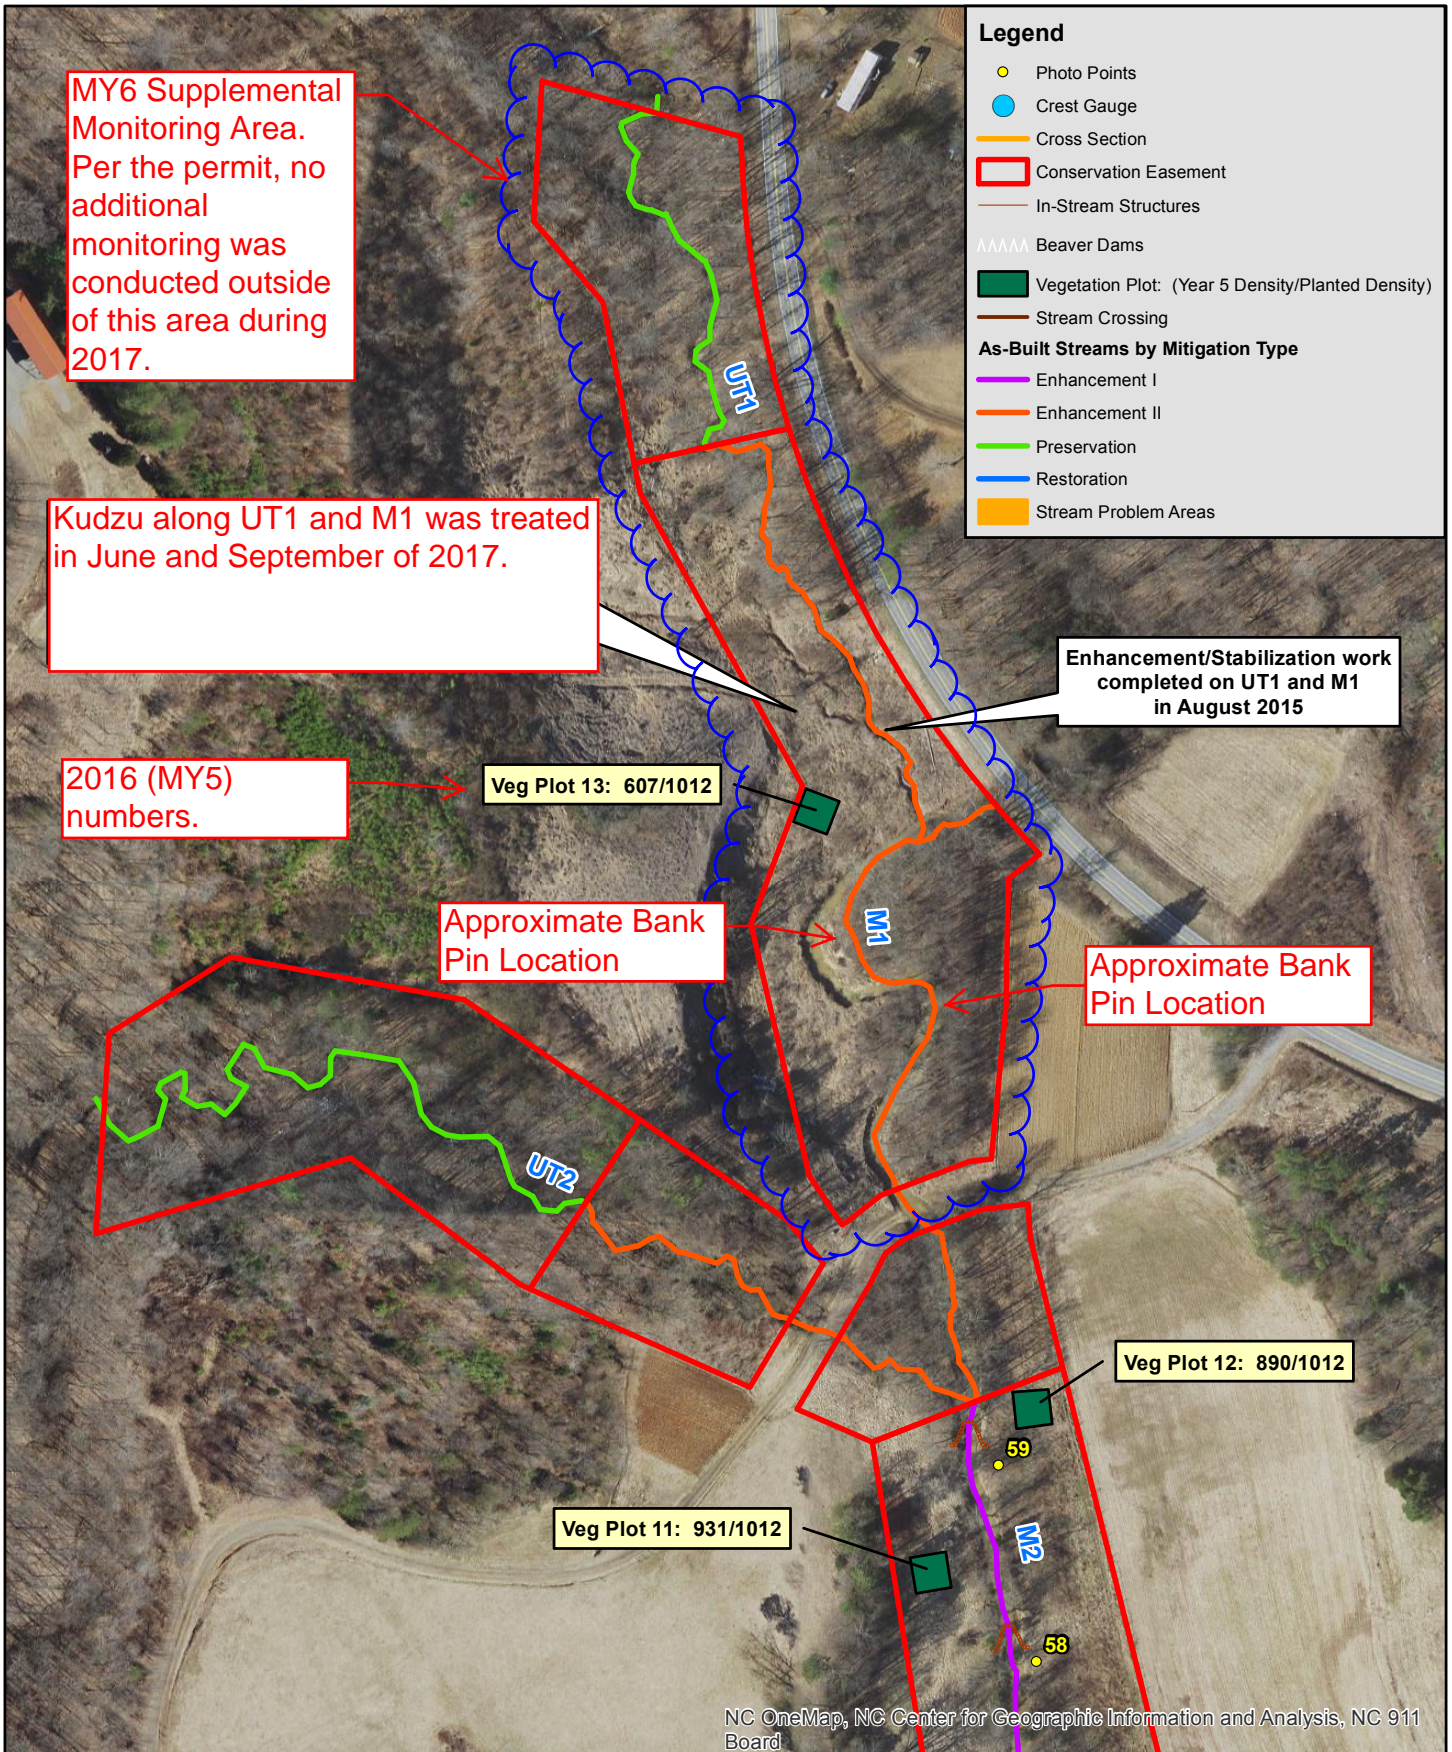
Current Condition
Plan View Figure 4A
Candiff Creek - Surry County, NC

Through visual inspection, it was determined that the remainder of the mitigation site is also functioning as intended and as described in the Monitoring Year 5 report. The only areas of concern were the two small (<10 feet) bank erosion areas noted in the Monitoring Year 5 report and shown in the CCPV below. These areas have not degraded anymore and are anticipated to stabilize with time. The site was fully inspected on October 20, 2017 and no beaver sign was noted.

MY6 Supplemental Monitoring Area.
Per the permit, no additional monitoring was conducted outside of this area during 2017.

Kudzu along UT1 and M1 was treated
in June and September of 2017.

Enhancement/Stabilization work completed on UT1 and M1 in August 2015
