# MONITORING YEAR 2 ANNUAL REPORT

## CANDY CREEK MITIGATION SITE

Guilford County, NC

DEQ Contract 5794

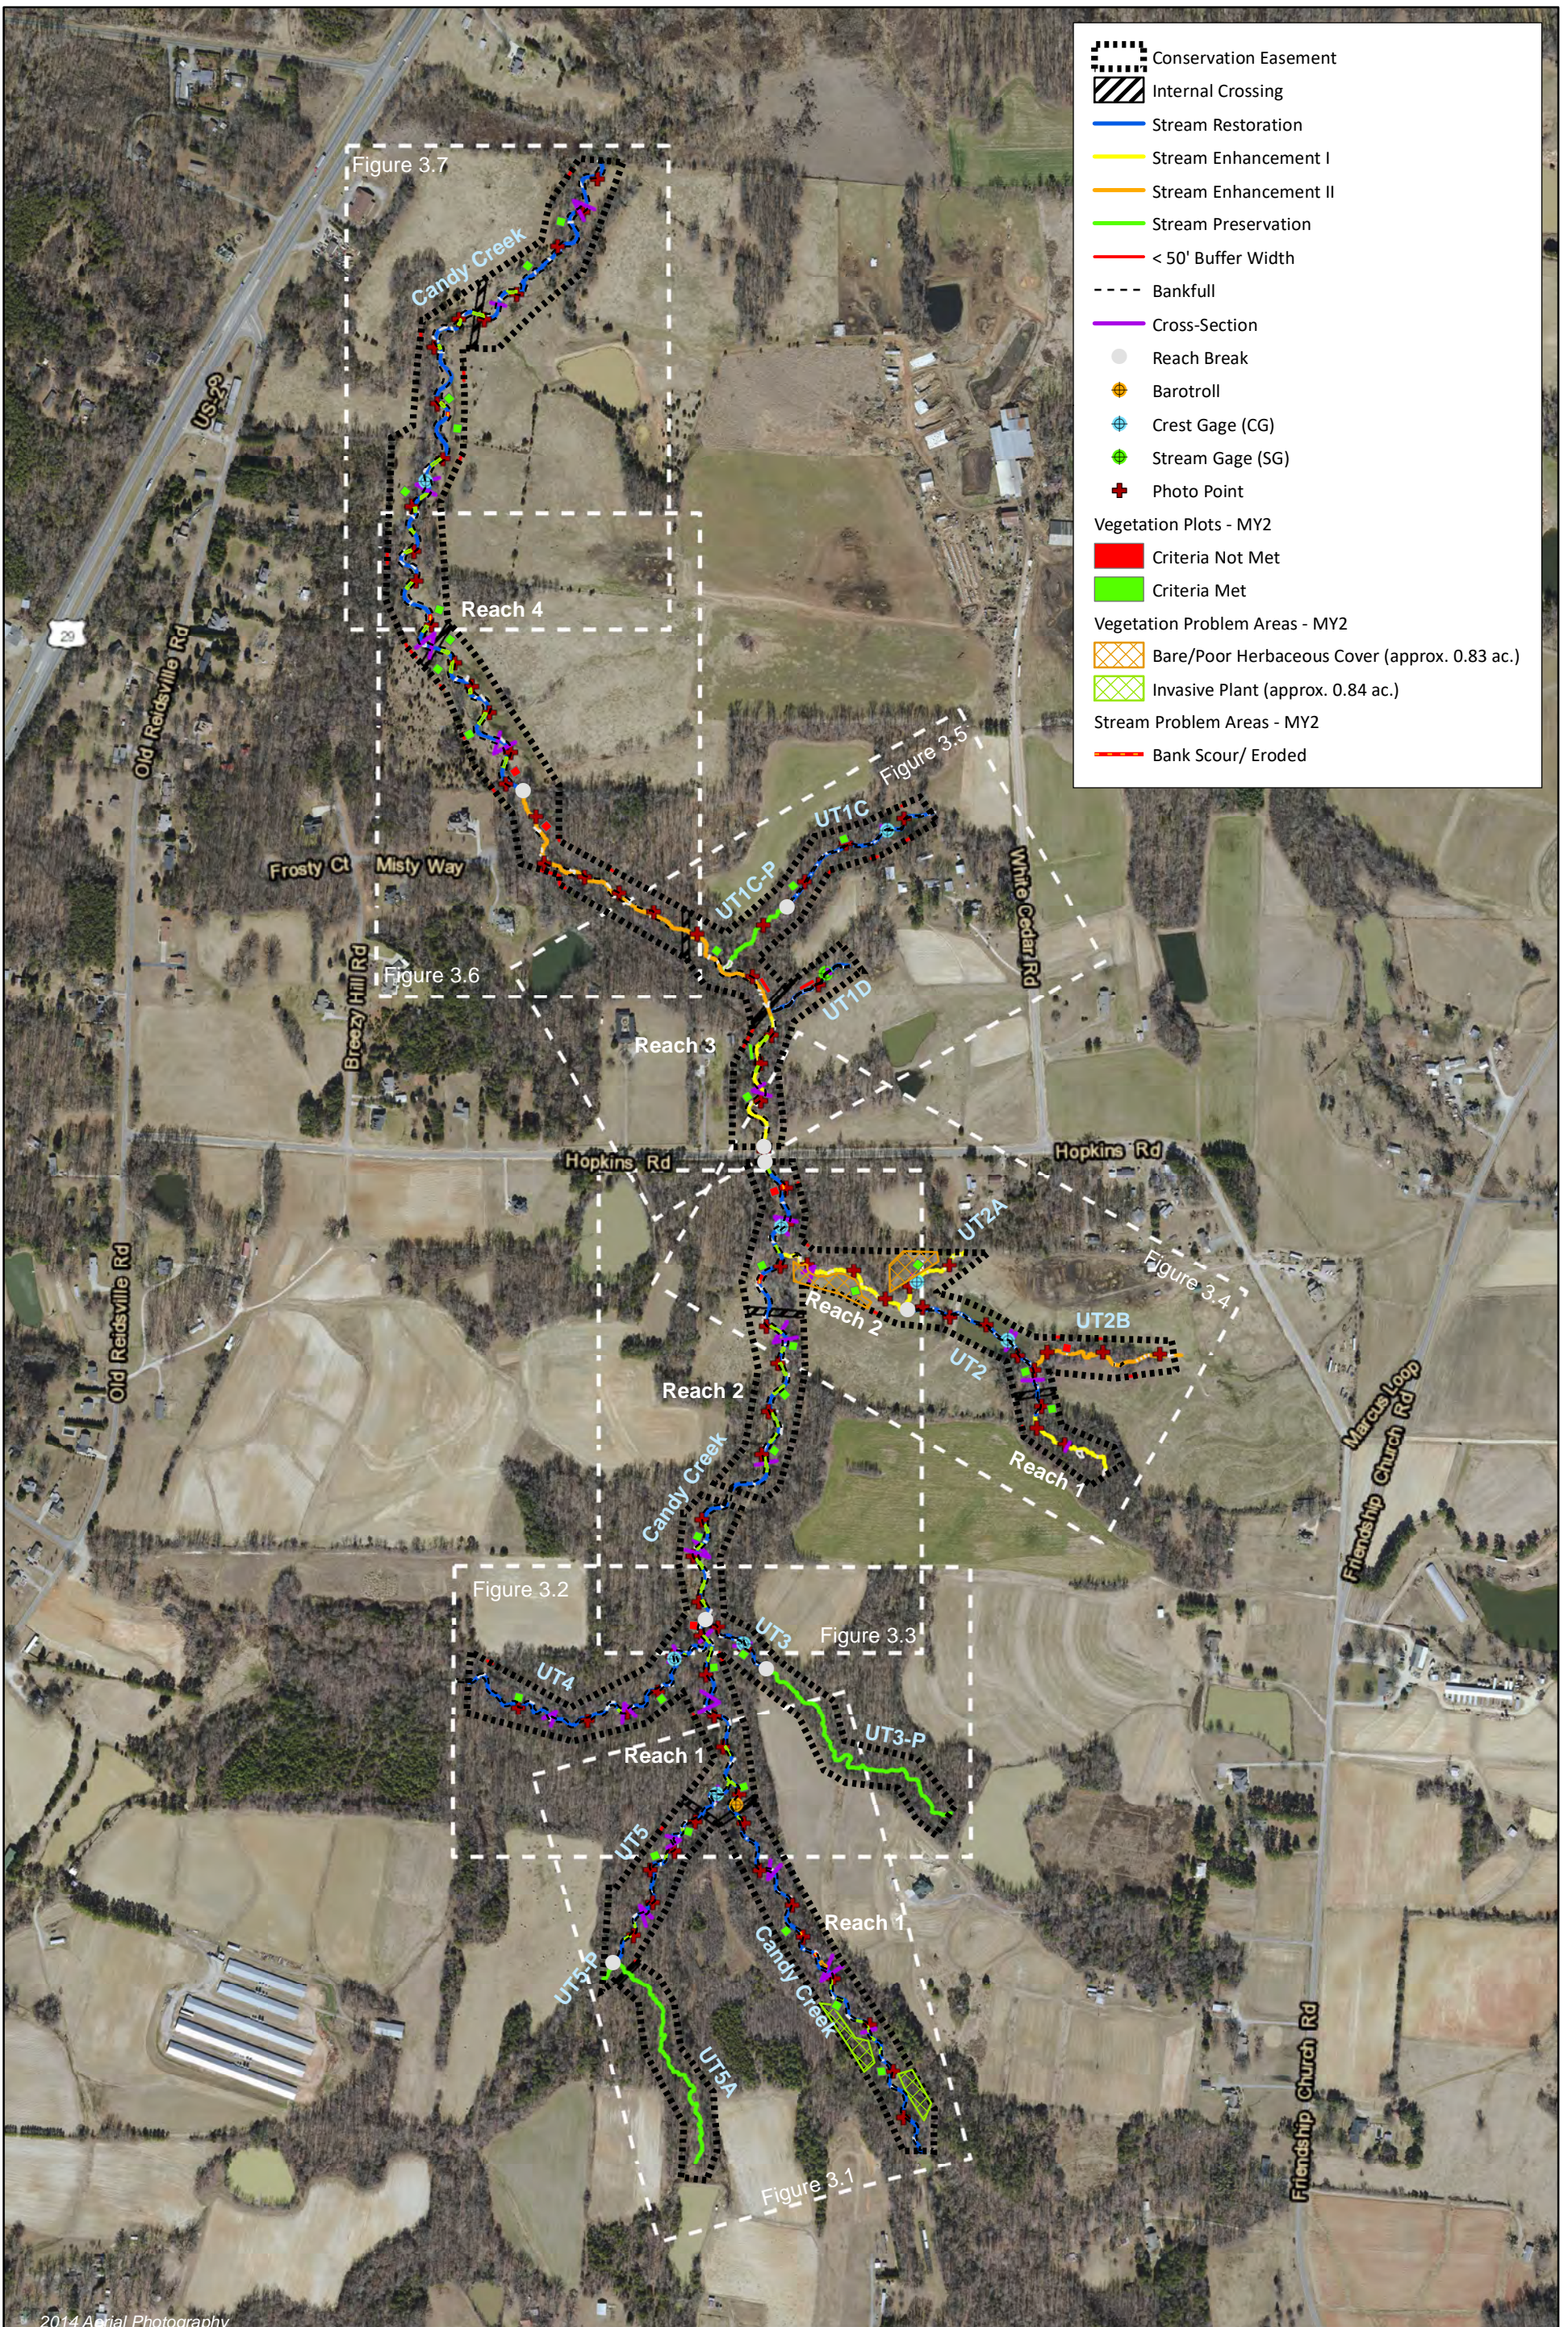
Figure 3.0 Integrated Current Condition Plan View  
 Candy Creek Mitigation Site  
 DMS Project No. 96315  
 Monitoring Year 2 - 2018  
 Guilford County, NC

In addition, the Site has several sections noted where the buffer width is less than 50 feet. The total length of these sections is approximately 3.1% of the total project length, less than the 5% allowed by the IRT. Please refer to Figures 2 and 3.

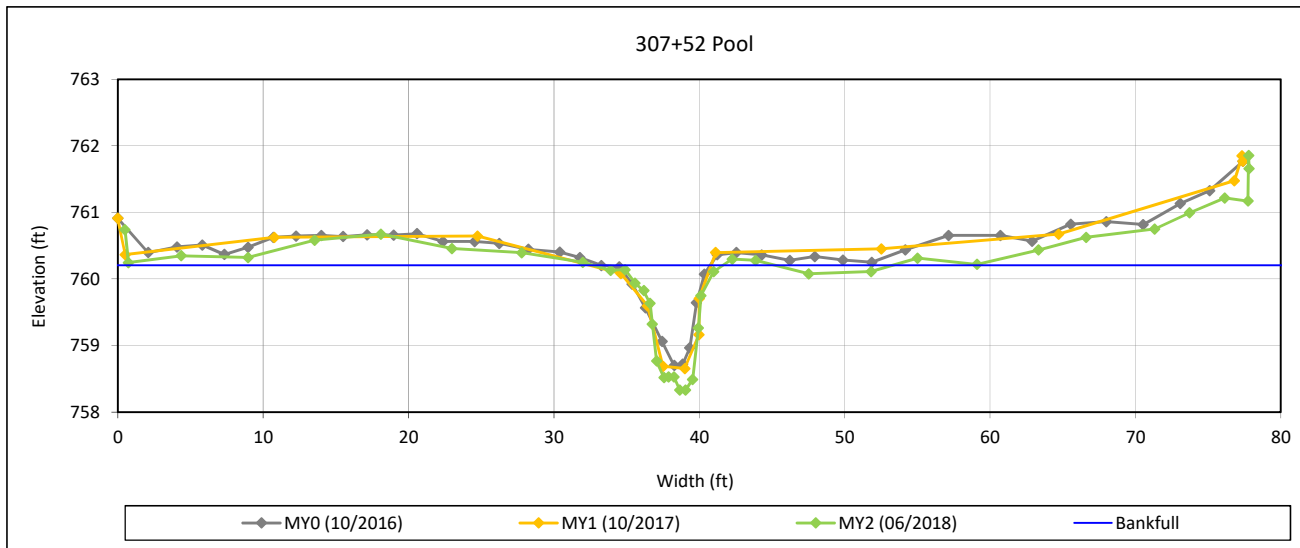
#### Cross-Section 32 - UT2 Reach 1

Morphological surveys for MY2 were conducted in June 2018. Bank erosion was observed within some isolated outside meander bends along Candy Creek Reach 1, 3 and 4, and slight scouring was also noted at cross-sections 32 and 33 on UT2 Reach 1; however, none of these areas are significant and the streams are functioning as designed. The remainder of the cross-sections appear consistent and all streams appear stable. Entrenchment ratios vary slightly from year to year due to minor changes in bankfull widths. Pools are deepening with point bar deposition occurring. Small adjustments in riffle widths occur due to vegetation, sediment deposition, and many other factors. These minor changes do not indicate channel instability. Refer to Appendix 2 for the visual stability assessment table, CCPV map, and reference photographs. Refer to Appendix 4 for the morphological data and plots.
