# MONITORING YEAR 6 ANNUAL REPORT

## CANDY CREEK MITIGATION SITE

Guilford County, NC  
NCDEQ Contract 5794  
NCDMS Project Number 96315  
USACE Action ID Number 2015-01209  
DWR Project Number 14-0334  
RFP Number 16-005568

Data Collection Period: February - October 2022  
Draft Submission Date: November 2022  
Final Submission Date: February 2023

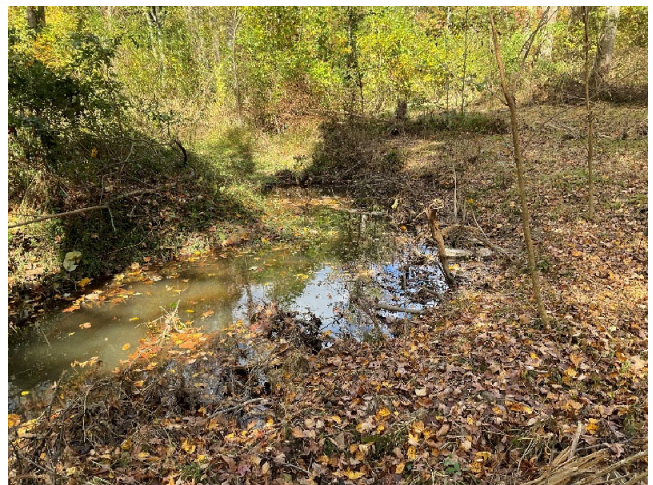
Candy Creek Reach 3 - Easement encroachment replanting  
at Hopkins Road,  
LB (Sta. 149+00-150+00) (10/19/2021)

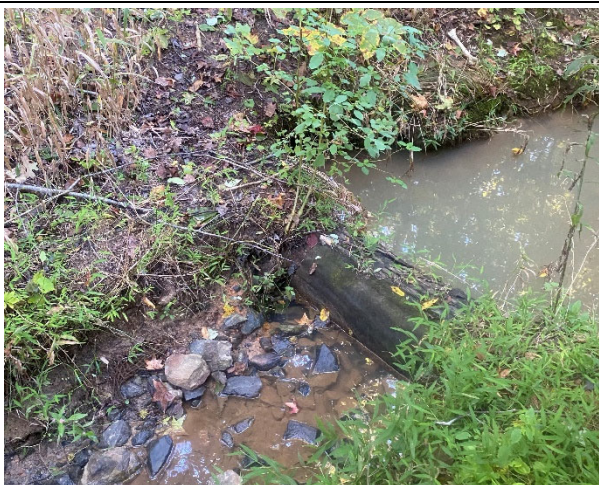
Candy Creek Reach 3 - Bank repair, RB (Sta. 151+70-152+00)  
(10/21/2022)

As was discussed during the IRT site walk in July 2021, machine repairs were scheduled for Candy Creek Reach 3 and UT1D. These repairs were performed in September 2022. The right bank of Candy Creek Reach 3 was reshaped to stop the outward erosion of the pool. A brush toe was added using the brush harvested from nearby trees that had fallen in the floodplain. The brush toe was capped with sod or woody transplants from the disturbed area along the bend. Originally these areas had been left to naturalize on their own because much of the area is wet and would not be conducive for planting container trees. However, after a brief discussion with DMS during the site walk in January 2023, Wildlands has decided to harvest live stakes on site and replant in the area in early 2023 where machine work was conducted. Trees that had fallen in the channel near the bridge across Candy Creek Reach 3 were also removed. Several large trees that had died and were likely to fall into the channel were removed or dropped into the conservation easement. The step-pool structures along UT1D were also repaired. Brush harvested from the channel debris removal was used to create mini brush toes where

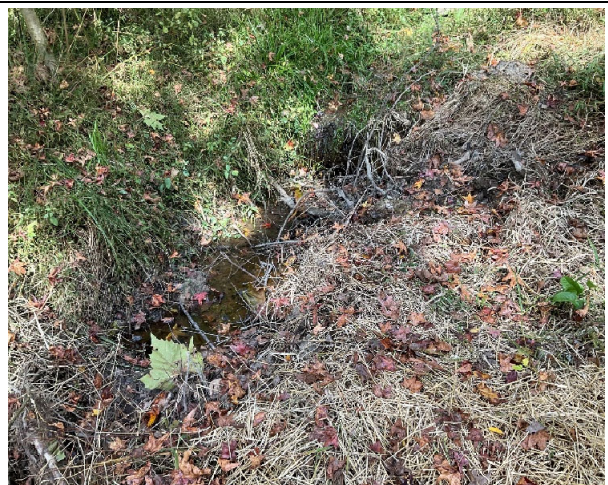
UT1C - Repaired structure (Sta. 207+25) (10/21/2022)

erosion was occurring below the sills. The brush was then capped with sod harvested from the floodplain. Both UT1C and UT1D will require additional manual repairs because water is still piping under the repaired structures. This work will be completed early in 2023. Photos of the repair areas are shown in the Areas of Concern and Improved Areas of Concern Photographs (Appendix 2).
