# Cane Creek Tributary Stream Restoration Site Monitoring Report MY03 Basin 03010104 / Contract # D06002

KCI Technologies, Inc.  
Landmark Center II, Suite 220  
4601 Six Forks Road  
Raleigh, NC 27609

NCDENR-EEP  
1652 Mail Service Center  
Raleigh, NC 27699-1652

January 2012

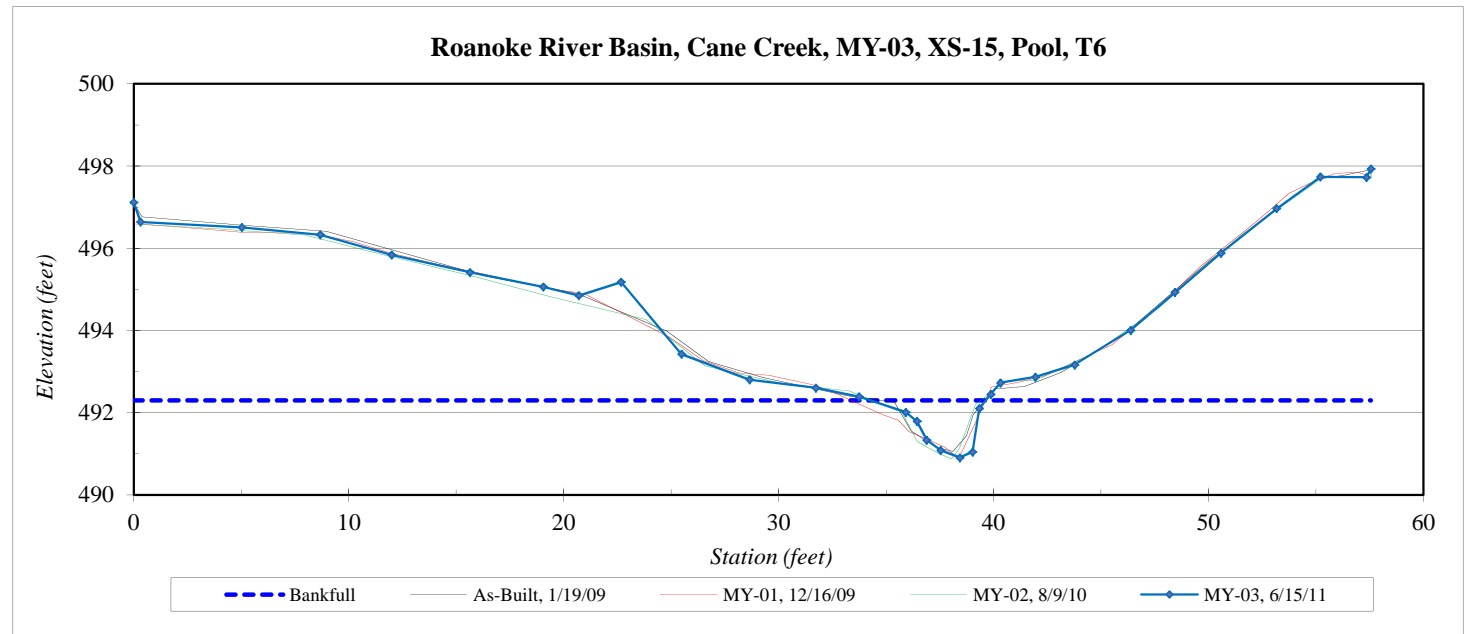
SUMMARY DATA	
<b>Bankfull Elevation:</b>	492.3
<b>Bankfull Cross-Sectional Area:</b>	4.4
<b>Bankfull Width:</b>	6.9
<b>Flood Prone Area Elevation:</b>	493.5
<b>Flood Prone Width:</b>	18.9
<b>Max Depth at Bankfull:</b>	1.2
<b>Mean Depth at Bankfull:</b>	0.6
<b>W / D Ratio:</b>	10.8
<b>Entrenchment Ratio:</b>	2.7
<b>Bank Height Ratio:</b>	1.0
