Cane Creek Stream Restoration Site

EEP Project #92325

Monitoring Year 05/Closeout

Submitted: January 2014

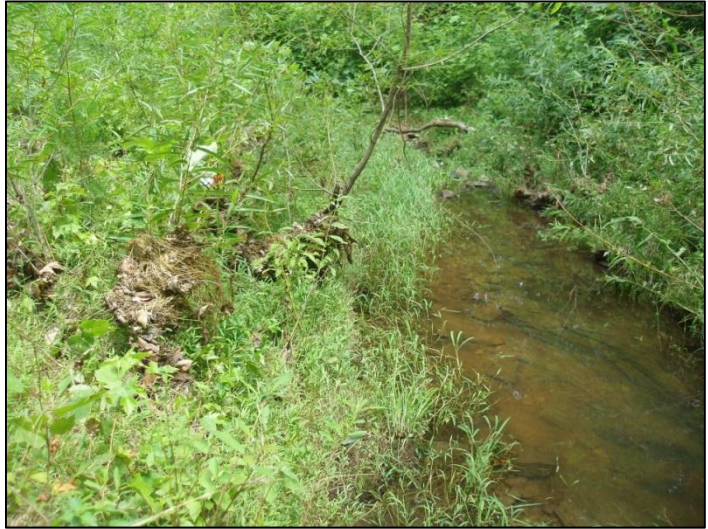
Photo taken July 24, 2013, depicting wrack lines on T7 floodplain near Stream Gauge 2.
