YEAR 1 (2008)
ANNUAL MONITORING REPORT
CANE CREEK RESTORATION SITE
RUTHERFORD COUNTY, NORTH CAROLINA

(CONTRACT D06027-E)
FULL DELIVERY PROJECT
BROAD RIVER BASIN
CATALOGING UNIT 03050105

November 2008

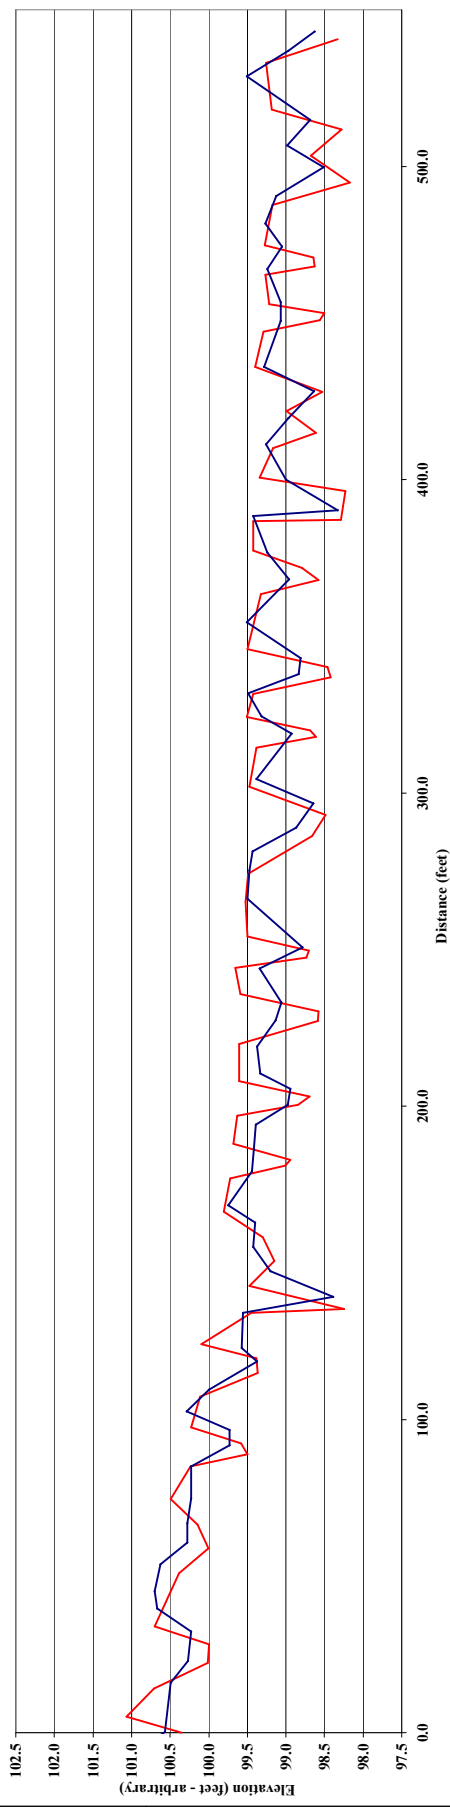
Cane Creek Profile - Reach 2

Note: Channel was dry at the time Year 1 measurements were collected; therefore, no water surface elevation is shown

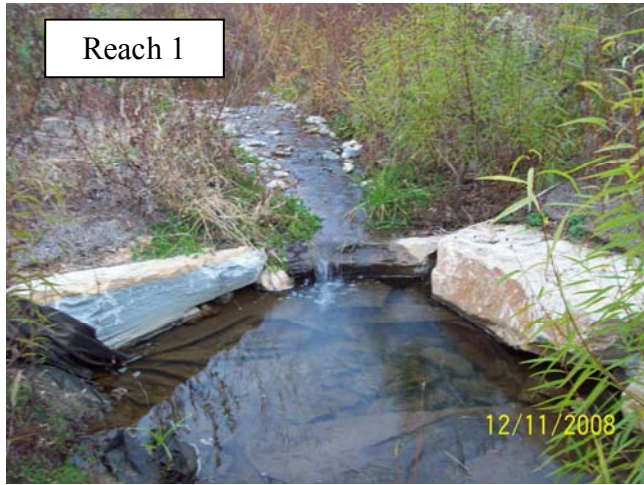
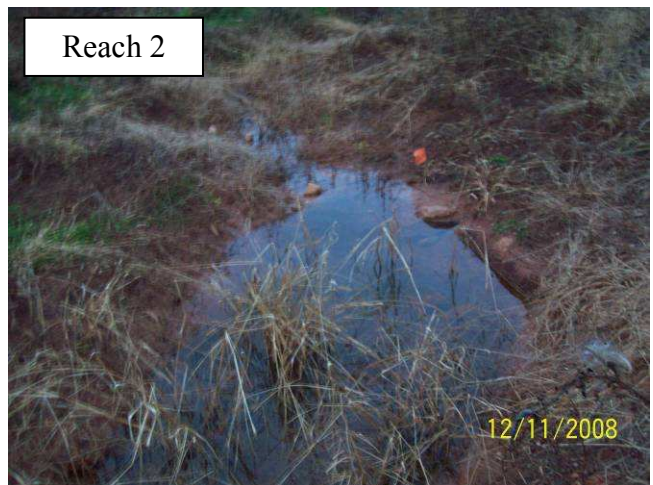
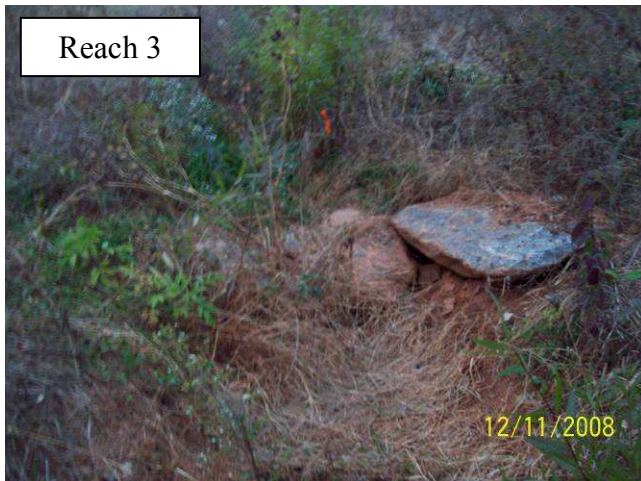
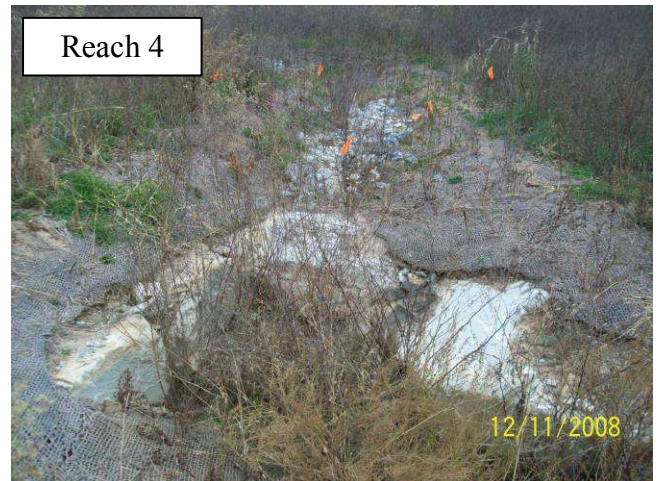
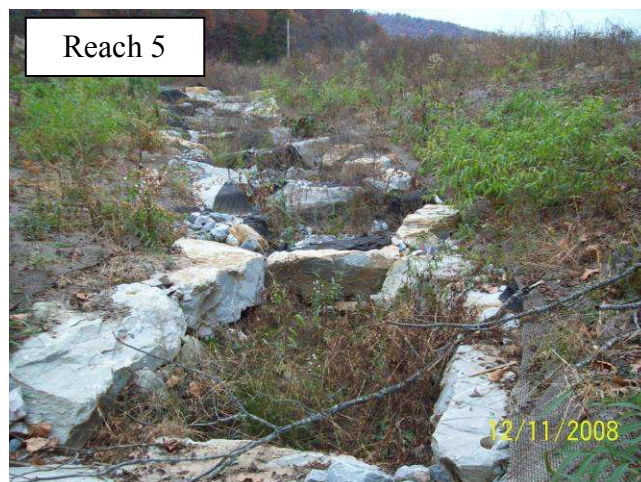
Cane Creek Stream and Wetland Restoration Site
Year 1 (2008) Annual Monitoring
Representative Structure Photos
Taken November 2008

Structures within Reaches 1 and 2 appear to have sunk slightly lowering the structure elevation within the channel; however, no instability has occurred upstream or downstream of the structures. In addition, one structure within Reach 3 has a minor amount of observed scour/piping; however, the scour/piping is minimal and is not causing any channel instability. Structures will continued to be monitored; however, no proactive measures are recommended at this time. The issues are minimal and are not causing any stream problems at this time.

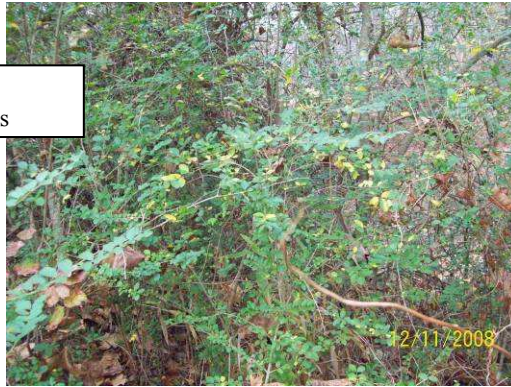
Photo 1
Brush Mattress

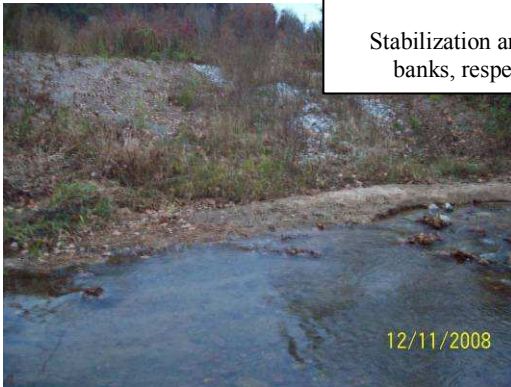
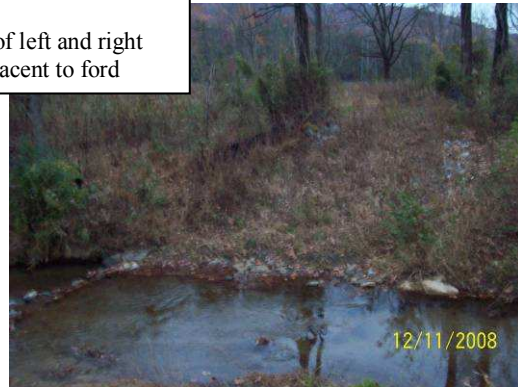
Photos 2-3
Stabilization and staking of left and right
banks, respectively, adjacent to ford

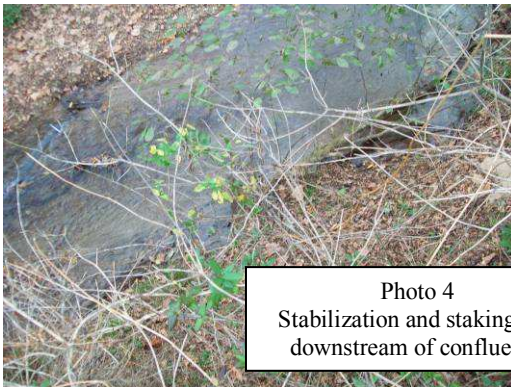
Photo 4
Stabilization and staking just
downstream of confluence

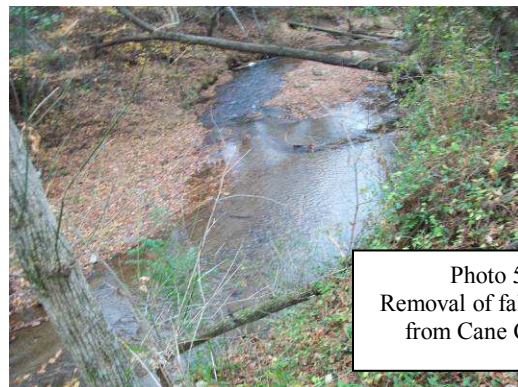
Photo 5
Removal of fallen tree
from Cane Creek

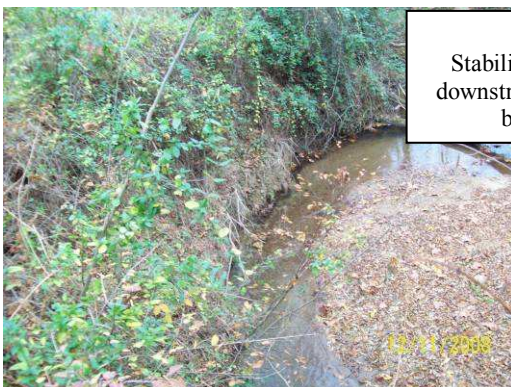
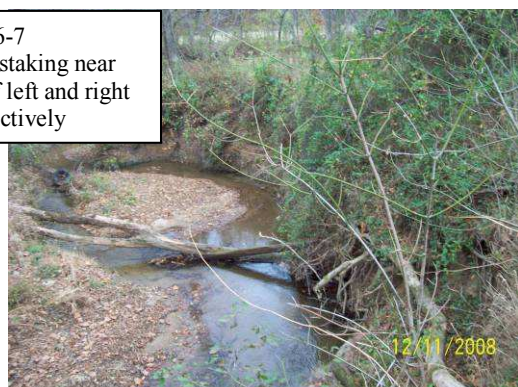
Photos 6-7
Stabilization and staking near
downstream end of left and right
banks, respectively
