**YEAR 2 (2009)**  
**ANNUAL MONITORING REPORT**  
**CANE CREEK RESTORATION SITE**  
**RUTHERFORD COUNTY, NORTH CAROLINA**

**(CONTRACT D06027-E)**  
**FULL DELIVERY PROJECT**  
**BROAD RIVER BASIN**  
**CATALOGING UNIT 03050105**

**October 2009**

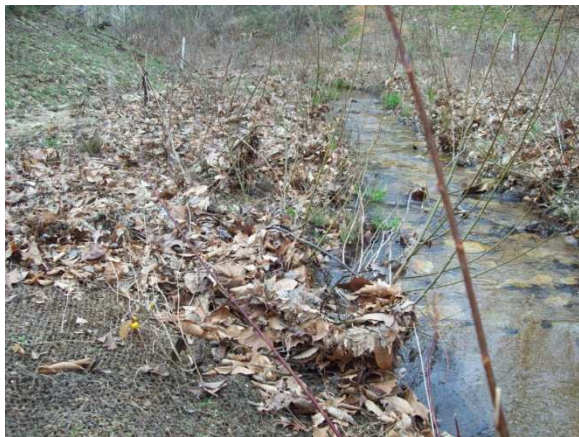
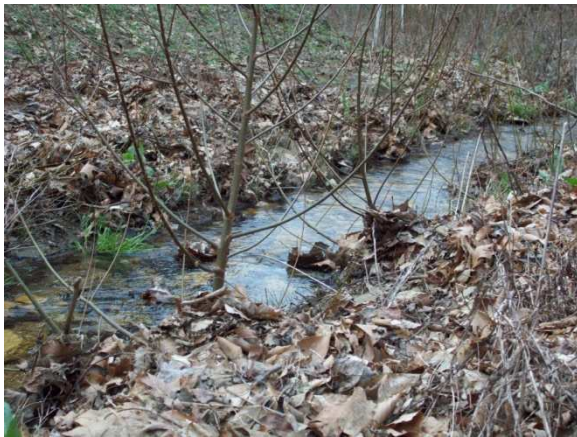
Date of Data Collection	Date of Occurrence	Method	Photo (if available)
March 12, 2009	March 2, 2009	A total of 3.65 inches of rain were documented to fall at the Site by an onsite rain gauge from February 27-March 2, 2009. In addition, wrack was observed adjacent to restored channels.	see below

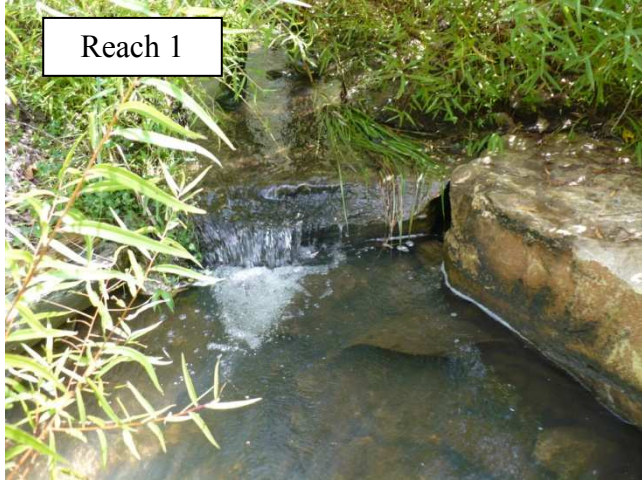
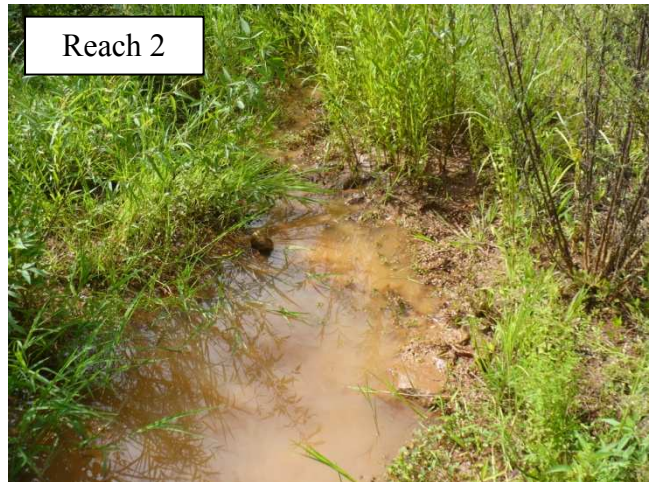
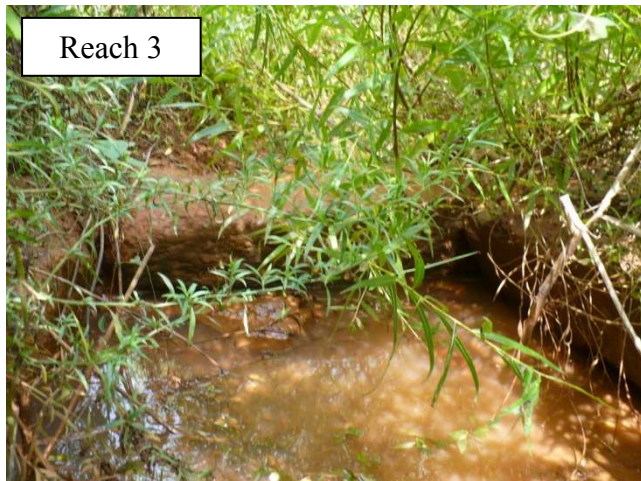
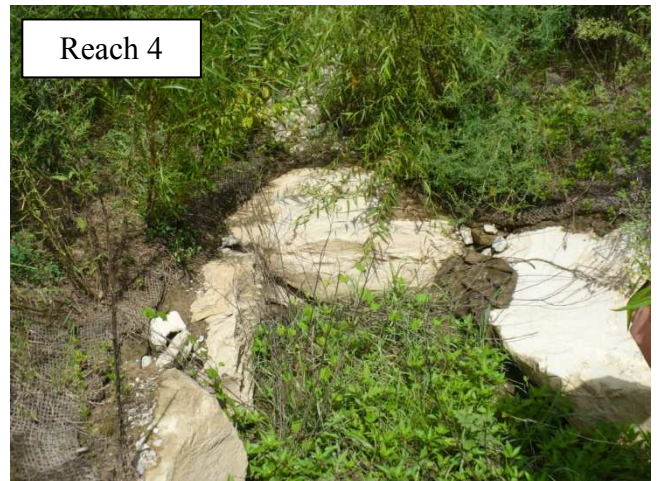
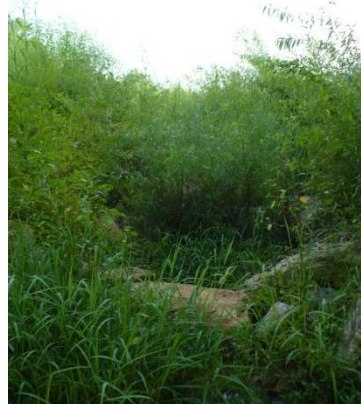
Structures within Reaches 1 and 2 appear to have sunk slightly lowering the structure elevation within the channel; however, no instability has occurred upstream or downstream of the structures. In addition, one structure within Reach 3 has a minor amount of observed scour/piping; however, the scour/piping is minimal and is not causing any channel instability. Structures will continued to be monitored; however, no proactive measures are recommended at this time. The issues are minimal and are not causing any stream problems at this time.

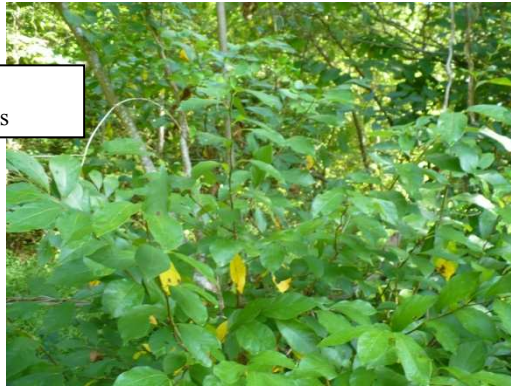
Photo 1  
Brush Mattress

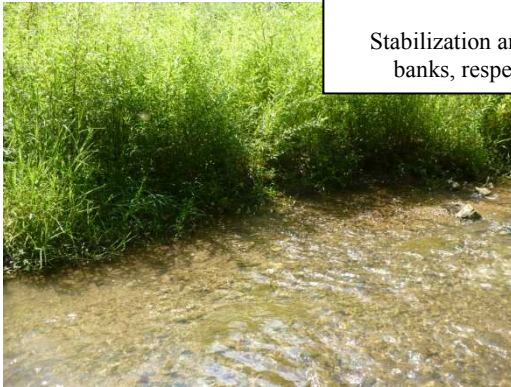
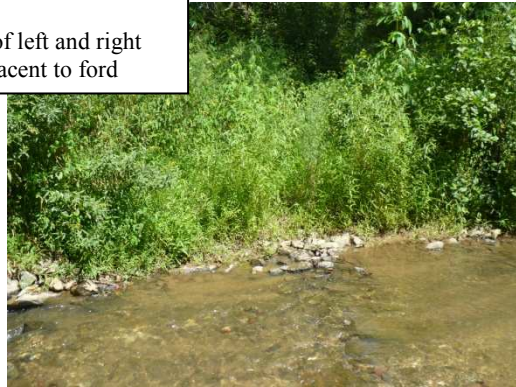
Photos 2-3  
Stabilization and staking of left and right  
banks, respectively, adjacent to ford

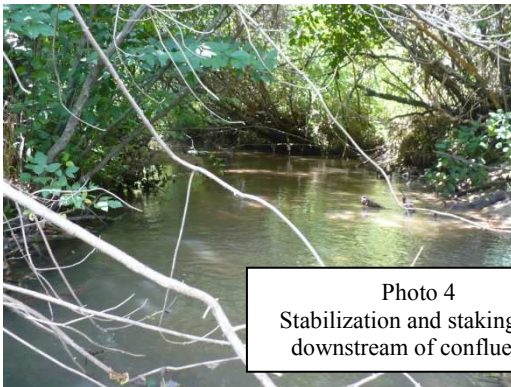
Photo 4  
Stabilization and staking just  
downstream of confluence

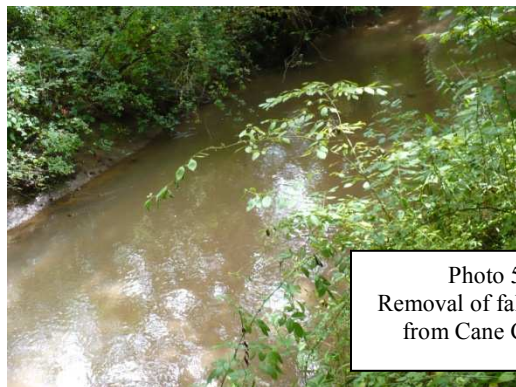
Photo 5  
Removal of fallen tree  
from Cane Creek

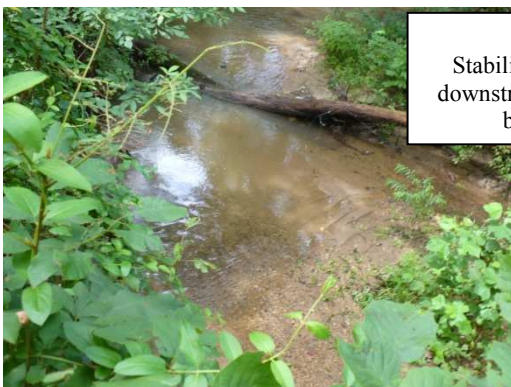
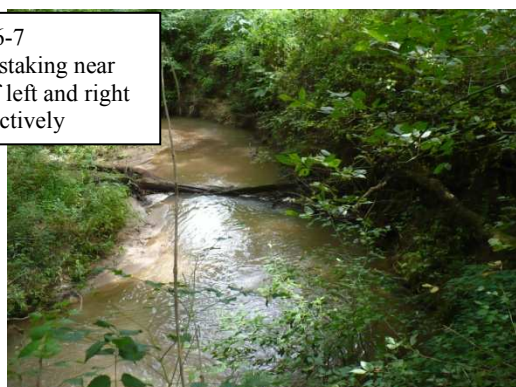
Photos 6-7  
Stabilization and staking near  
downstream end of left and right  
banks, respectively
