YEAR 3 (2010)
ANNUAL MONITORING REPORT
CANE CREEK RESTORATION SITE
RUTHERFORD COUNTY, NORTH CAROLINA

(CONTRACT D06027-E)
FULL DELIVERY PROJECT
BROAD RIVER BASIN
CATALOGING UNIT 03050105

September 2010

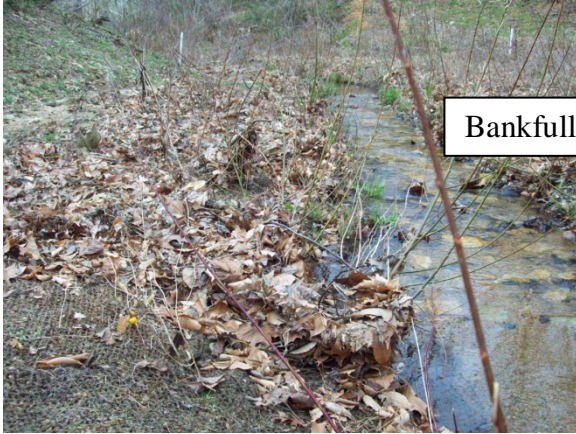
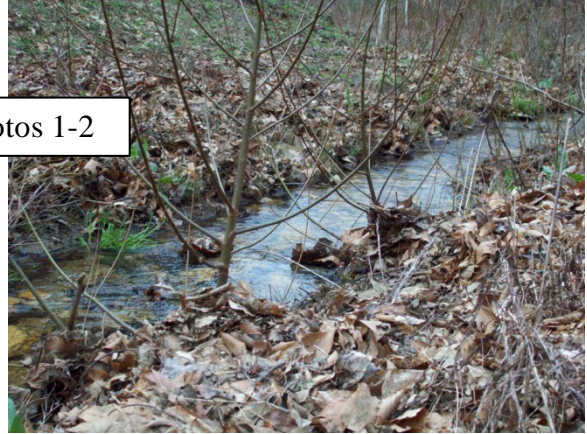
Bankfull Photos 1-2

Date of Data Collection	Date of Occurrence	Method	Photo
March 12, 2009	March 2, 2009	A total of 3.65 inches of rain were documented to fall at the Site by an onsite rain gauge from February 27-March 2, 2009. In addition, wrack was observed adjacent to restored channels.	1-2
November 30, 2009	November 11, 2009	A total of 2.3 inches of rain were documented to fall at the Site November 10-11, 2009*. In addition, wrack was observed adjacent to restored channels.	3
May 13, 2010	January 24, 2010	A total of 3.19 inches of rain were documented to fall at the Site January 24, 2010*. In addition, wrack was observed adjacent to restored channels.	4-5
September 28, 2010	August 19, 2010	A total of 4.63 inches of rain were documented to fall at the Site from August 13- 21, 2010*.	--
September 28, 2010	September 27, 2010	A total of 2.12 inches of rain were documented to fall at the Site from September 26-27, 2010*.	--

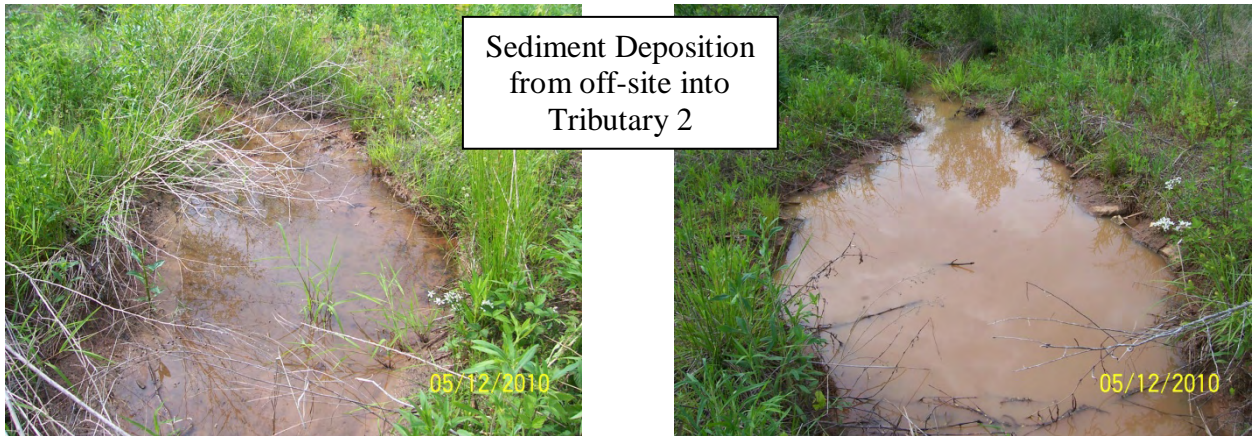
2.2.3 Stream Problem Areas

One stream problem area was noted within the Site during the Year 3 (2010) monitoring year. Clearing of land and subsequent erosion upstream of the Site has resulted in sediment input into the upper reaches of Tributary 2. Remedial actions are not recommended at this time; however, close monitoring of Tributary 2 will continue to occur.

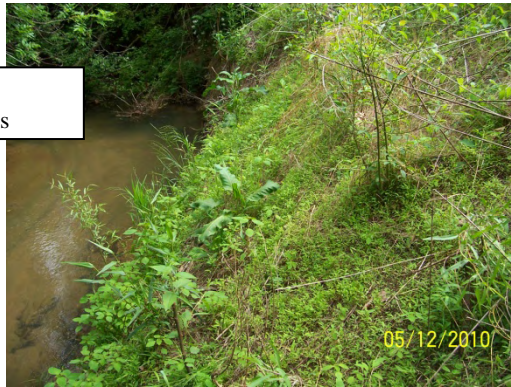
Photo 1
Brush Mattress

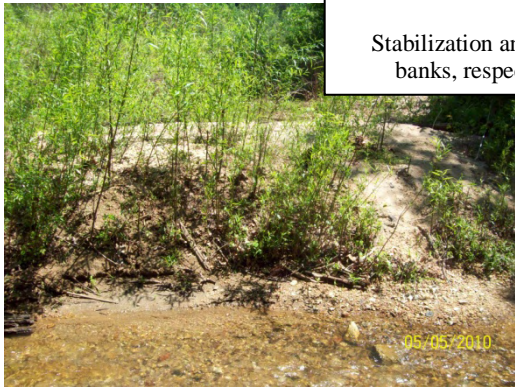
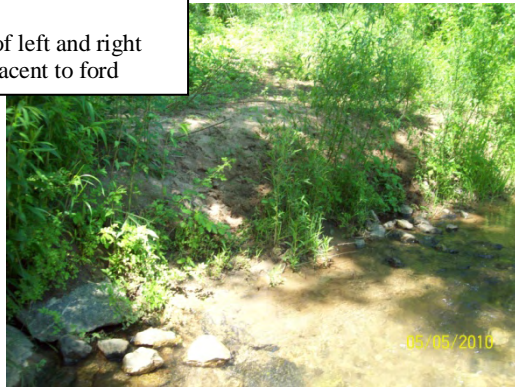
Photos 2-3
Stabilization and staking of left and right
banks, respectively, adjacent to ford

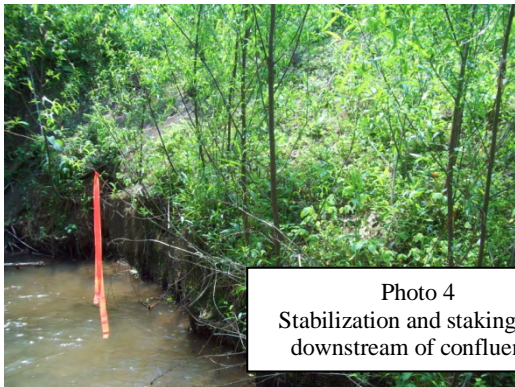
Photo 4
Stabilization and staking just
downstream of confluence

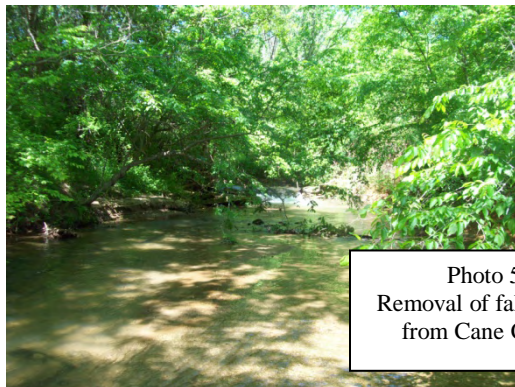
Photo 5
Removal of fallen tree
from Cane Creek

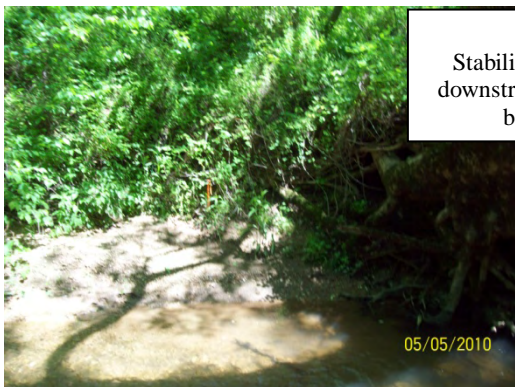
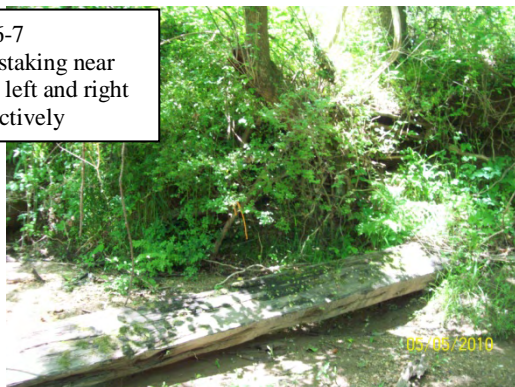
Photos 6-7
Stabilization and staking near
downstream end of left and right
banks, respectively
