YEAR 4 (2011)
ANNUAL MONITORING REPORT
CANE CREEK RESTORATION SITE
RUTHERFORD COUNTY, NORTH CAROLINA

(CONTRACT D06027-E)
FULL DELIVERY PROJECT
BROAD RIVER BASIN
CATALOGING UNIT 03050105

October 2011

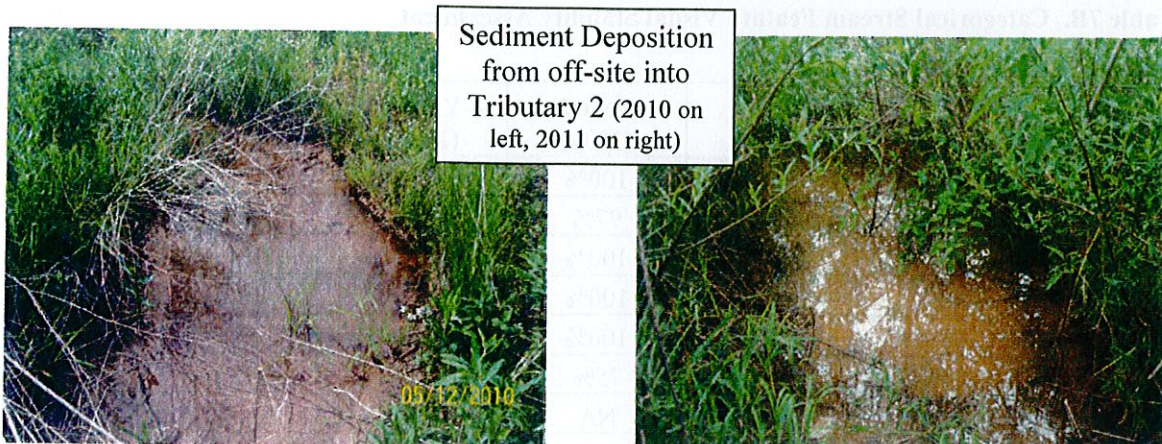
One stream problem area was noted within the Site during the Year 3 (2010) monitoring year. Clearing of land and subsequent erosion upstream of the Site has resulted in sediment input into the upper reaches of Tributary 2. Remedial actions are not recommended at this time; however, close monitoring of Tributary 2 will continue to occur.

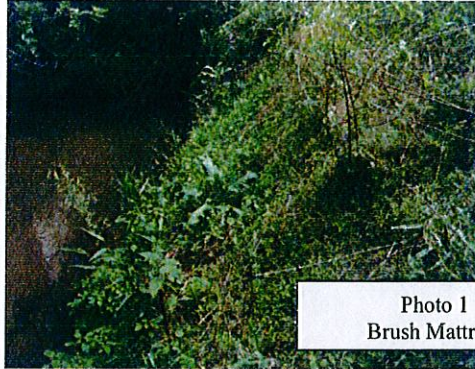
Photo 1
Brush Mattress

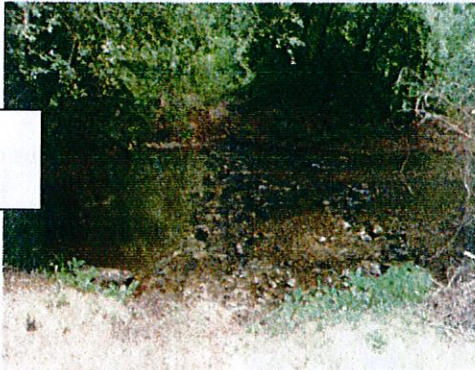
Photo 2-3
Stabilization and staking of left and right banks, respectively, adjacent to ford

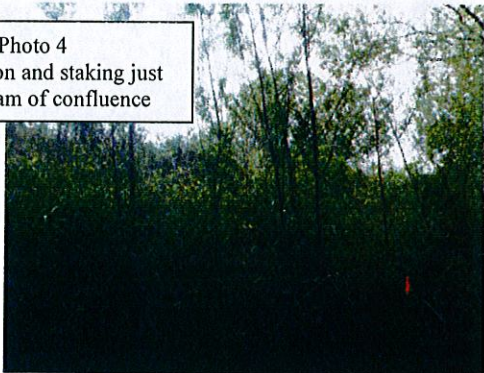
Photo 4
Stabilization and staking just downstream of confluence

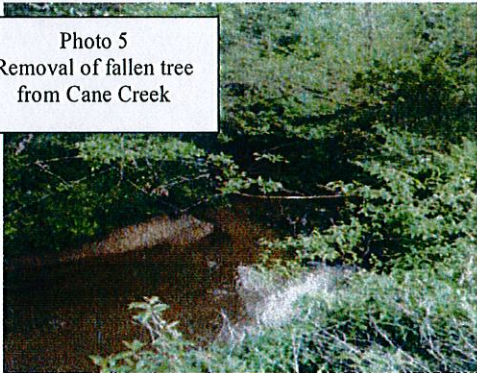
Photo 5
Removal of fallen tree from Cane Creek

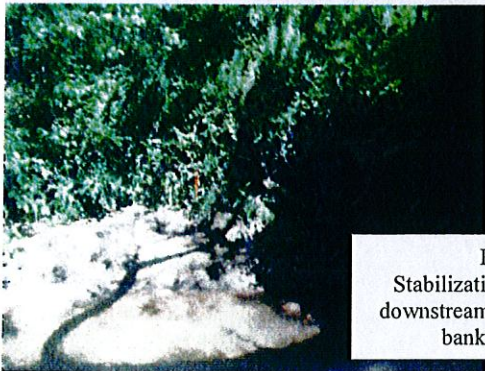
Photos 6-7
Stabilization and staking near downstream end of left and right banks, respectively

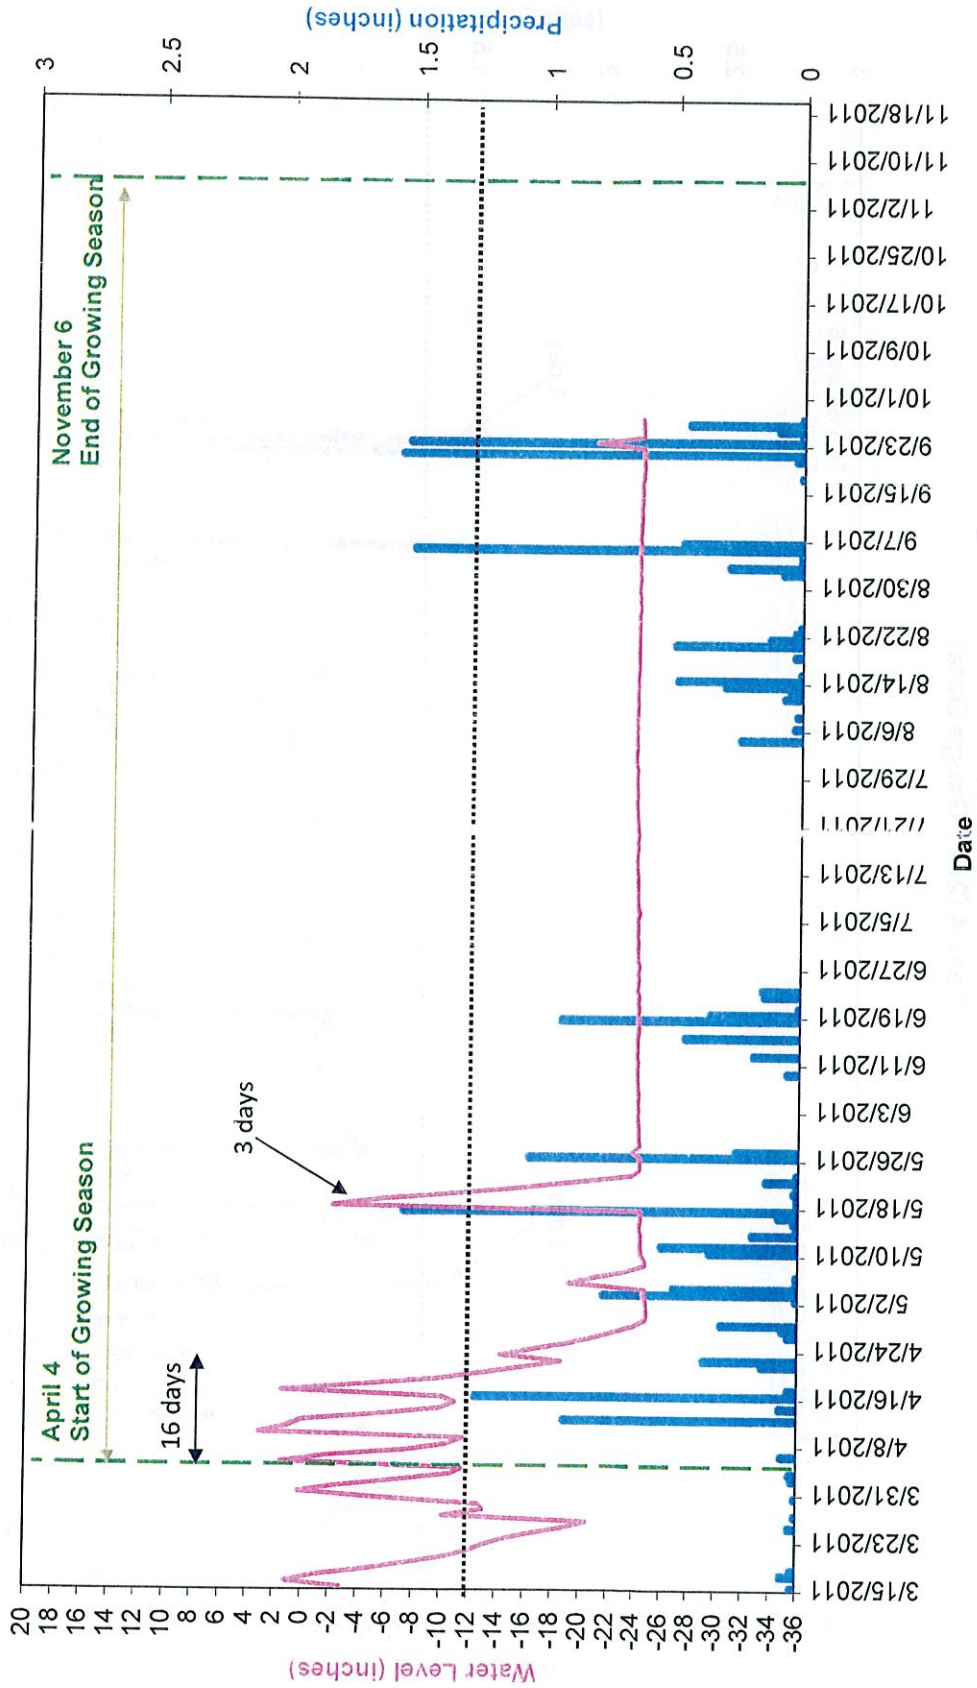
Cane Creek Groundwater Gauge 5 Year 4 (2011 Gauge Data)

One of the five monitored gauges (Gauge 5) within restoration areas was inundated/saturated within 12 inches of the surface for greater than 5 percent of the growing season, which extends from April 4 to November 6 (217 days) (Table 10). Hydrographs containing groundwater and precipitation data for each gauge can be found in Appendix B.
