**YEAR 5 (2012)**  
**ANNUAL MONITORING REPORT**  
**CANE CREEK RESTORATION SITE**  
**RUTHERFORD COUNTY, NORTH CAROLINA**

**(CONTRACT D06027-E)**  
**FULL DELIVERY PROJECT**  
**BROAD RIVER BASIN**  
**CATALOGING UNIT 03050105**

**November 2012**

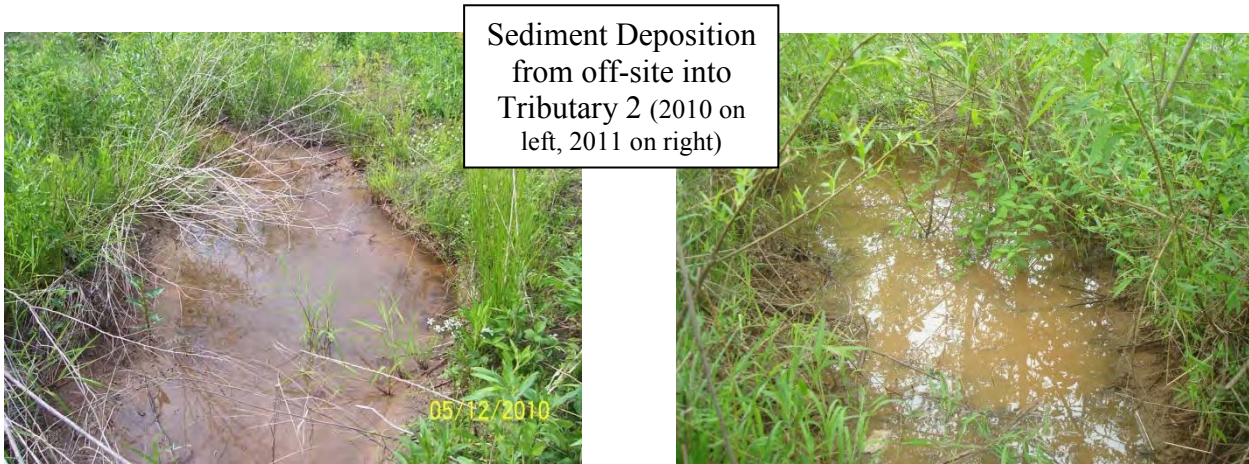
One stream problem area was noted within the Site during the Year 3 (2010) monitoring year. Clearing of land and subsequent erosion upstream of the Site has resulted in sediment input into the upper reaches of Tributary 2. Remedial actions are not recommended at this time; however, close monitoring of Tributary 2 will continue to occur.

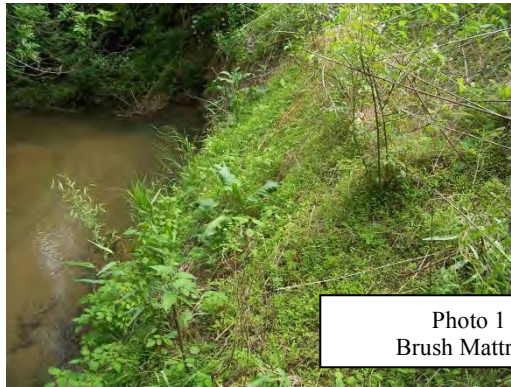
Photo 1  
Brush Mattress

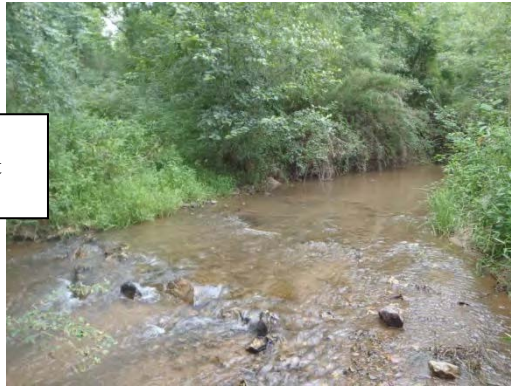
Photo 4  
Stabilization and staking just  
downstream of confluence

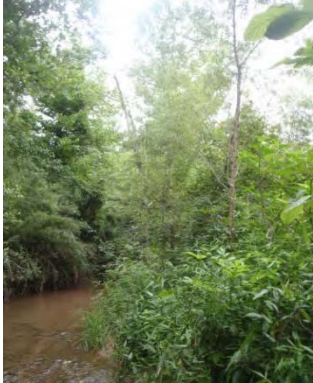
Photo 5  
Removal of fallen tree  
from Cane Creek

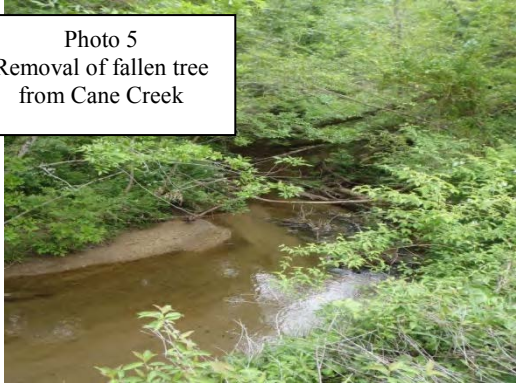
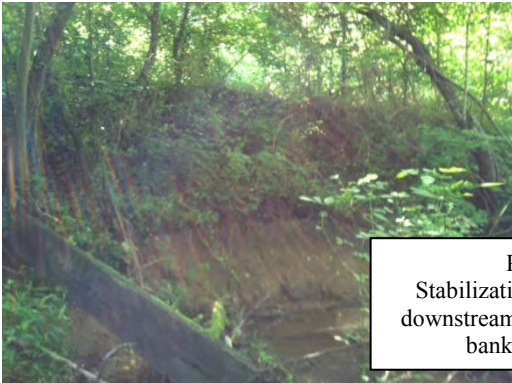
Photos 6-7  
Stabilization and staking near  
downstream end of left and right  
banks, respectively
