MONITORING YEAR 1 ANNUAL REPORT FINAL

CARPENTER BOTTOM MITIGATION SITE

Gaston County, NC
Catawba River Basin
HUC 03050102
(03050103 Expanded Service Area)

DMS Project No. 100090
NC DEQ Contract No. 7731
DMS RFQ No. 16-007133-CT03
Date of Issue: April 24, 2017
USACE Action ID No. SAW-2018-02062
DWR Project No. 2019-0049
Data Collection Dates: March – November 2022

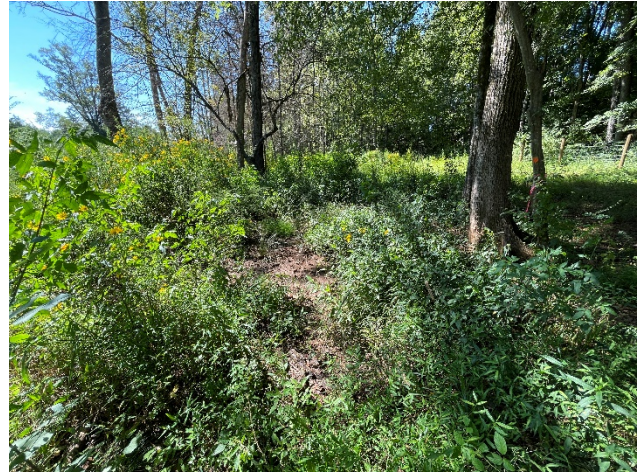
FLOODPLAIN POOL 1 (FP1):
Maximum water depth: 0.50 feet.
(8/31/2022)

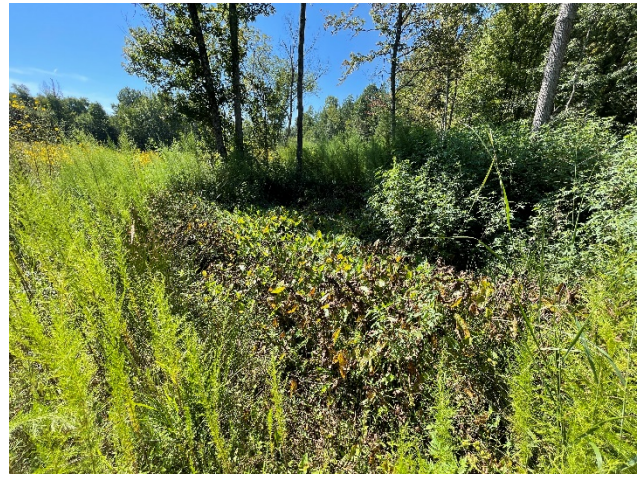
FLOODPLAIN POOL 3 (FP3):
Maximum water depth: 0.00 feet (i.e., dry).
(8/31/2022)

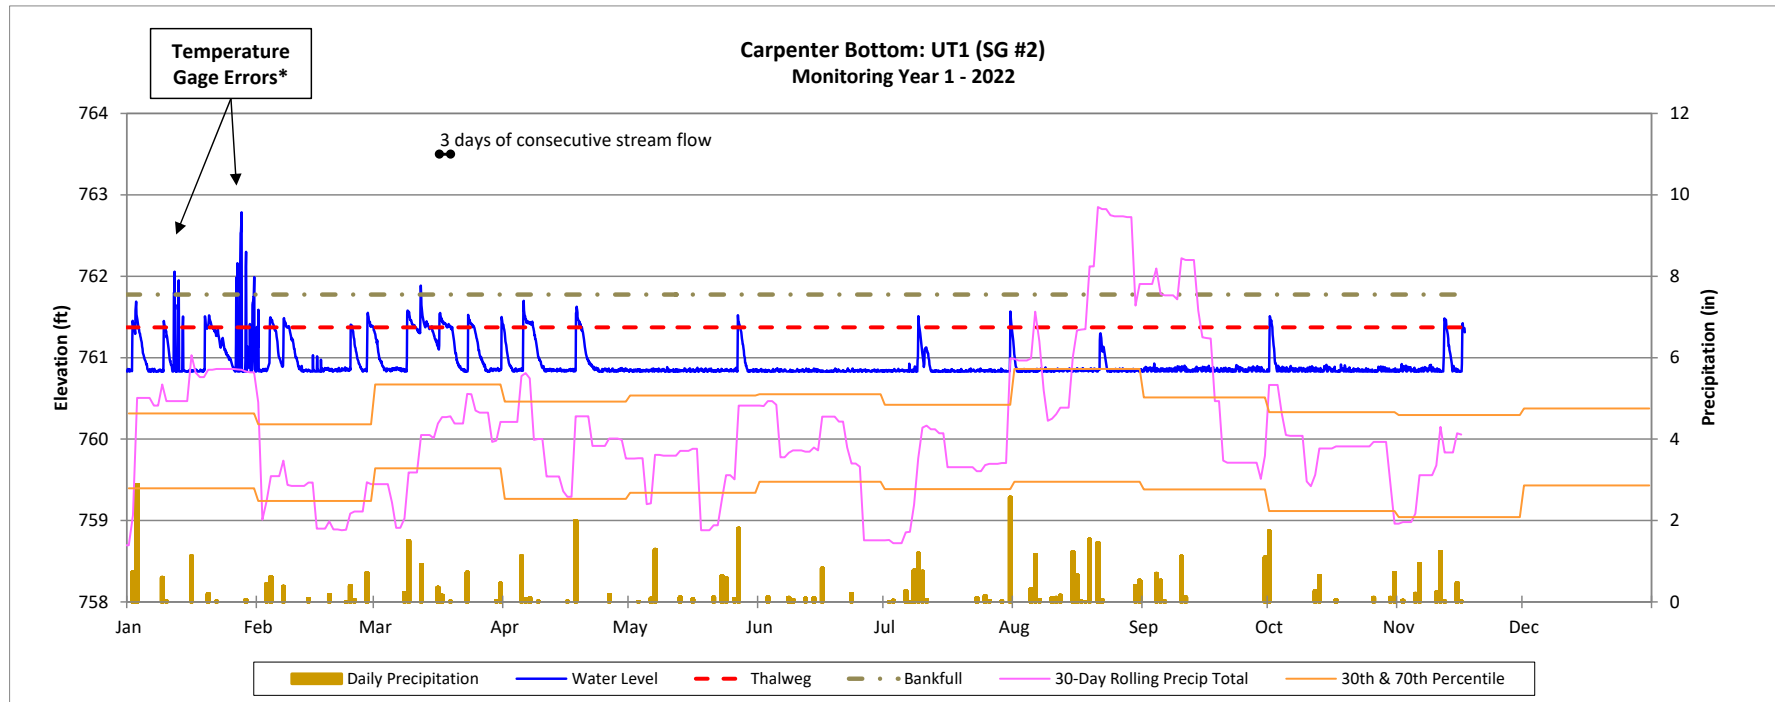
* - Probe recorded false readings, likely due to sub-freezing temperatures. 1/12 - 1/31/2022. Bankfull events during this timeframe don't count towards performance criteria.
