MONITORING YEAR 2 ANNUAL REPORT FINAL

CARPENTER BOTTOM MITIGATION SITE

Gaston County, NC
Catawba River Basin
HUC 03050102
(03050103 Expanded Service Area)

DMS Project No. 100090
NC DEQ Contract No. 7731
DMS RFQ No. 16-007133-CT03
Date of Issue: April 24, 2017
USACE Action ID No. SAW-2018-02062
DWR Project No. 2019-0049
Data Collection Dates: January – November 2023

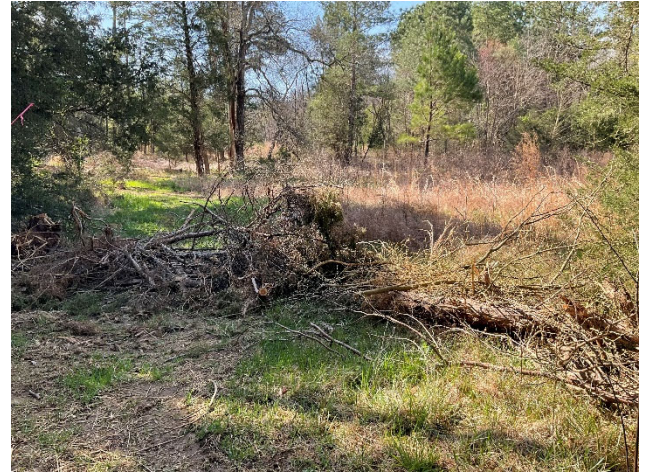
Encroachment 1 – Resolved mowing encroachment in upstream floodplain (11/14/2023)

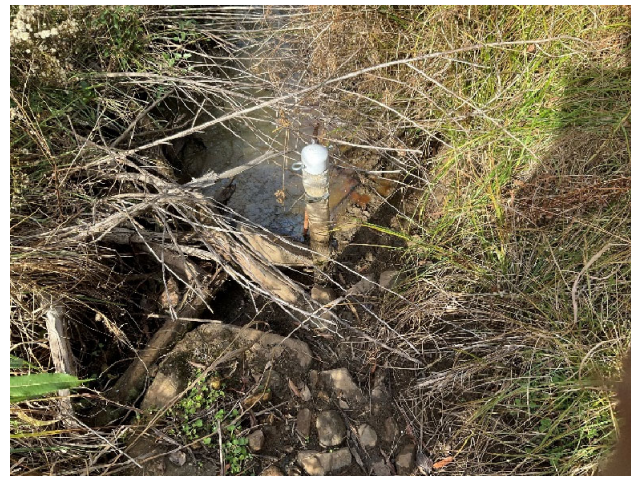
Photo 9 – UT2 – No flow. This photo was taken during a site visit and confirms the water level data shown in the Recorded In-Stream Flow Events Plot (11/14/2023)
