**As-built report for the Carp Mitigation Site,  
Unnamed Tributary to Laxon Creek,  
Watauga County**

**North Carolina Wildlife Resources Commission**

**May 2001**

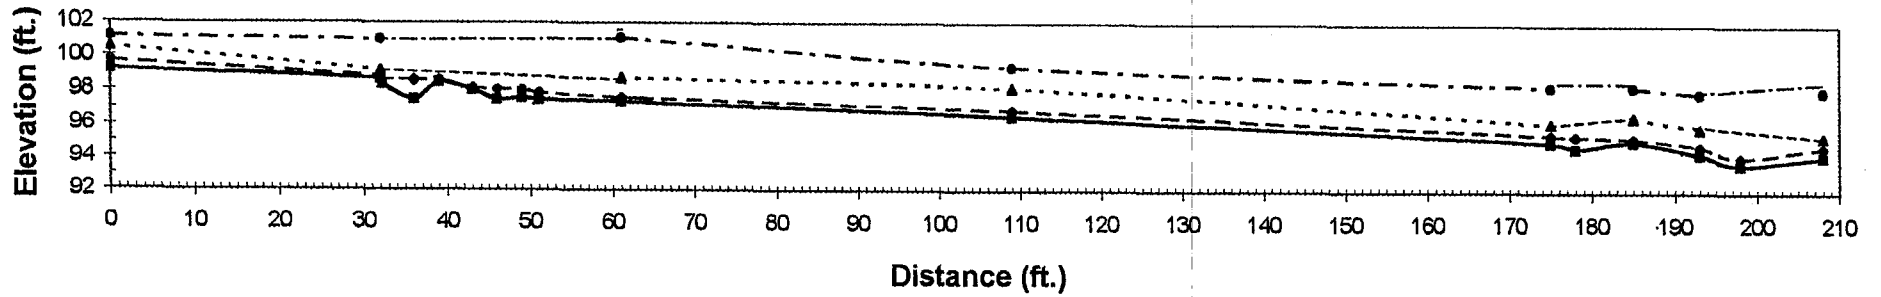
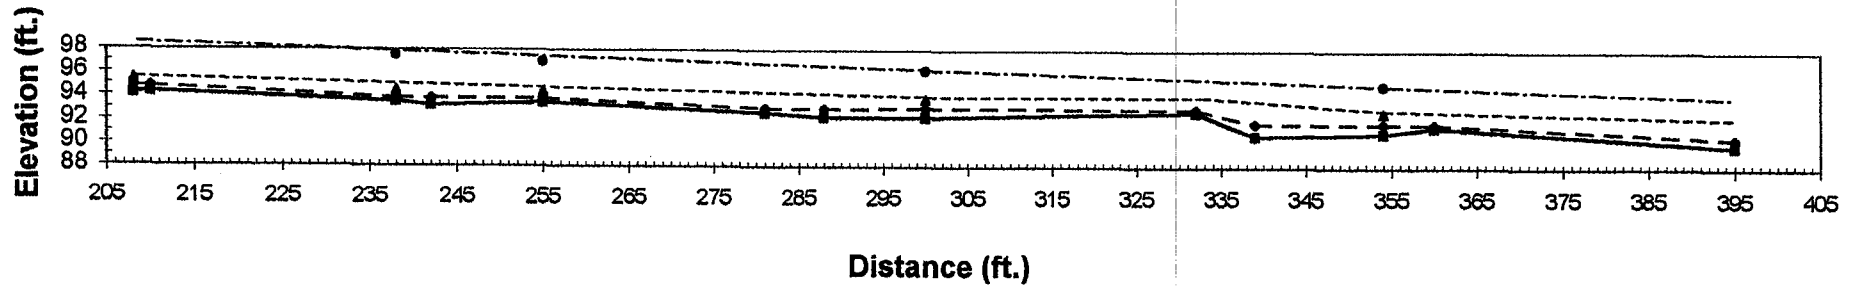
**Figure 3. Pre-Construction Longitudinal Profile - Carp Site, UT Laxon Creek**

The pre-construction and post-construction longitudinal profiles (Figures 3 & 4) show how the priority I construction has increased stream length and deep-water habitat. The scour action of root wad meanders, rock weirs, and rock and log vanes can be observed from the as-built profile (Figure 4). Pool habitat has increased from 26% to 44%. The weirs and vanes are creating the desired deep-water habitat and sorting bed material in a way that will provide needed fish spawning gravel.

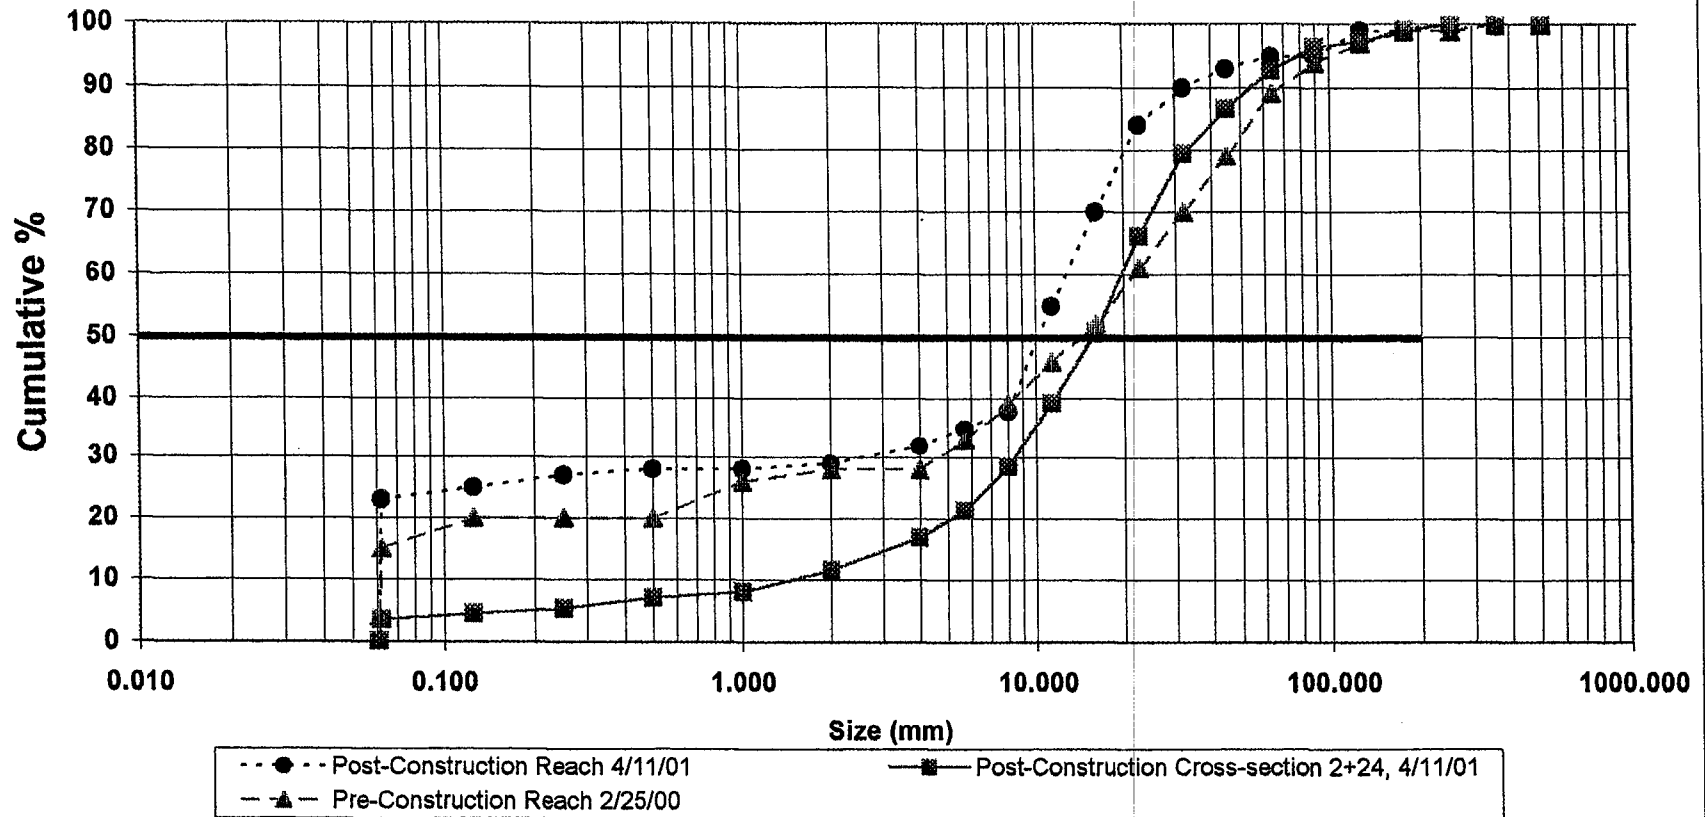
Figure 5. Pebble Count Carp - UT Laxon Creek

Figure 5 summarizes post and pre-construction pebble count data. Post-construction pebble count data for the reach shows a decline in particle size when compared to pre-construction data. This can be explained due to an increase in pool habitat which contains smaller particle sizes and a decrease in slope following construction (B to C channel type). As the stream bottom becomes more stable over time, it is expected that particle size through the reach should increase slightly.

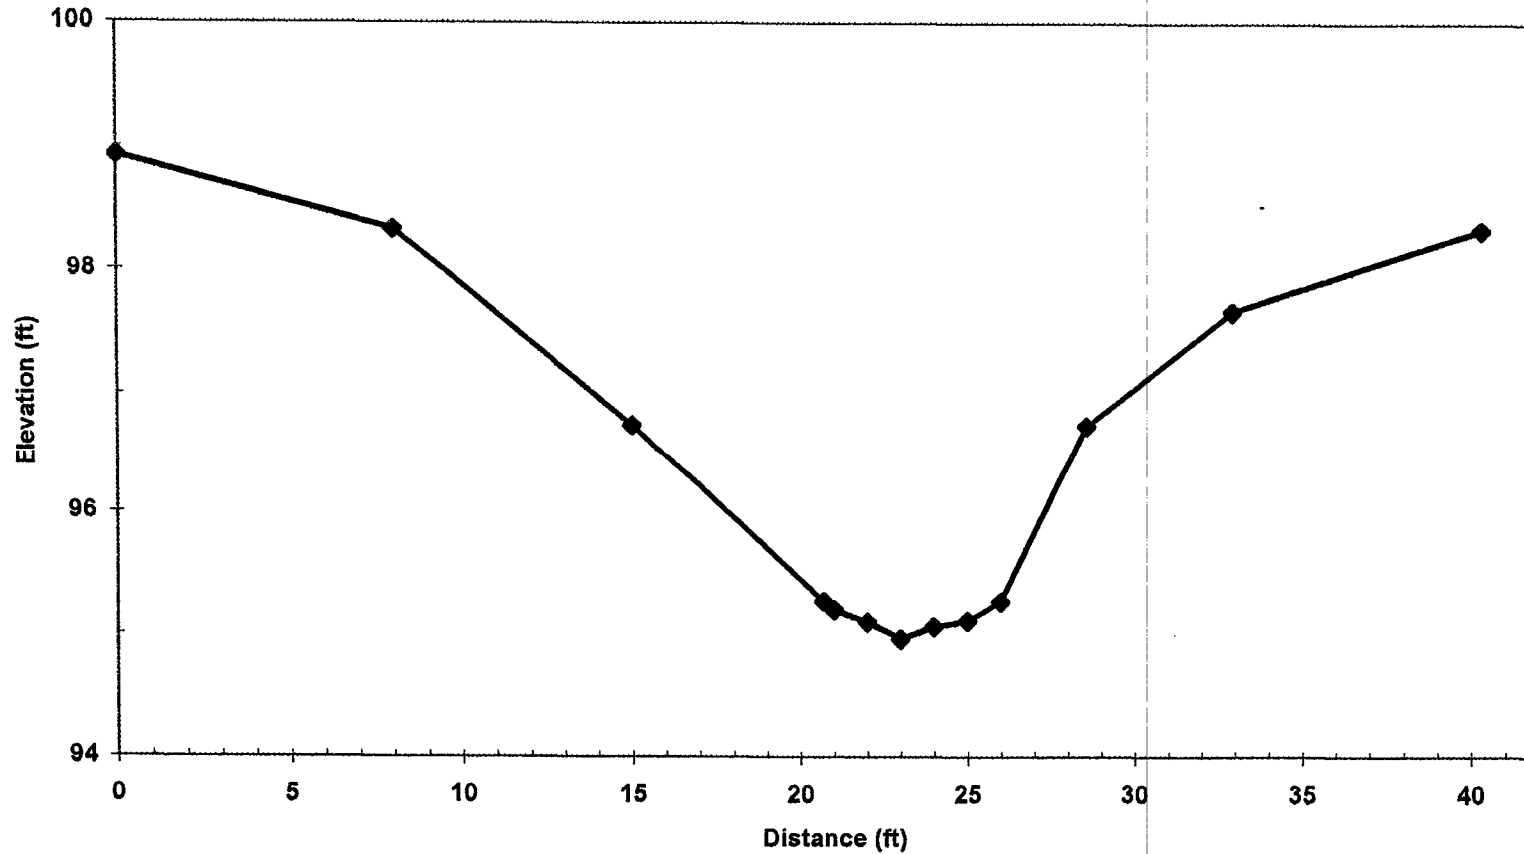
**Figure 6c. Carp - UT Laxon Creek**  
**Cross Section STN #2+24 Riffle between rock weirs**

Figure 6 shows post construction cross-sections of the new channel. These cross-sections will be used to monitor long-term channel stability. Based on data from the riffle cross-section at station 2+24 (Figure 6c), the new channel is classified as a C4e (Table 1).

2+24	Feature	Type	Wfpa	LBKF	RBKF	ELEVbkf	Wbkf	Dbkf	W/D	Abkf	Dmax	ER
Existing	Riffle	C4e	40	15.0	28.6	96.74	13.6	0.9	14.4	12.9	1.8	2.9

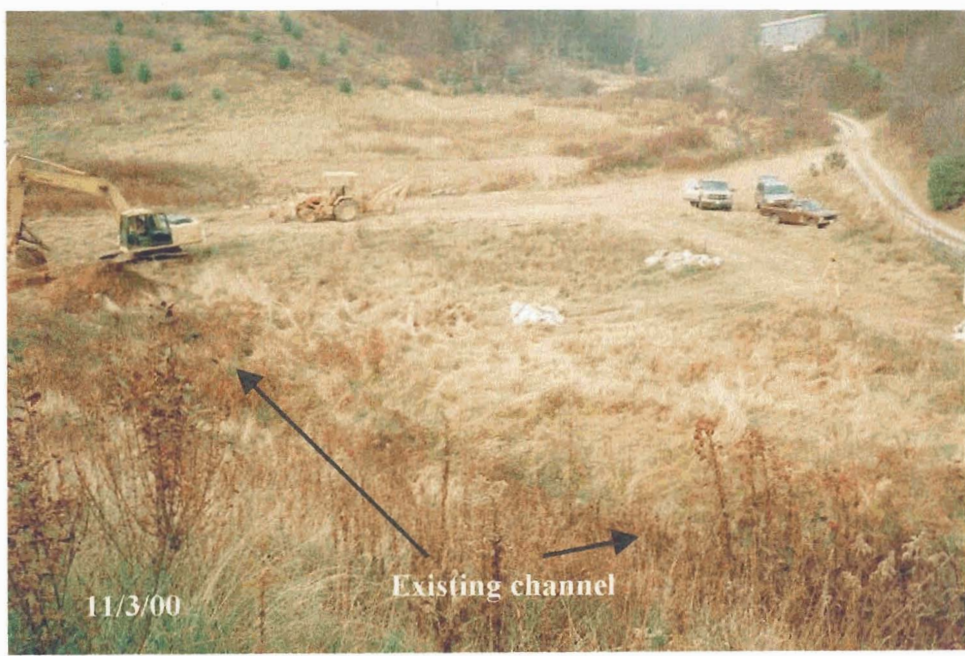
**New channel location before construction.**

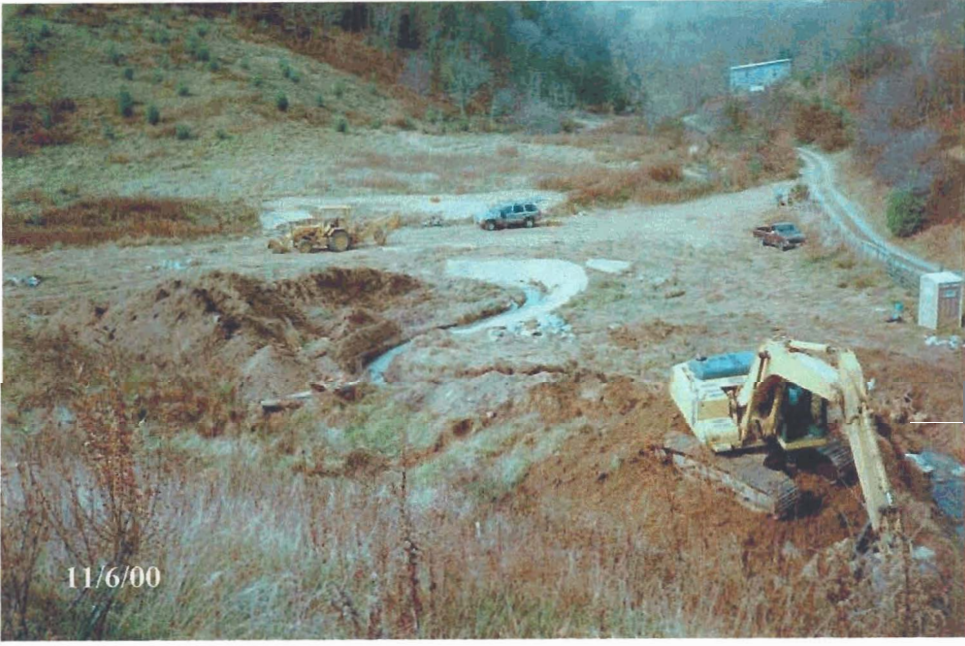
**Construction of new channel pools and riffles. The outside of meanders are stabilized with root wads.**

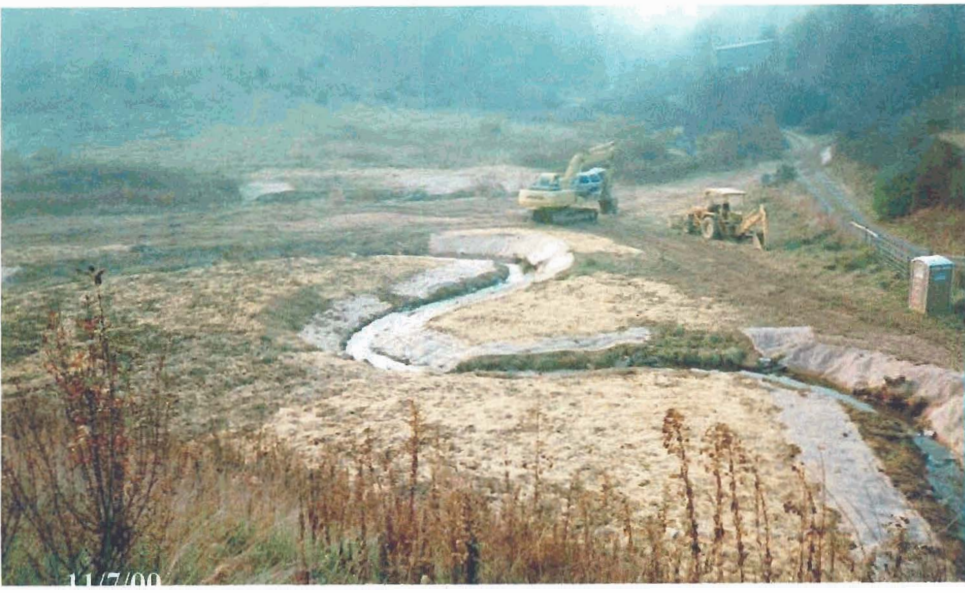
**New Channel completed, station 1+28 - 4+32.**

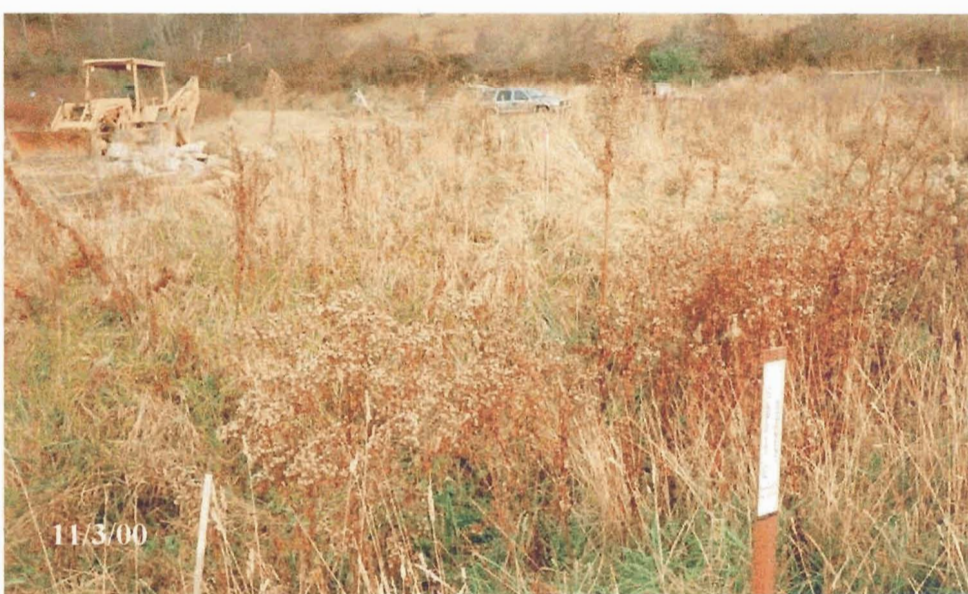
**Location of new channel at lower tie-in with existing stream, station 4+32.**

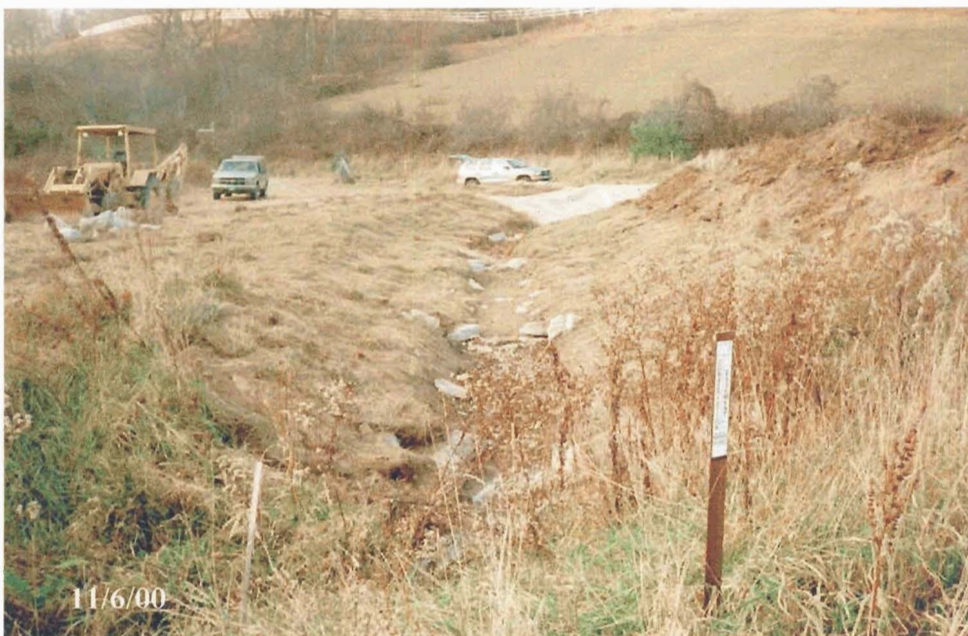
**Completed new channel before water is diverted into it. Looking upstream from station 4+32 to 3+16.**

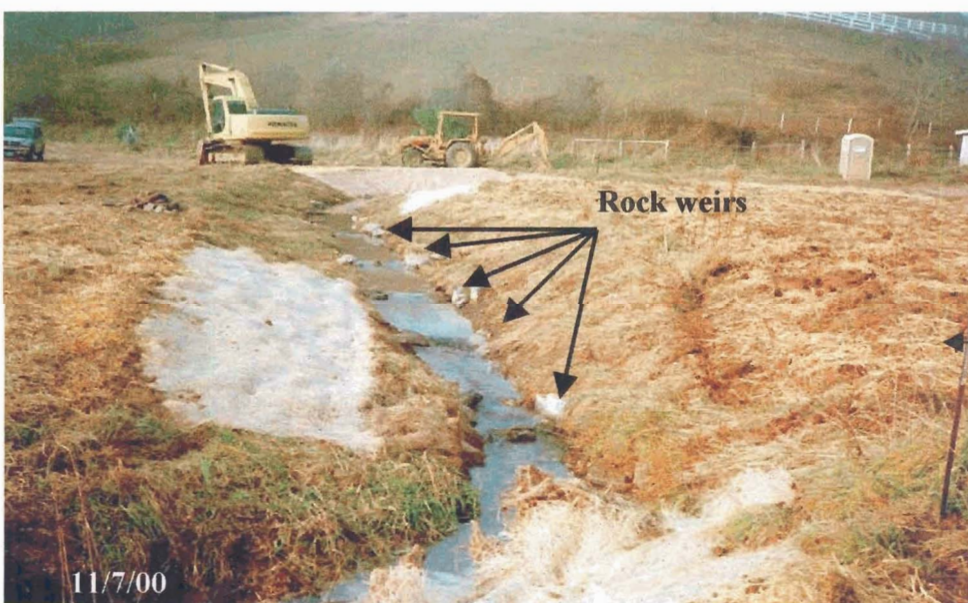
**New channel, lower section, looking upstream from station 4+32 to 3+16.**

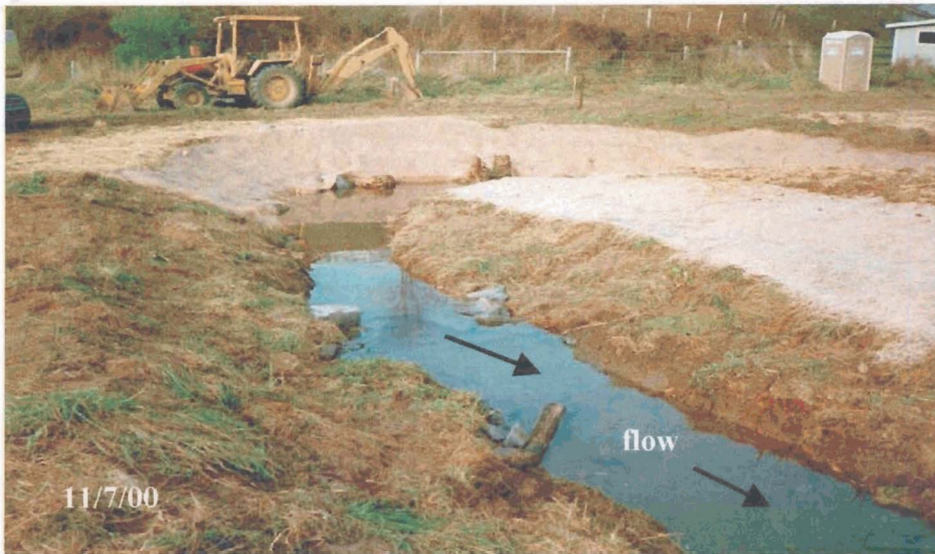
New channel showing first meander and deep run, station 3+46 to 3+16.

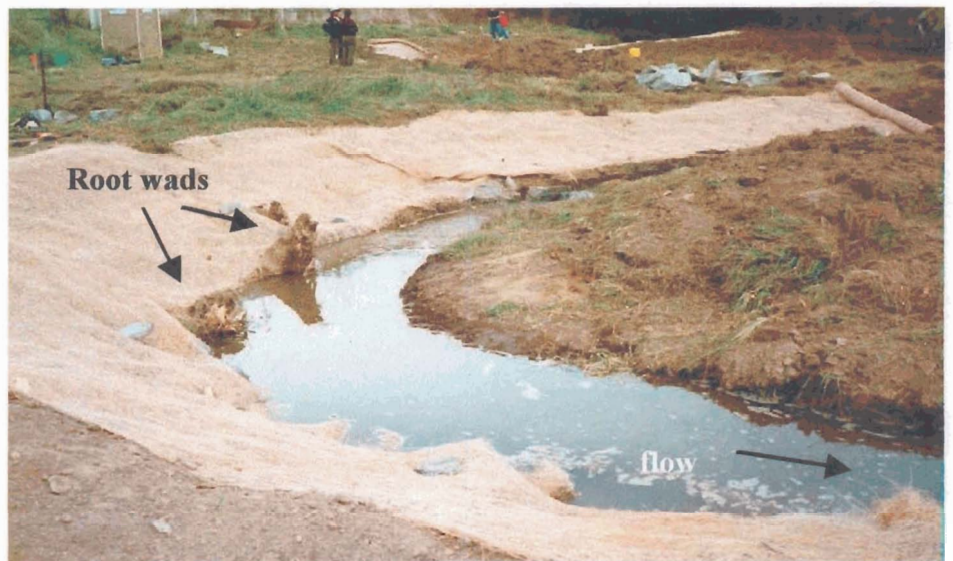
First meander showing root wads and constructed point bar, station 3+16.

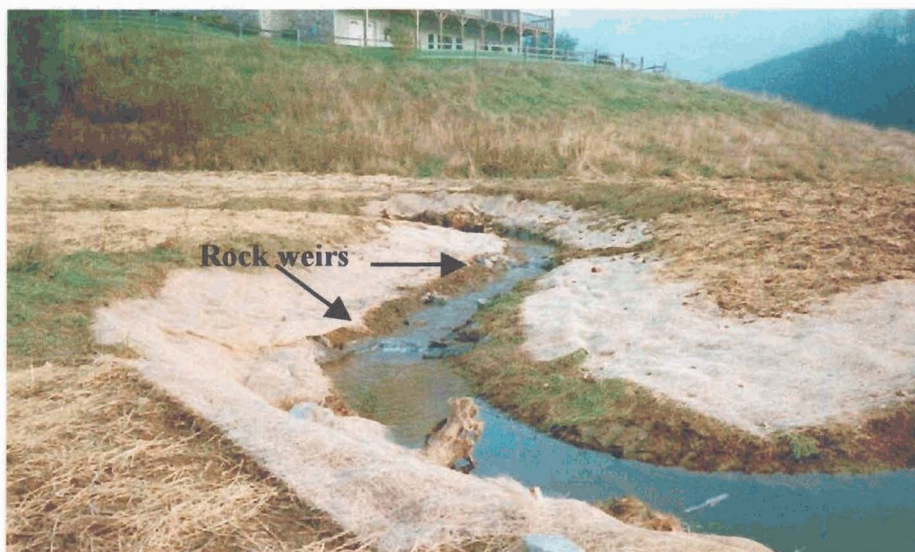
Looking upstream from first meander to second meander, station 3+16 to 2+46.

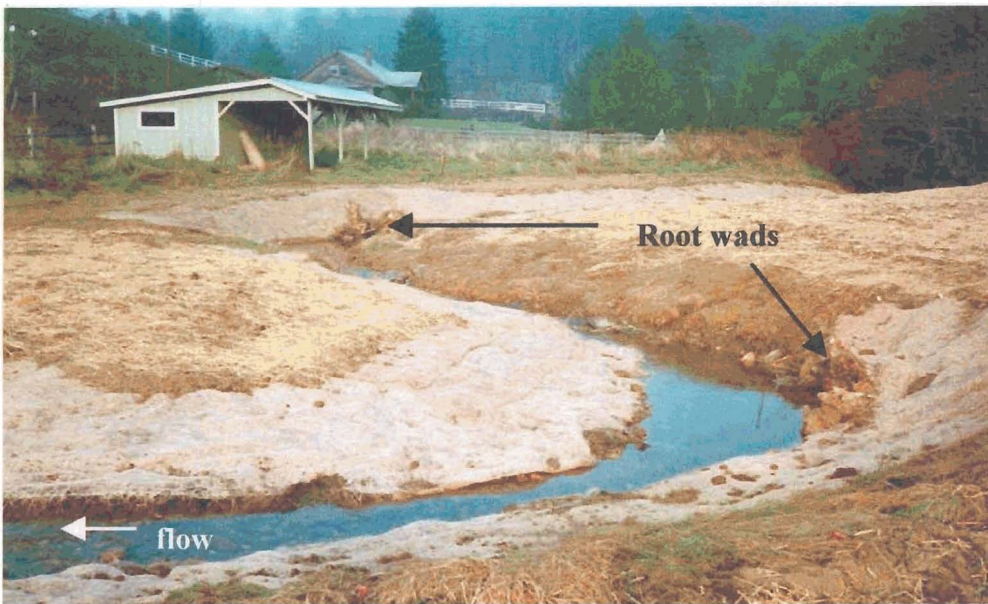
Looking upstream from second meander to third meander, station 2+46 to 1+59

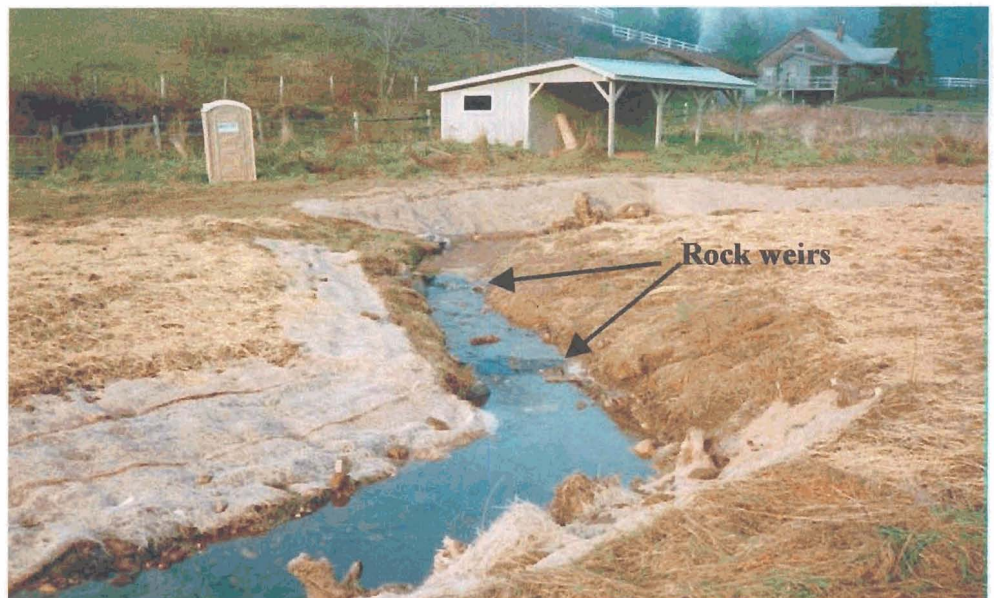
Riffle section between second and third meander, station 2+46 to 1+59.

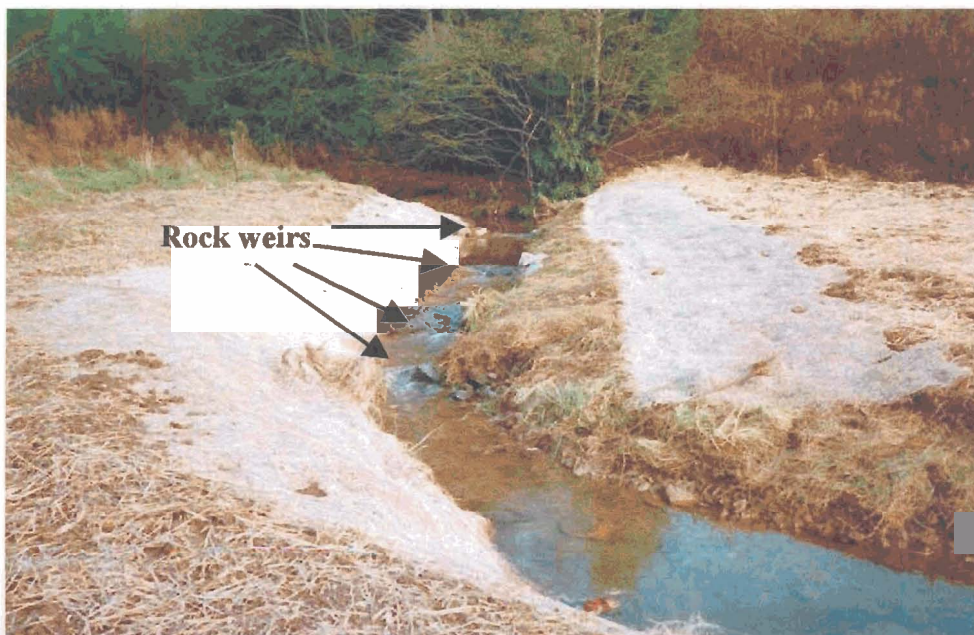
Looking upstream from third meander pool to tie-in with existing channel. Note the step/pool riffle complex, station 1+59 to 1+28.
