**CARP MITIGATION SITE, UNNAMED TRIBUTARY TO
LAXON CREEK, WATAUGA COUNTY**

Monitoring Report

**NORTH CAROLINA DEPARTMENT OF TRANSPORTATION STREAM
MITIGATION PROGRAM**

Period Covered: April 2, 2002 - April 15, 2003

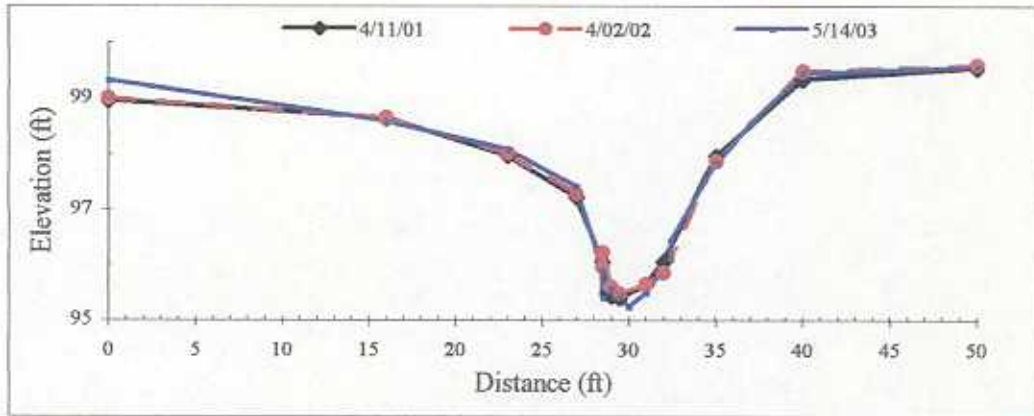
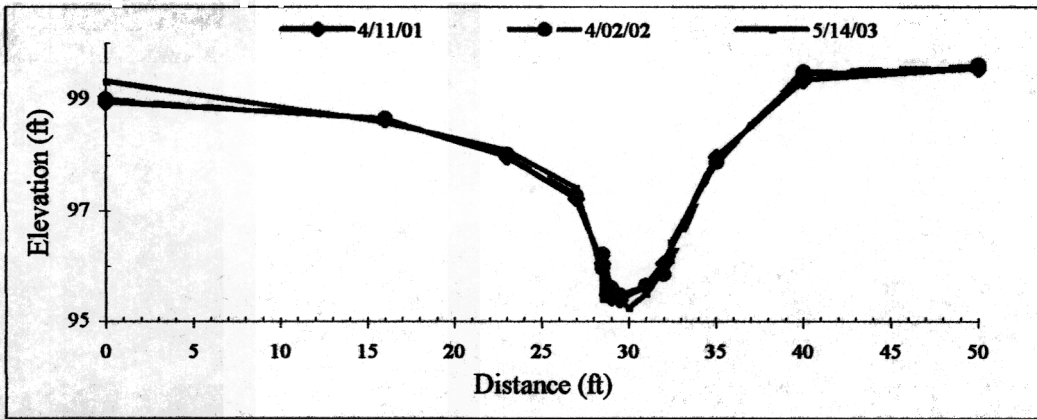
FIGURE 2.1. Cross-section station 1+69, stair step pool.

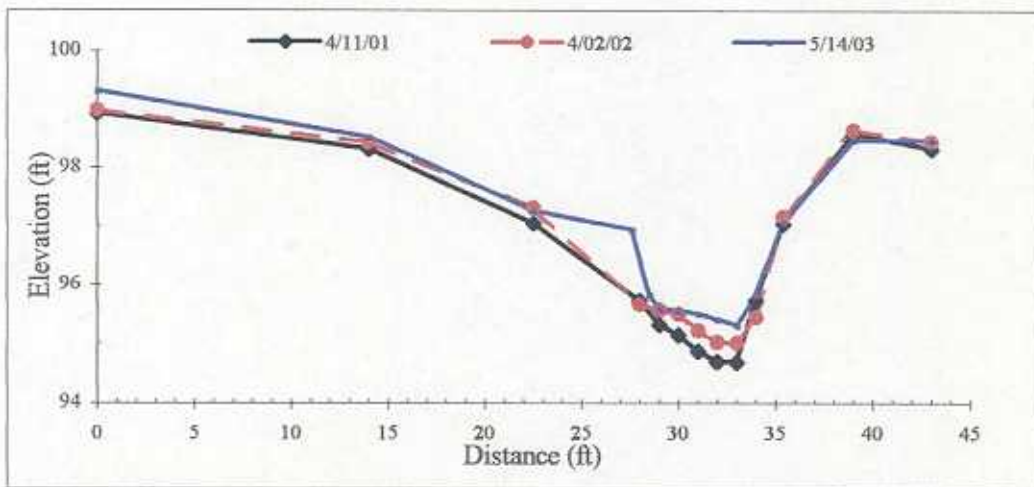
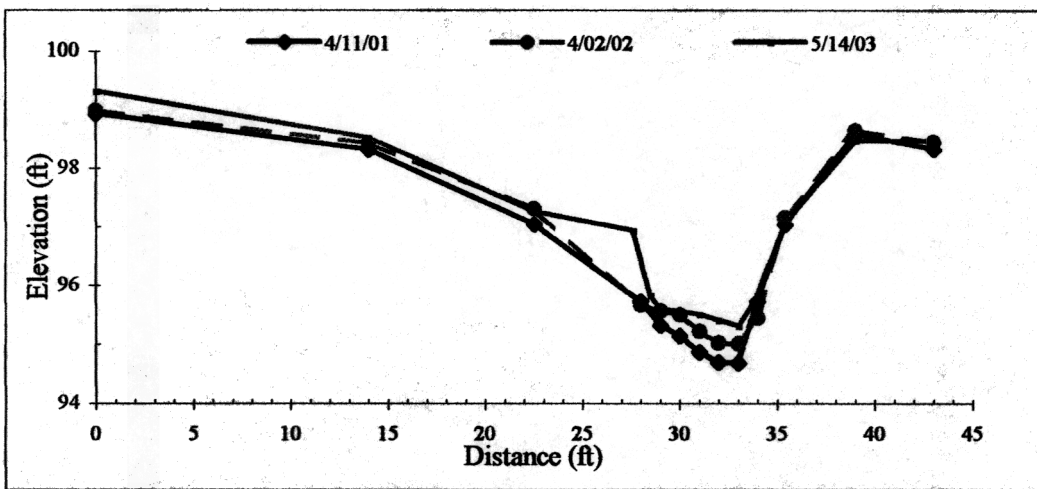
FIGURE 2.2. Cross-section station 1+94, pool.

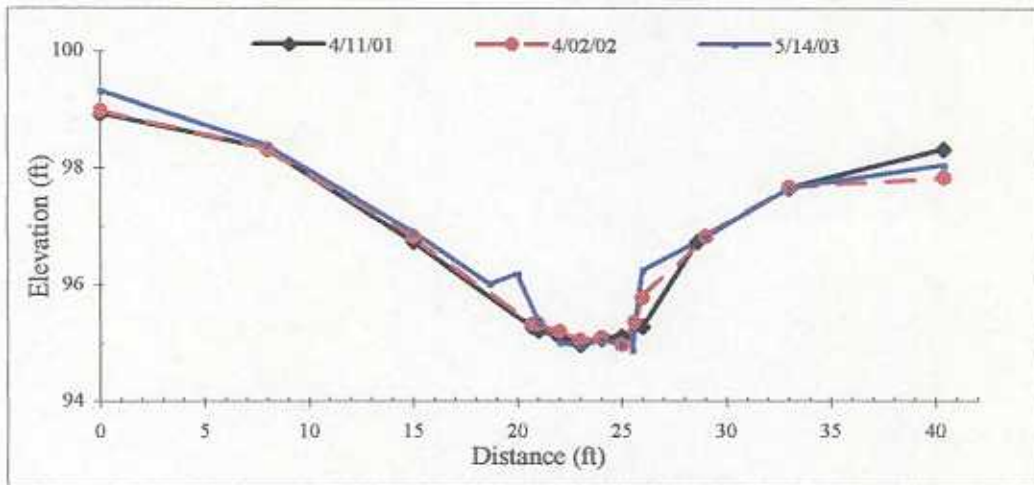
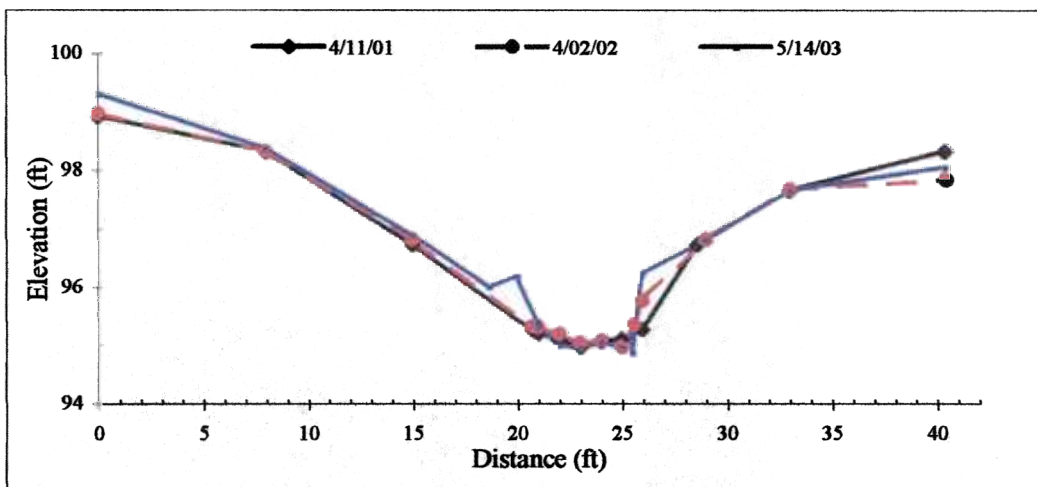
FIGURE 2.3. Cross-section station 2+24, riffle between rock weirs.

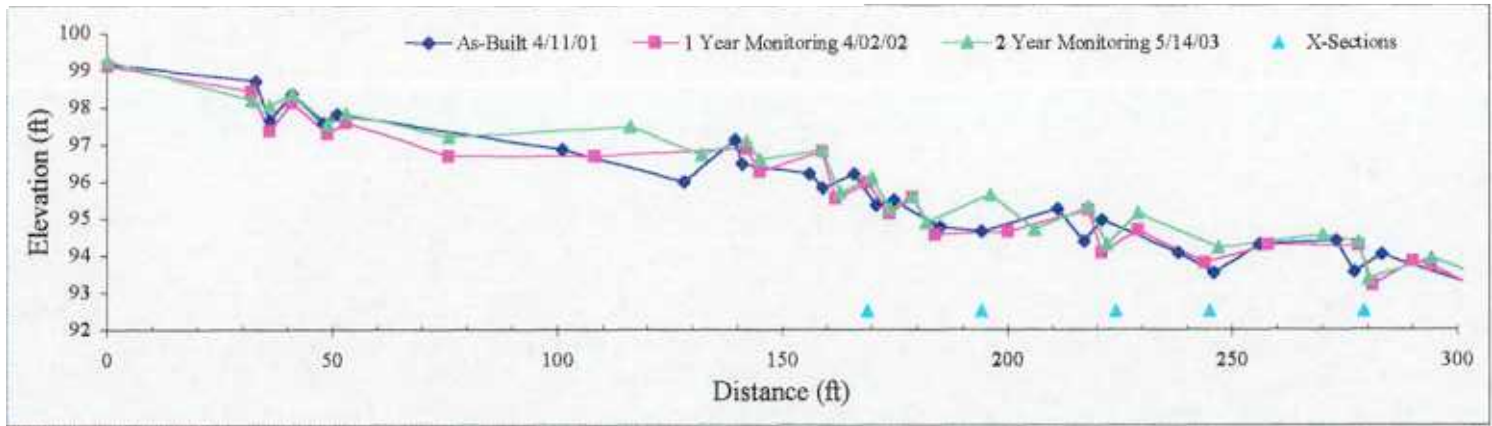
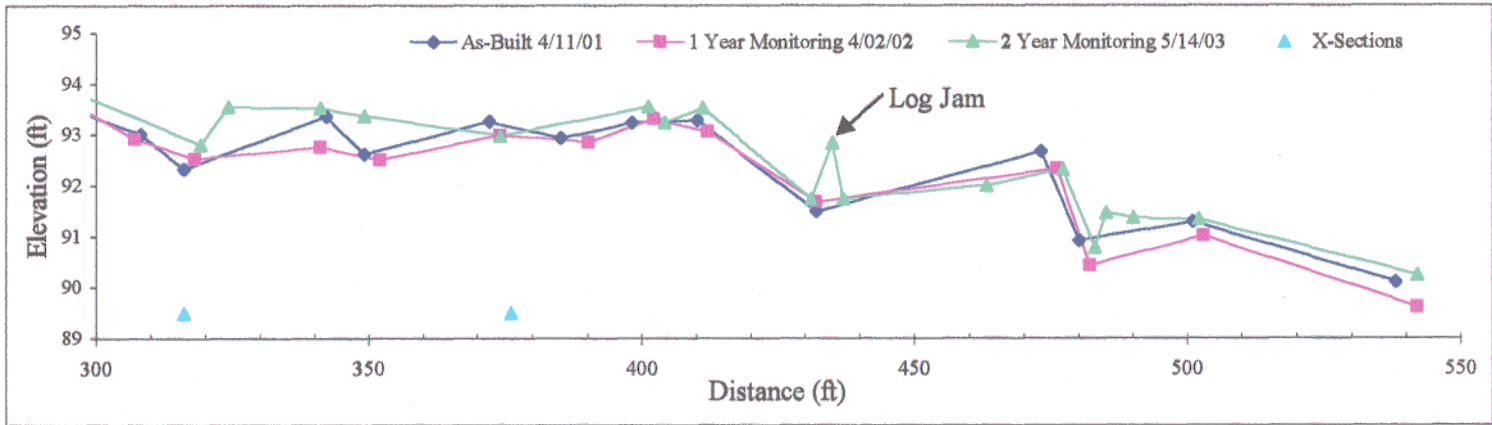
Longitudinal profile data were collected from the 542 linear feet of restored stream. Longitudinal profiles were overlaid to show changes in bed form from previous years (Figure 3). The as-built survey data showed there were 44% pools in 2001 (Mickey and Scott), whereas in 2002 and 2003 pool habitat comprised 44% and 42% of the total reach. The longitudinal profile revealed some bed aggradation at stations 0+55-1+45, 3+24-3+76 and 4+90-5+42. A debris jam was located at station 4+35.

There has been some change in the as-built longitudinal profile when compared to the 2002 and 2003 profiles. Pool habitat has remained fairly constant since the as-built survey. There has been some aggradation of materials at some locations and some deepening at other locations; however, none of this activity indicates a migration towards an unstable stream channel. These changes appear to be normal stream adjustments to stream flow and weather conditions. The bed aggradation observed at stations 0+55-1+45 appears to be a natural stream channel adjustment since there was no construction work done at or upstream of this point. The aggradation at the long pool/glide constructed at stations 3+24-3+76 is also the result of natural channel processes. The aggradation at stations 4+90-5+42 is probably the direct result of existing streambed levels taken during 2001, 2002 and 2003 at the confluence with Laxon Creek (station 5+42). There has been no shift in the meander pattern as the stream has remained stable and in-stream structures are functioning as designed. No bank scour or erosion was evident and no problems were noted with any of the structures.

FIGURE 3. Longitudinal profile comparisons between post-construction, 04/11/01, and monitoring, 04/02/03 and 05/14/03, at the Carp mitigation site, unnamed tributary to Laxon Creek, Watauga County, 2001-2003.

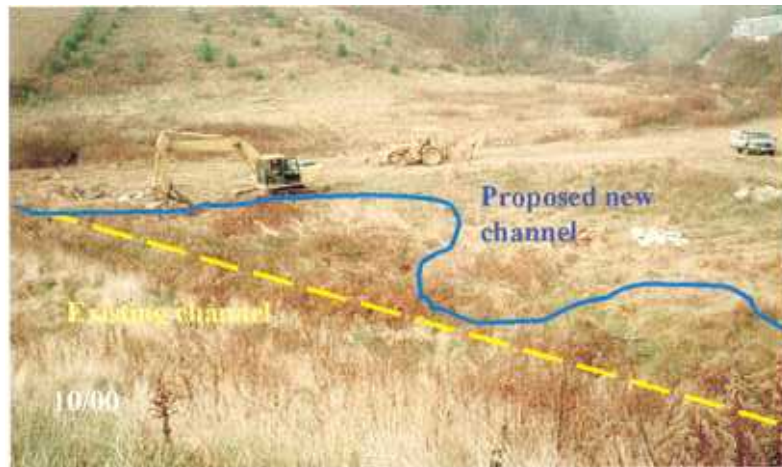
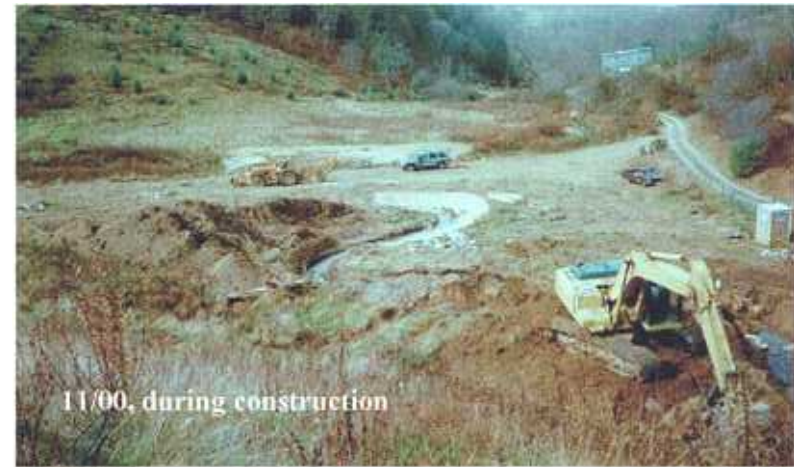
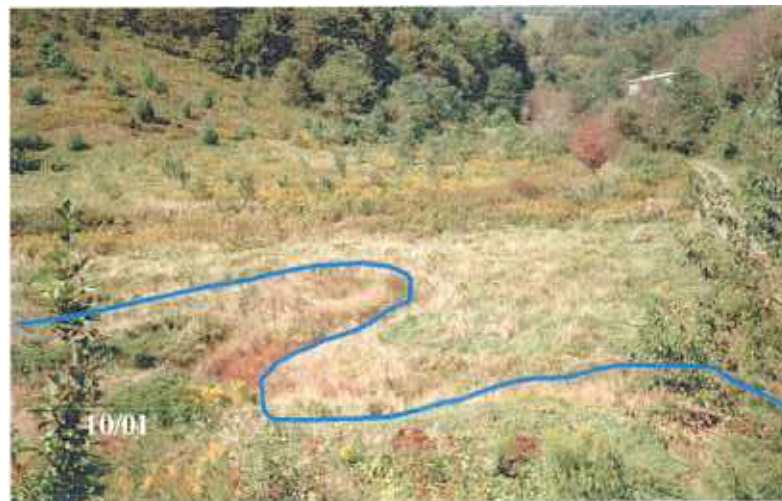
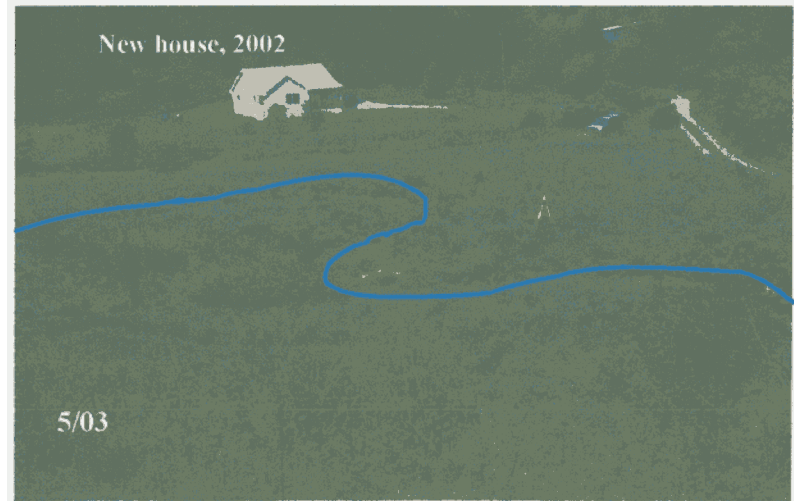
Reference photographs show a maturing riparian buffer. Photographs also show bank stability from year to year with no development of unstable depositional areas or bank erosion along the reach (Appendix 2).

FIGURE A2 —Overview of Carp site showing pre-construction, construction, and post-construction conditions, 2000-2003.

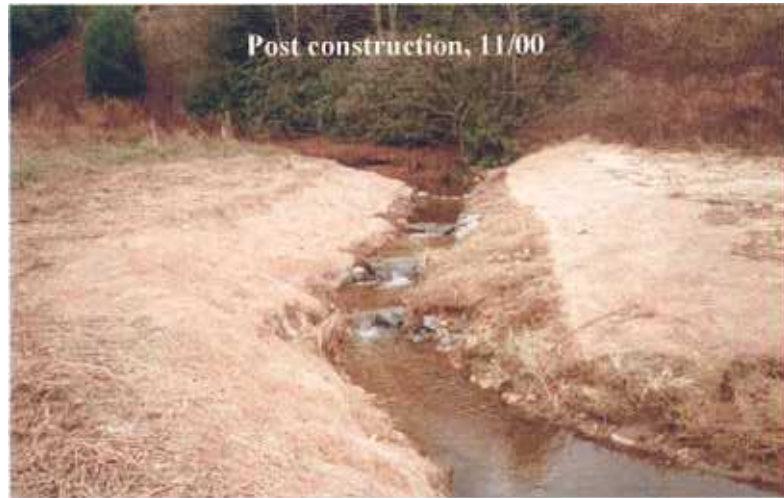
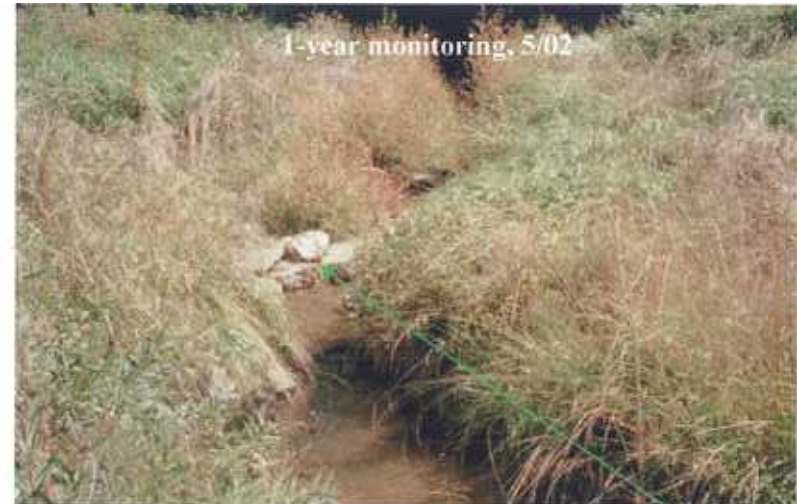
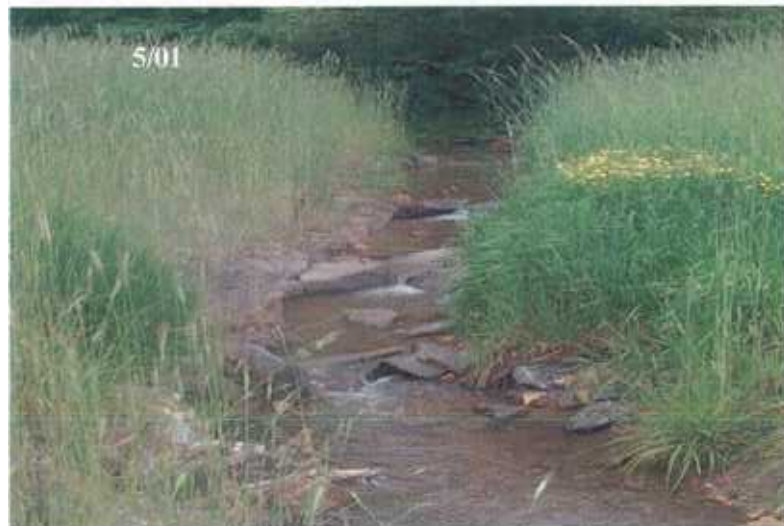
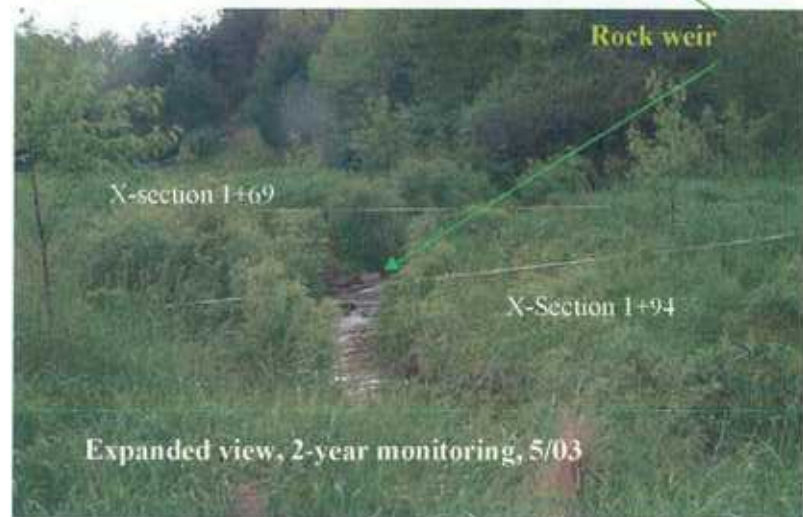
FIGURE A2.2.—Upper end of channel showing stable step pools, looking upstream from station +82 to +92.
