**As-Built Baseline Monitoring Report**

**CATBIRD SITE**

NCDMS Project #100022 (Contract #7186)

**July 2020**

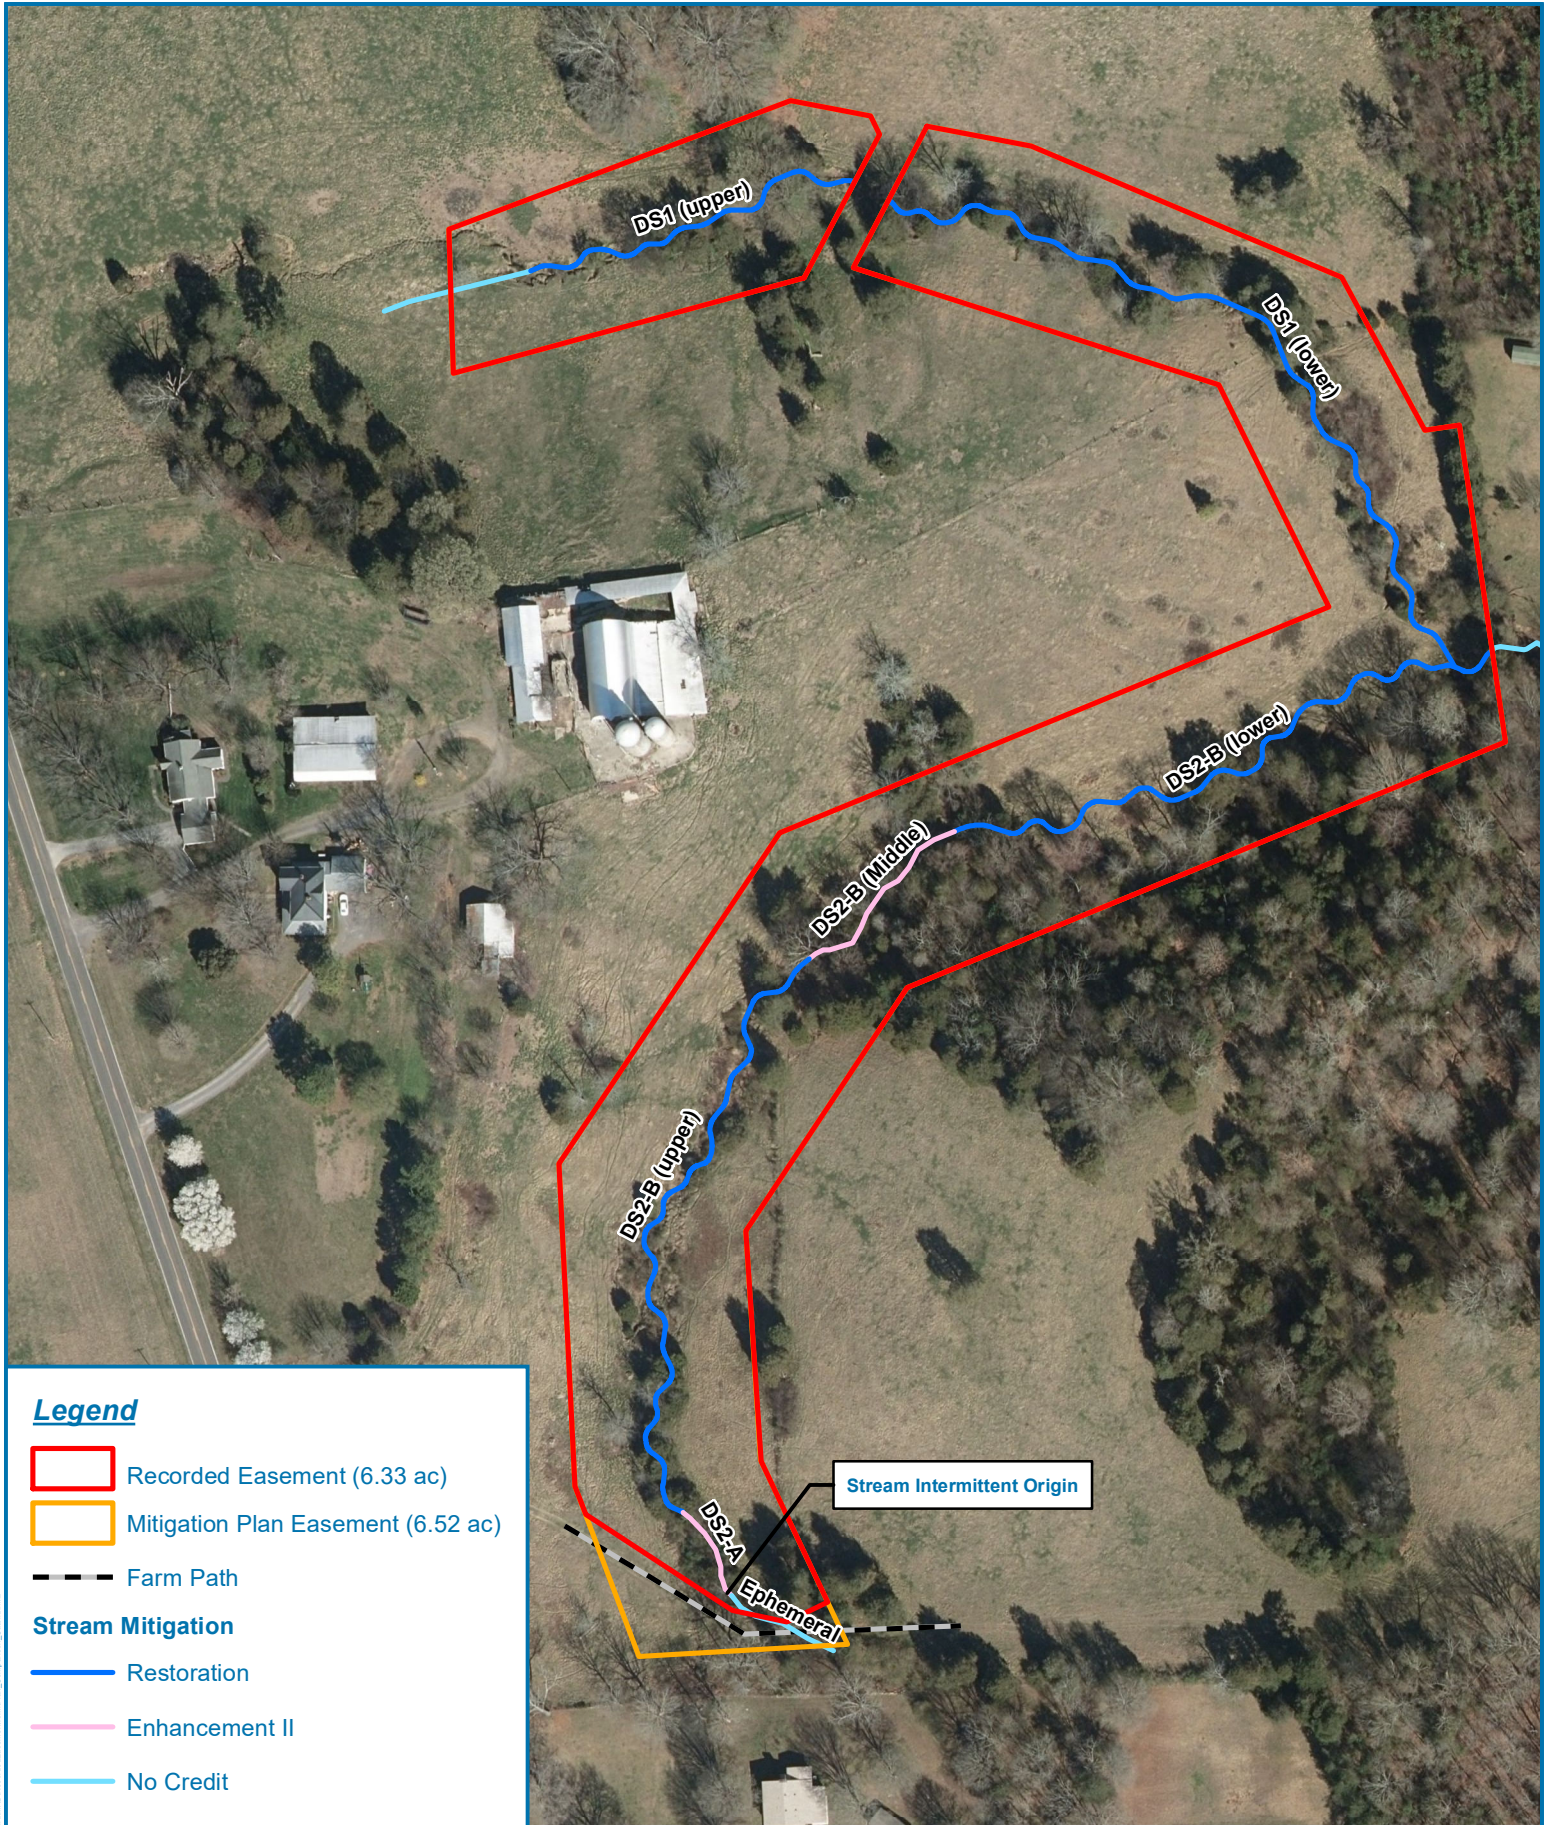
## Easement Comparison Map

Uncredited reach is shown as white against a white background in the legend. Please use a color/pattern that is visible.

Please modify figure and report tables as discussed, to reflect accurate crediting and discussion of easement adjustment vs. mitigation plan, at upper limit of DS2-A. Please provide the resulting final digital support files for review.

[Done.](#)
