Year 1 Monitoring Report

CATBIRD SITE

NCDMS Project #100022 (Contract #7186)
USACE Action ID: SAW-2017-01506
DWR Project #20171039

Davie County, North Carolina
Yadkin River Basin
HUC 03040101

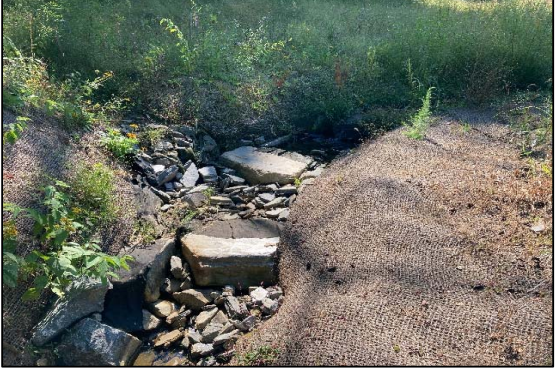
Visual assessment of the stream channel was performed to document signs of instability, such as eroding banks, structural instability, or excessive sedimentation. The channel is transporting sediment as designed and will continue to be monitored for aggradation and degradation. The rock drop structure below the confluence of DS2-B and DS-1 began piping again at the end of MY1. RES plans to rebuild this structure with smaller rock material in early 2021. RES does not believe this failing structure is an immediate threat to the project streams.

Stream Problem Areas Catbird	
Feature Issue / Location	Photo
Failing Rock Drop Structure / DS2-B

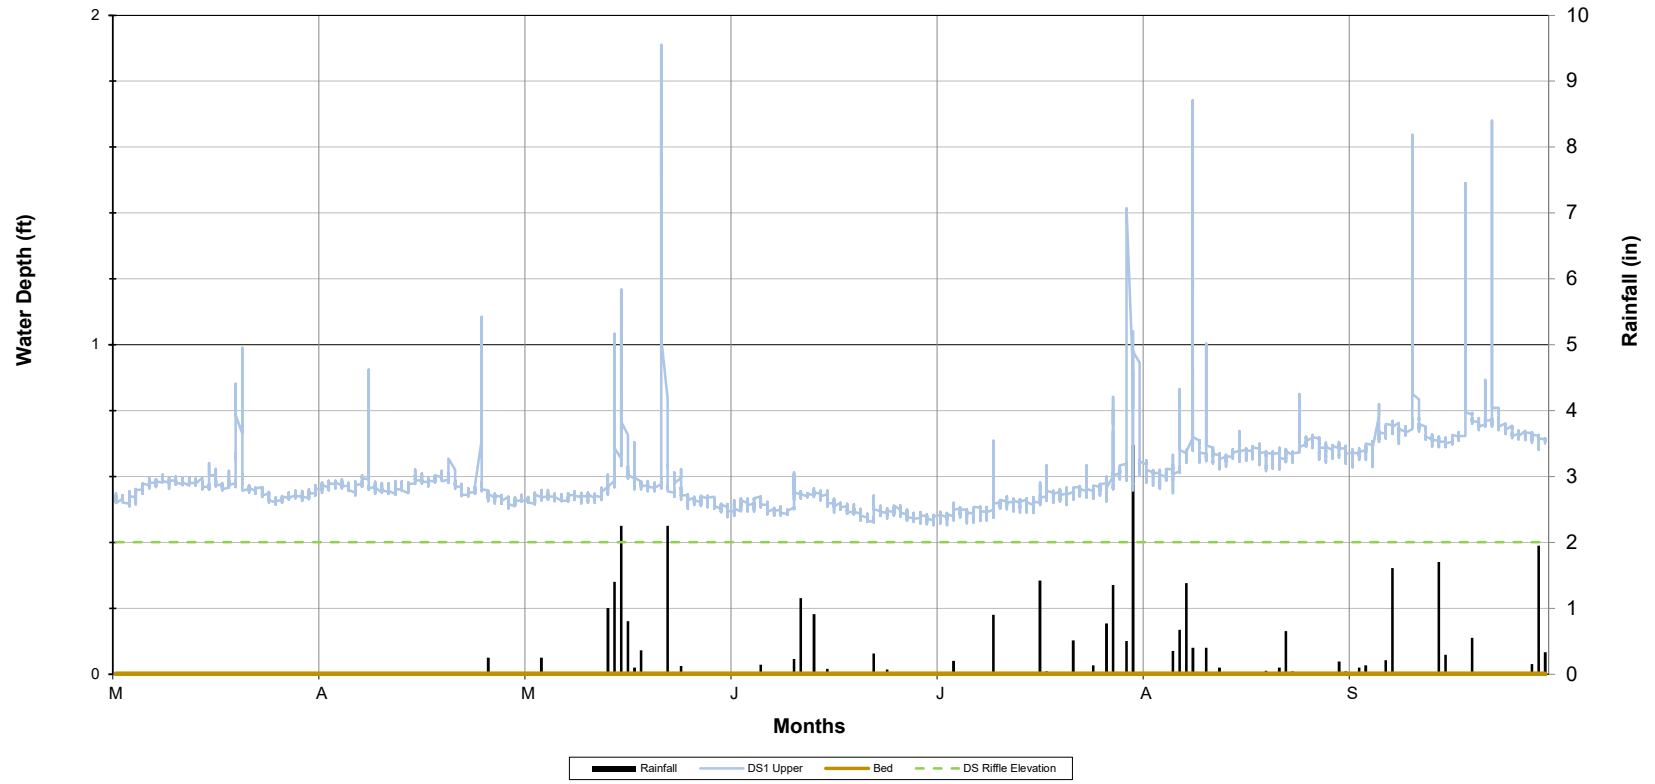
MY1 Catbird Flow Gauge DS1 Upper Stream Flow Hydrograph

Two stage recorders and one flow gauge were installed on March 4, 2020: one stage recorder on DS1 (Lower), one stage recorder on DS2-B (Lower) and one flow gauge on DS1 (Upper). The stage recorder on DS1 (Lower) recorded eight bankfull events in MY1 with the highest reading being 0.92 feet above top of bank. The stage recorder on DS2-B (Lower) also recorded eight bankfull events with the highest reading being 0.62 feet above top of bank. The flow gauge on DS1 (Upper) recorded one flow event lasting 215 consecutive days. Gauge locations can be found on Figure 2 and data are in **Appendix E**.
