Year 3 Monitoring Report

CATBIRD SITE

NCDMS Project #100022 (Contract #7186)
USACE Action ID: SAW-2017-01506
DWR Project #20171039

RE: Catbird Site: Year 3 Monitoring Report (NCDMS ID 100022)

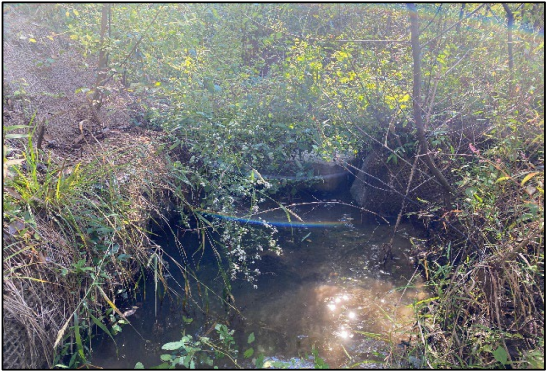
Visual assessment of the stream channel was performed to document signs of instability, such as eroding banks, structural instability, or excessive sedimentation. The channel is transporting sediment as designed and will continue to be monitored for aggradation and degradation. The rock drop structure below the

confluence of DS2-B and DS-1 that was repaired this structure with smaller rock material, as designed, in April 2021 is stable and functioning as intended.

Stream Problem Areas Catbird	
Feature Issue / Location	Photo
<p>Failing Rock Drop Structure / DS2-B (Repaired April 2021)</p>

Stream construction and planting was completed in March 2020. The Catbird Site was built to design plans and guidelines. Two structures were identified as needing repair during the initial post-construction site visit with DMS. The first was located at the top of DS-B (Lower) and included resetting a rock sill. The second was on the bottom of DS2-B (Lower) (below the confluence with DS-1) where a rock drop structure

was repaired, and the left bank was graded to alleviate shear stress. The first area was repaired in April 2020 and the second was repaired in June 2020.

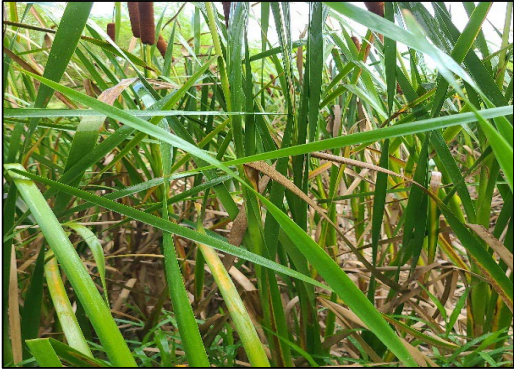
Vegetation Problem Areas Catbird	
Feature Category / Location / Size	Photo
<p>Cattail Foliar Spray Treatment (DS1)</p>

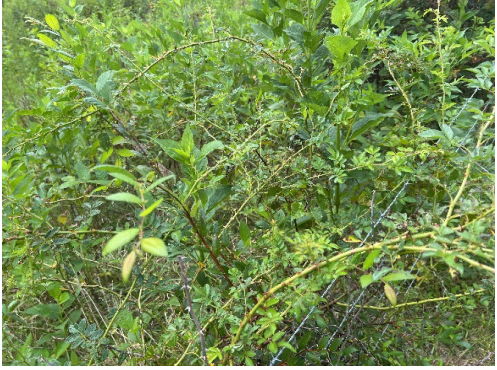
<p>Mutliflora rose Foliar Spray Treatment (DS1)</p>

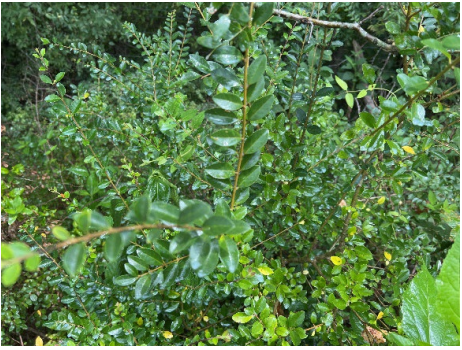
<p>Chinese privet Foliar Spray Treatment (DS1)</p>
